**URGENT Field Safety Notice**

Trilogy EV300 and Trilogy Evo O2

August 2021

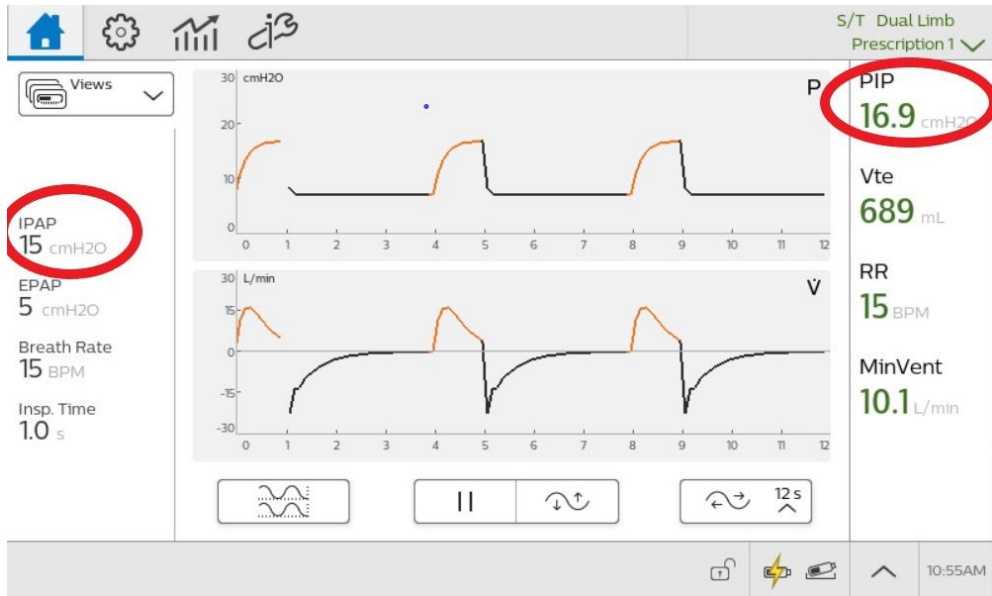
The following methods should be used to inspect the device to determine if a pressure drift has occurred as the pressure alarms will not detect it:

The caregiver/clinician can detect the increase in pressure by observing the measured parameters on the device's screen (measured PIP value or pressure waveform as shown below where the IPAP is set to 15 cmH<sub>2</sub>O but because of the pressure increase the actual delivered pressure is 16.9 cmH<sub>2</sub>O).

**If a pressure drift is detected, the decision to reset the device and return to its original, intended settings MUST be made in consultation with a clinician. Take steps to support the patient during a brief interruption in therapy, as needed.**
