URGENT - Field Safety Notice

Philips EPIQ Ultrasound Systems
Control Panel Arm Swivel Locking Failure

12-JUL-2021

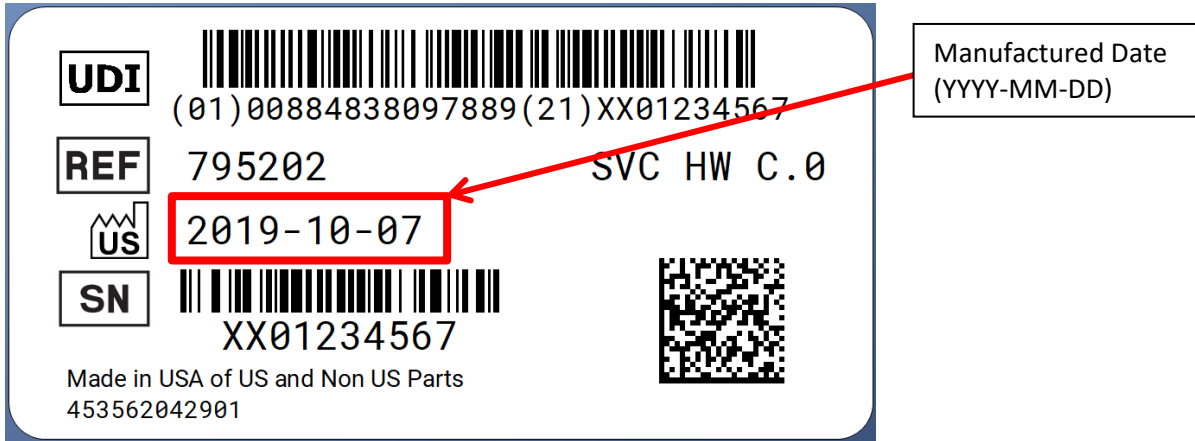
System	Model	Manufactured
EPIQ	EPIQ Elite EPIQ 5G EPIQ 5C EPIQ 5W EPIQ 7G EPIQ 7C EPIQ 7W EPIQ CVx EPIQ CVxi	Between 2020-02-27 to 2021-05-25 (Refer to the main system label shown below for the manufactured date)
