**Urgent Field Safety Notice**  
**Medtronic HeartWare™ HVAD™ System**  
 Customer Notification

August 2021

Medtronic reference: FA1180

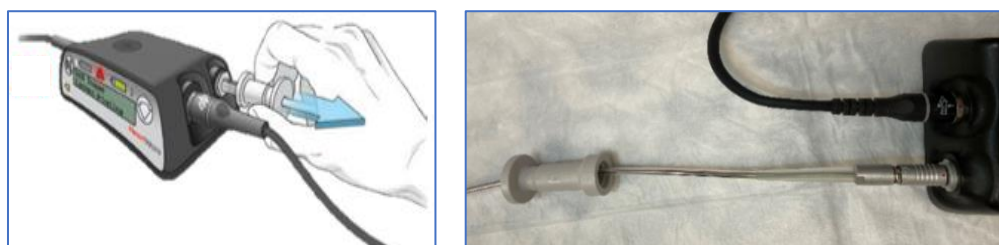
Figure 1

Difficulty in pulling back the driveline cover over a strain relief repair may cause a delay in accessing the driveline connector. This delay may lead to a prolonged pump stop if access to the driveline connector is required to address a marginal driveline connection or change controllers. In addition, pulling back the driveline cover over a driveline strain relief repair may compromise the integrity of the repair. In lab testing, the most common issue observed was the tape that overlaps the end of the driveline connector rolled back when pulling the driveline cover away from the controller.

A strain relief repair is intended to repair damage to the strain relief without requiring pump-off time for a driveline splice repair or a pump exchange. The potential difficulty in pulling back the driveline cover over the repair is not currently included in the labeling; therefore, we are communicating to clinicians so they can make informed risk/benefit decisions and appropriately manage their patients. Pulling back the driveline cover is required to access the driveline connector (see figure 1 below), for example, during a controller exchange to disconnect the driveline from the controller.

- Leave the driveline cover in place. Medtronic does not recommend to tamper with or cut off the Driveline cover or otherwise remove it.
- Advise patients that, whenever possible, controller exchanges should be performed under clinical supervision, as it will likely be difficult to pull back the driveline cover to access the driveline connector. When a prospective controller exchange is planned (e.g., when exchanging a controller that has exceeded its 2-year useful life), schedule a Medtronic Field Service Engineer to be present to assess the strain relief repair and evaluate the need for a splice repair, a more extensive repair requiring brief pump off time which replaces the distal end of the driveline including the connector and strain relief.

- Consider a splice repair to replace the portion of the driveline outside the patient's body. A splice repair requires pump-off time to replace the damaged area. The decision to perform a splice repair should be made on a case-by-case basis, considering the unique risks for each patient's ability to withstand pump-off time and risk acceptance.
