**Urgent Field Safety Notice**  
**Medtronic HeartWare™ HVAD™ System**  
 Customer Notification

August 2021

Medtronic reference: FA1180

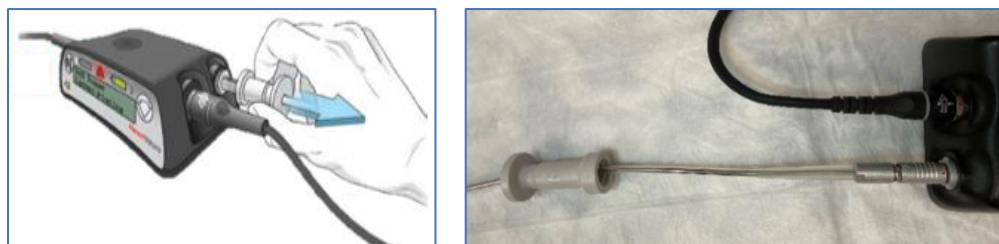
Figure 1

**Our records indicate that one or more of your patients' HVAD Systems has had a strain relief repair.** Medtronic internal testing has shown that it may be difficult to pull back the driveline cover over a strain relief repair when attempting to access the driveline connector. On the next page, we have provided the Medtronic patient management recommendations associated with difficulty in pulling back the driveline cover.

Difficulty in pulling back the driveline cover over a strain relief repair may cause a delay in accessing the driveline connector. This delay may lead to a prolonged pump stop if access to the driveline connector is required to address a marginal driveline connection or to change controllers. In addition, pulling back the driveline cover over a driveline strain relief repair may compromise the integrity of the repair. In lab testing, the most common issue observed was the tape that overlaps the end of the driveline connector rolled back when pulling the driveline cover away from the controller.

A strain relief repair is intended to repair damage to the strain relief without requiring pump-off time for a driveline splice repair or a pump exchange. The potential difficulty in pulling back the driveline cover over the repair is not currently included in the labeling; therefore, we are communicating to clinicians so they can make informed risk/benefit decisions and appropriately manage their patients. Pulling back the driveline cover is required to access the driveline connector (see figure 1 below), for example, during a controller exchange to disconnect the driveline from the controller.

- Leave the driveline cover in place. Medtronic does not recommend to tamper with or cut off the Driveline cover or otherwise remove it.
- Advise patients that, whenever possible, controller exchanges should be performed under clinical supervision, as it will likely be difficult to pull back the driveline cover to access the driveline connector. When a prospective controller exchange is planned (e.g. when exchanging a controller that has exceeded its 2 year useful life), schedule a Medtronic Field Service Engineer to be present to assess the strain relief repair and evaluate the need for a splice repair, a more extensive repair requiring brief pump off time which replaces the distal end of the driveline including the connector and strain relief.

- Consider a splice repair to replace the portion of the driveline outside the patient's body. A splice repair requires pump-off time to replace the damaged area. The decision to perform a splice repair should be made on a case-by-case basis, considering the unique risks for each patient's ability to withstand pump-off time and risk acceptance.
