**URGENT FIELD SAFETY NOTICE
UPDATED**

Philips EPIQ & Affiniti Ultrasound Systems
System Lock-Up Issue and PW Doppler
Signal Dual Mode Issue

October 2021

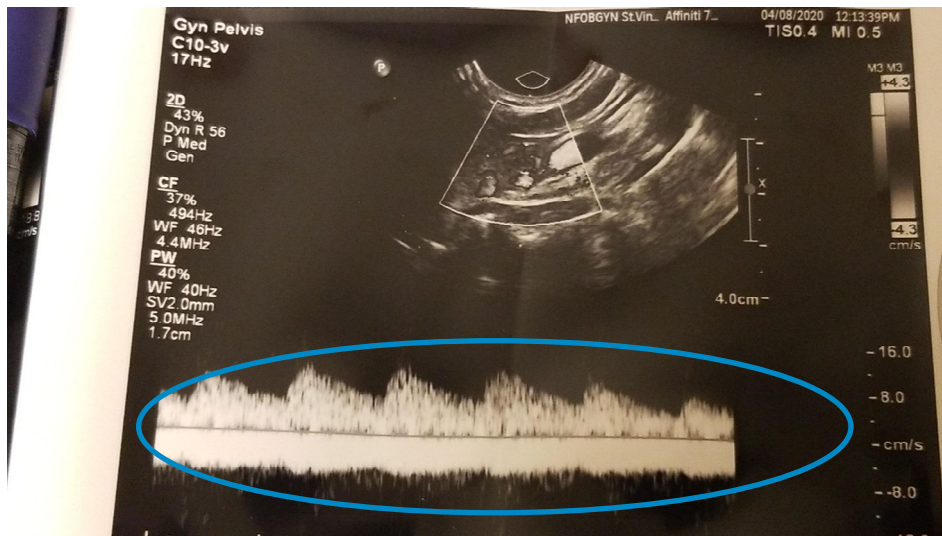
Figure 1 shows a normal PW Doppler signal, highlighted in the blue oval. When the issue occurs, this signal is compromised as shown in Figure 2 below, highlighted by the red oval.

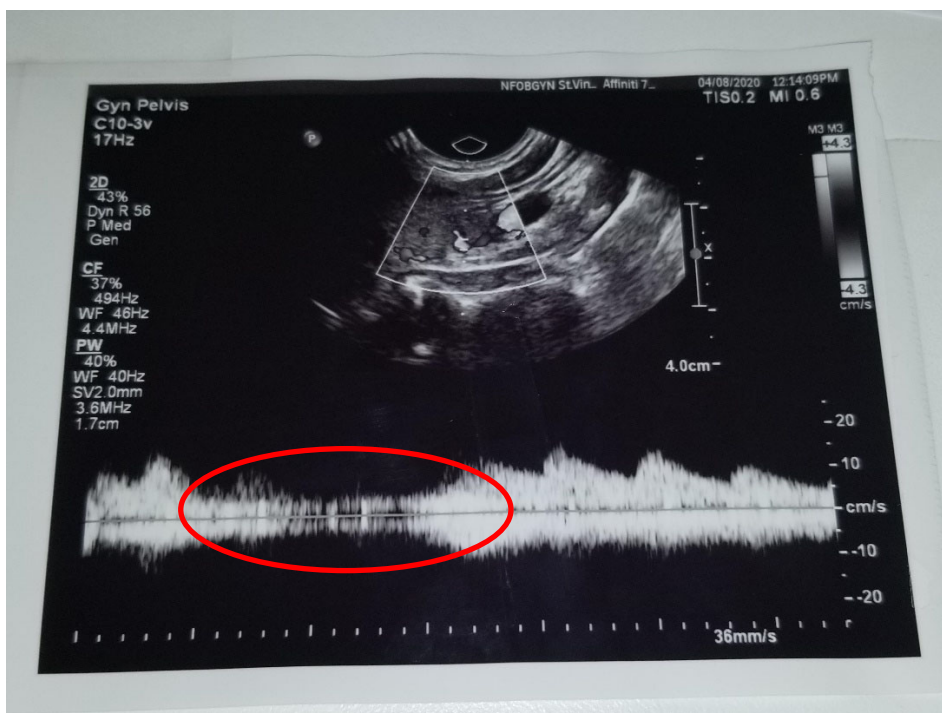
Figure 2

Philips Ultrasound has identified an issue where the Pulse Wave (PW) Doppler signal, both visual and audio can be compromised under specific workflows.

The issue occurs if a user enters Dual Mode, exits Dual Mode and then turns on the PW Doppler signal. The PW Doppler signal cannot be engaged while in Dual Mode, so the user must leave this Mode to use PW Doppler. At this point, having been in Dual Mode creates the issue in the PW Doppler Signal.

The PW Doppler function can be used prior to entering Dual Mode. This avoids the issue by **preventing** the Dual Mode from impacting the use of the PW Doppler function.

- 1) The user can reselect the transducer after exiting Dual Mode which will resolve the issue in the signal allowing normal use of the PW Doppler function. Note, this mitigation would need to be used each time the user goes into and exits Dual Mode. Note, any function which reselects the transducer, such as closing and opening the exam will also solve the problem.
- 2) The user can validate their PW Doppler signal using a different Doppler Mode such as Color Doppler. Color Doppler is not affected by this issue. Note, Color Doppler is a different clinical function. However, its output correlates to the PW Doppler output to indicate to the user there is a problem.

A Philips Field Service Engineer or Representative will contact you to schedule a software update for all ultrasound systems that have VMQ5.0., 5.0.1 or 5.0.2 software to permanently resolve these issues (reference FCO79500535).
