URGENT FIELD SAFETY NOTICE

Surgical Microscope Leica M220 F12
FSCA Identifier: CAPA-HER-MD-21-002
Additional Retention Fixture to secure M220 Optics Carrier

Heerbrugg, November 2nd, 2021
Leica Microsystems (Schweiz) AG

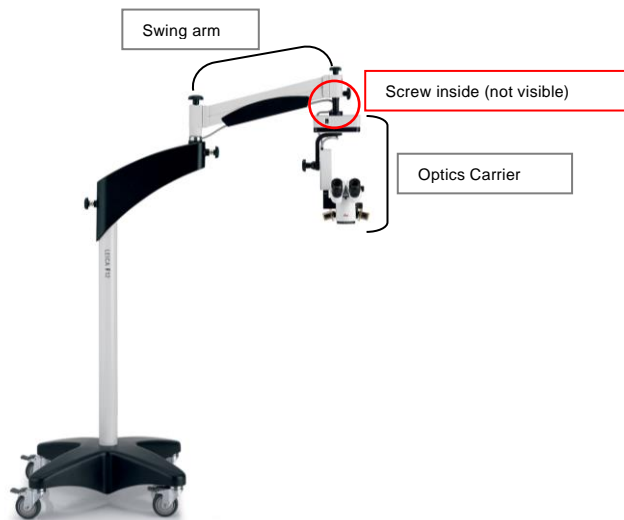
The identified defect is a mechanical part failure with the screw that connects the optics carrier to the free end of the swing arm (see Figure 1).

Figure 1: Leica M220 F12 Surgical Microscope

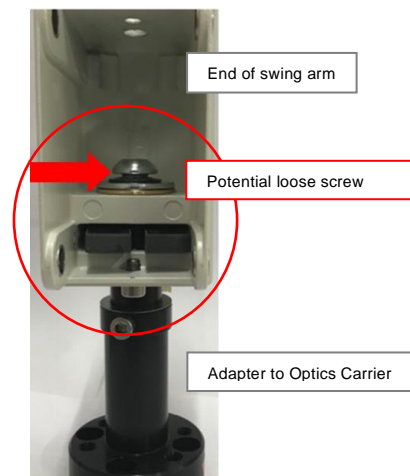
Figure 2: Potential loose screw connecting the swing arm with the optics carrier

Leica Microsystems has performed a thorough root cause investigation which has identified the cause of the observed issue to be insufficient securing of the screw that connects the swing arm with the optics carrier (see Figure 2). This screw was found to not be secured by an adequate amount of high strength thread adhesive to ensure a reliable connection of the swing arm with the optics carrier. This inadequate securing of the swing arm was not identified during production and final inspection of the M220 swing arms. These swing arms were then built into M220 F12 Surgical Microscopes manufactured before March 9th, 2017*. Due to this, the screw that connects the swing arm with the optics carrier has loosened over time (see Figure 2) and subsequently resulted in the optics carrier falling. Based on the results of the root cause investigation the probability of occurrence of this defect for the end user is very low.

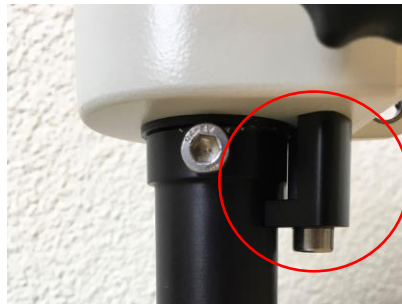
Figure 3: Detailed view of the retention fixture as an additional means of securing the M220 Optics Carrier

As a matter of precaution Leica Microsystems has chosen to initiate a field safety corrective action to provide a retention fixture (see Figure 3) to be added on all Leica M220 F12 Surgical Microscopes manufactured before March 9th, 2017 to ensure patient safety and customer satisfaction.

Your Leica Microsystems representative will provide you a retention fixture as an additional means of securing the M220 Optics Carrier free of charge.

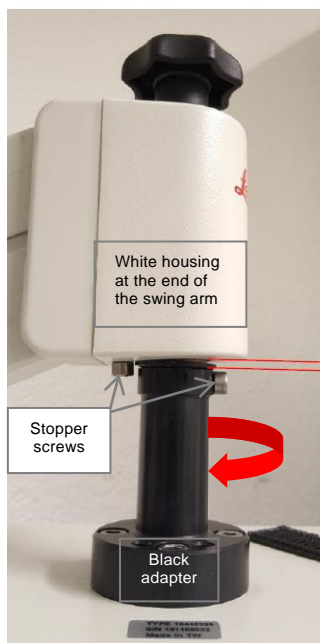
- If the gap between the black adapter and the white housing at the end of the swing arm becomes bigger than 3mm (see Figure 4) or a free rotation of the optics carrier is possible for more than 360° (see Figure 5): **→ Immediately stop using the device!**

Figure 4: Detailed view of gap between black adapter and white housing of swing arm.

X A gap bigger than 3mm or possible free rotation of the optics carrier for more than 360° indicates that the screw holding the adapter is loose and there is a potential risk that the optics carrier becomes disconnected and potentially fall.

In this case the M220 F12 can no longer be used.

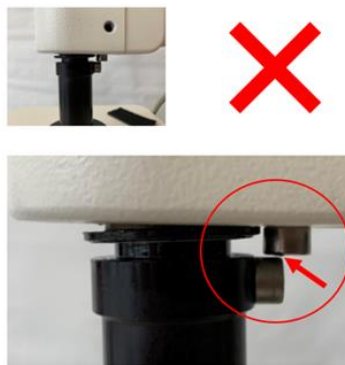
Figure 5: Detailed view of stopper screw when M220 F12 is faulty: Stopper screws are not effective and allow free rotation > 360°. **→ Immediately stop using the device!** The M220 F12 can no longer be used.

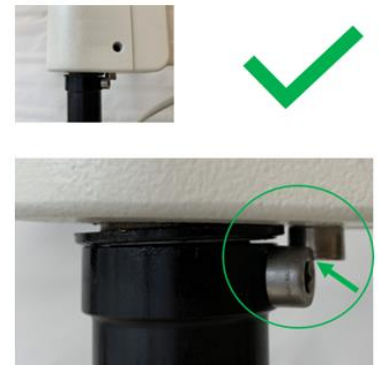
Figure 6: Detailed view of stopper screws when M220 F12 is according to specification: Stopper screws are effective and do NOT allow free rotation > 360°. **→ Instrument can be used as intended.** There is no risk for the optics carrier to disconnect from the swing arm and potentially fall.

✓ With a gap of less than 3mm, and it is NOT possible to rotate the optics carrier 360° the screw holding the adapter is NOT loose and the device can be continued to use as intended.
