Urgent Field Safety Notice

QIAcube® Connect MDx Instrument REF 9003070

QIAcube Connect MDx User Screen Issue – November 2021

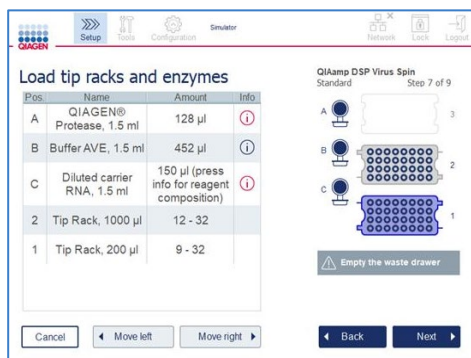
Figure 1 – Run Set-Up Screen.

The issue relates to information given during run set-up, which is intended to guide the user on the volumes of reagents to be added to the tube. During the “Load tip racks and enzymes” step of the run set-up, users have the option to access more detailed information by clicking the **Info** ⓘ button as shown in Figure 1. The screen then switches to a similar screen, as shown in Figure 2, containing the information that a **minimum volume** is to be added instead of the exact volume as detailed in Figure 1.

1. Follow instructions in the run set-up menu initial screen (Figure 1) and ensure that the volume detailed within the run set-up screen is adhered to using an actual volume only.
2. Upgrade to the latest version of the protocol which is due for release by 01 December 2021 and will be available at www.qiagen.com in the QIAcube Connect MDx instrument product page. Apart from correcting the protocol text, no other changes to the protocol will be implemented.
3. Complete the Acknowledgement of Receipt form attached in this letter and return it to QIAGEN ASAP.

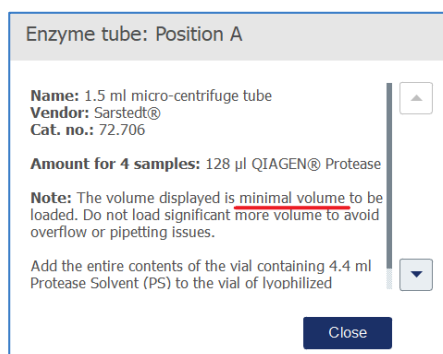
Figure 2 – Screen display after pressing ⓘ.

While the actual amount indicated is accurate, the additional information provided in the Note section does not clearly state that this volume should be exactly loaded onto the instrument.

If a user misunderstands the guidance on the info screen (Figure 2) and pipettes more than the recommended volume detailed on the run set-up screen (Figure 1), it is possible that the tubes will then contain either too much or not enough reagent. This could lead to an over diluted, under diluted, or improperly lysed sample, which in turn would affect downstream processing, leading to a false negative or false positive result, should it not be realized that there has been an issue with sample preparation process.

QIAGEN recognizes that this issue may impact your workflow and are currently updating and verifying the affected protocols. New versions of each protocol, as well as instructions on how to install the new versions will be in place by 01 December 2021. The new versions can be downloaded in the QIAcube Connect MDx instrument product page at www.qiagen.com.

QIAGEN have assessed the risk of the issue occurring during routine use of the affected protocol and have determined that this notification should be provided to all customers to ensure that they are informed to follow the information given on the screen in Figure 1 and to ignore the statement of the 'minimal volume' on screen 2. Once the customer is aware of the issue, it would be a suitable mitigation to avoid the risks highlighted within this communication.
