Hillrom™ Hillrom Luleå Nedre Vägen 100, 975 92 Luleå, Sweden	Field Safety Notice	FA 2021-010-002-LUL-001
---	----------------------------	--------------------------------

Field Action Identifier: **FA 2021-010-002-LUL-001**

Subject: Missing bushing on Liko M220 and M230 causing wear and potential for falls.

Commercial name of affected product: Liko M220, Liko M230

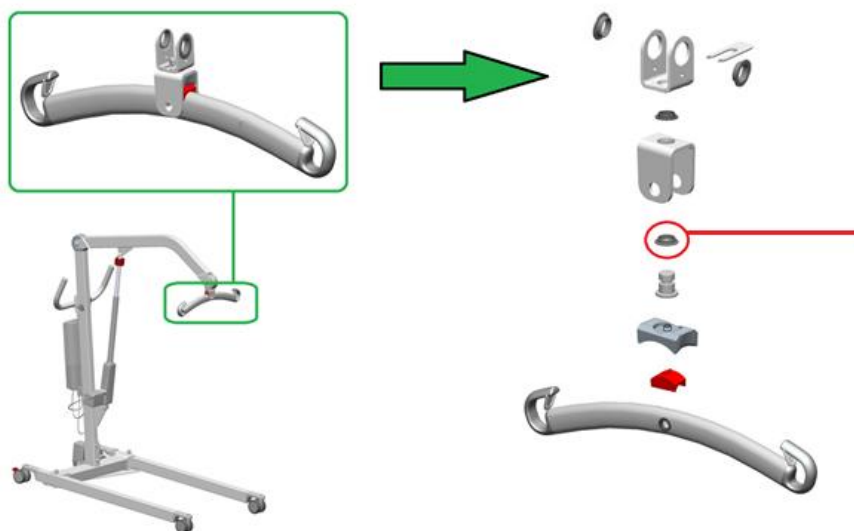
The sling bar on the Liko M220 and M230 mobile lift is locked into its position onto the lifting arm through two link plates, see figure 1. These two link plates are attached to each other through a bolt and a locking plate that allows for a rotation of the sling bar in one direction relative to the upper link plate.

Figure 1: Mechanism and parts included in the sling bar for M220/M230. Bushing marked in red.

Hillrom investigation determined that the root cause of the slingbar detachment is caused by wearing at the slingbar attachment due to the missing of a plastic bushing (see red markings in Figure 1) as part of the assembly during manufacturing of the device. It was determined that assembly of this device has the potential to not contain this plastic bushing on devices manufactured between 2016-DEC-27 and 2021-SEP-01.

A missing plastic bushing on the device can cause wearing on the slingbar attachment. Over time, this wearing can cause the slingbar to detach from the lift, which may result in a patient fall. Hillrom can confirm there have been no death or serious injuries reported from this failure.

Upon receipt of the response form, identifying potentially impacted devices, Hillrom or an official Hillrom distributor/representative will be in contact to schedule inspection of your device to confirm presence of the bushing. Where it is confirmed that the device is missing the bushing, a replacement slingbar with the bushing will be installed.

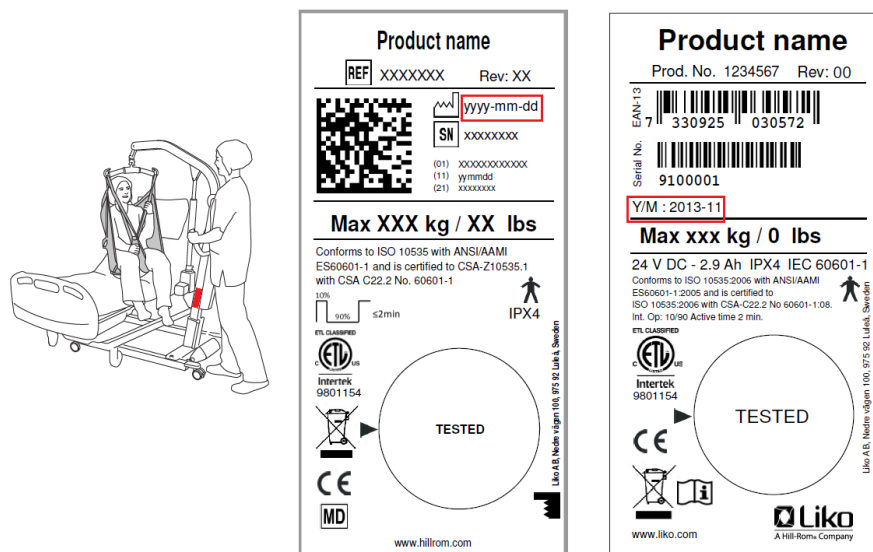
Figure 2: Placement of the label and its designs. Left: New design. Right: Old design.

1. Review the product label on your Liko M220/M230 to determine if it is impacted by this field action by identifying the manufacturing date of the device (i.e. Manufacturing date between 2016-DEC-27 and 2021-SEP-01). See figure 2.
