## **Urgent Field Safety Notice**

**FSN Ref:** FSN\_PR20210830-01\_EN\_CH

### **Risk of unstable fixation of accessories**

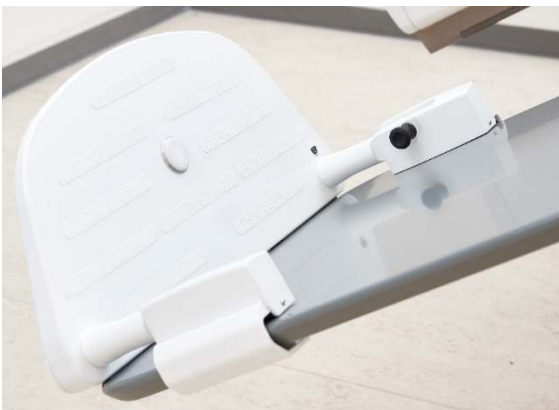
03282000 - Footrest clamped to the patient tabletop

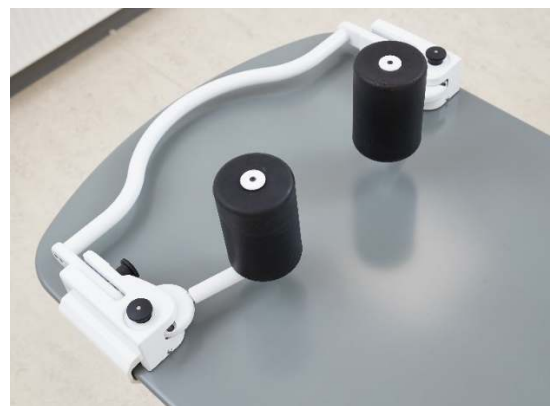
03283000 – Shoulder Support clamped to the patient tabletop

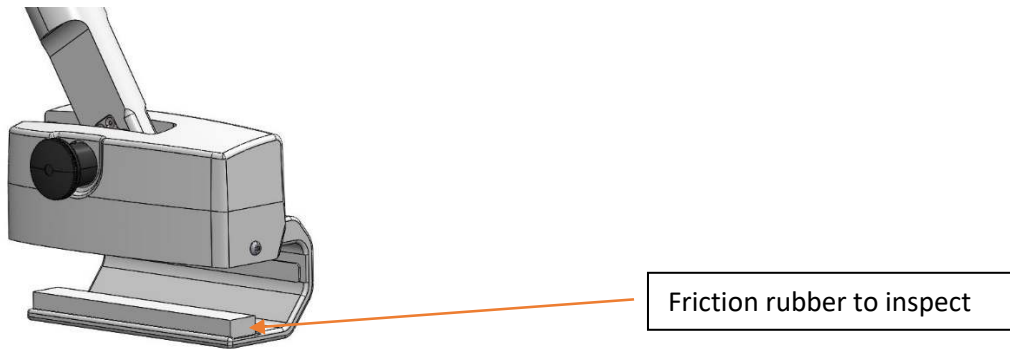
The friction rubber that must be inspected is placed inside the clamping profile, see illustration below. It is the thick rubber seen in the illustration, which must be firmly in place. The rubber is glued on the profile, and you should look for the overall adhesion. If slightly pressed from each side and end, the rubber should not show signs of detachment from the profile.

If the rubber is firmly in place, you may continue using the equipment.

If the rubber is detaching along either side or end, do not use the accessory until the repair has been made.
