MDR-FSN-GLOBAL
	Field Safety Notice

URGENT PRODUCT SAFETY INFORMATION

Commercial name of the affected product: BIP O-Twist Marker SRX

Date: 2022-01-31

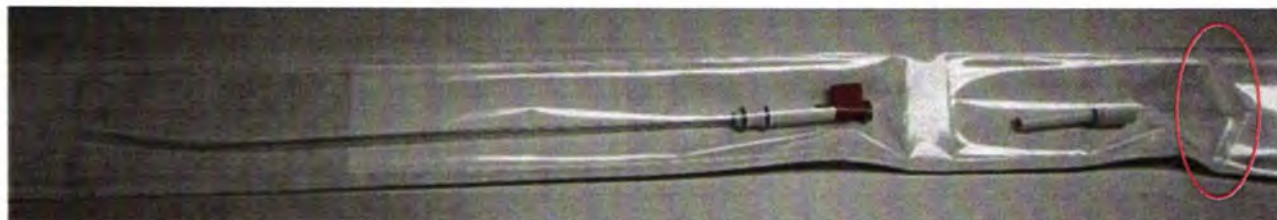
The affected sealing seam is located on the side for opening the sterile pouch, on the side with the guide sleeve (see Fig.2, red marking)

Fig.2: Product OTM3.0SRX, application cannula with implantable marking ring (left) and guide sleeve (right), separated by an intermediate sealing seam. Red marking = affected sealing seam.

As a corrective action, a change in sterile packaging for the product REF OTM-SRX will be implemented and alternative sterile pouch types shall be used, which are already used for other BIP sterile products.

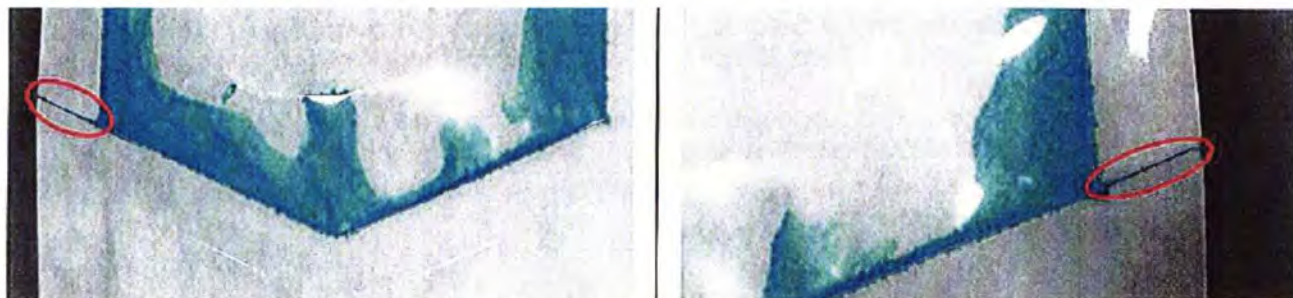
In the course of performing dye penetration tests in accordance with ASTM F1929-15 on currently used sterile peel pouches of the concerned products, it was found that in isolated cases penetration of the used test liquid can occur at a specific point of the sealing seam (see Fig. 3).

This could have the consequence that the integrity of the sterile barrier is no longer given and the sterility of the products cannot be guaranteed beyond the shelf life of 3 years as indicated on the packaging.

Fig.3: Example images of the penetrated sealing seam (red marking)

The root cause was clearly identified as a defect at the supplier's sealing tool, which is used for this transverse sealing seam. So far, only one series batch has been produced with the defective tool and it could be proven on the basis of the performed tests that the defect only appeared in a few sterile pouches.

Nevertheless, as an extended precautionary measure, BIP GmbH is performing a recall of all unused products of the affected lots whose shelf life of 3 years has not yet expired.
