Field Safety Notice

Philips StentBoost Live R2.0 application

Acquisition does not stop automatically

2022-Feb-02

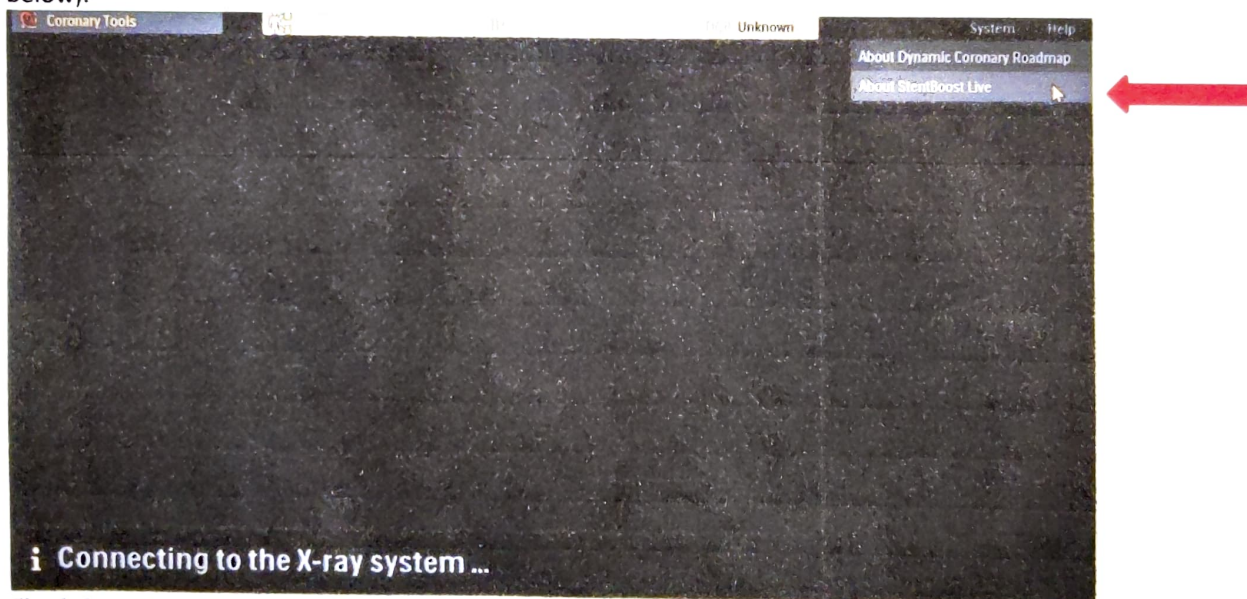
Fig. 1: Location of the “About” box in the user interface.

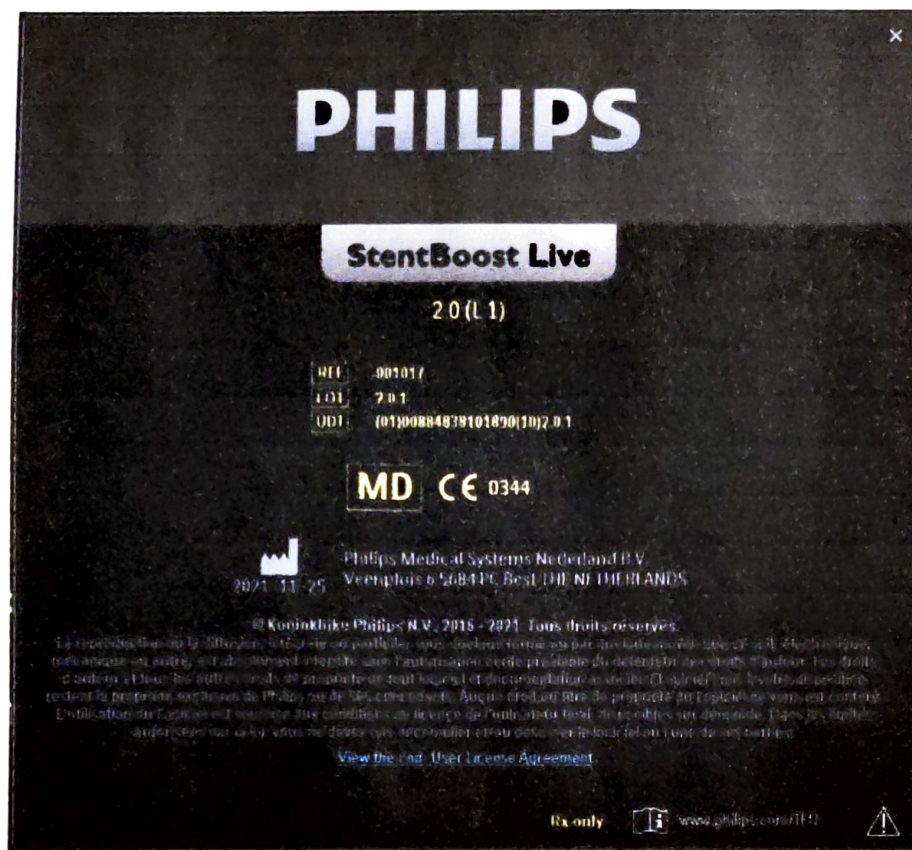
Fig. 2: Software version of StentBoost Live.
