URGENT FIELD SAFETY NOTICE

Subject: Field Safety Corrective Action to Replace Mount Clamp Component of the HFD100 Head Fixation Device Linkage used with ORT400 Operating Room Tables

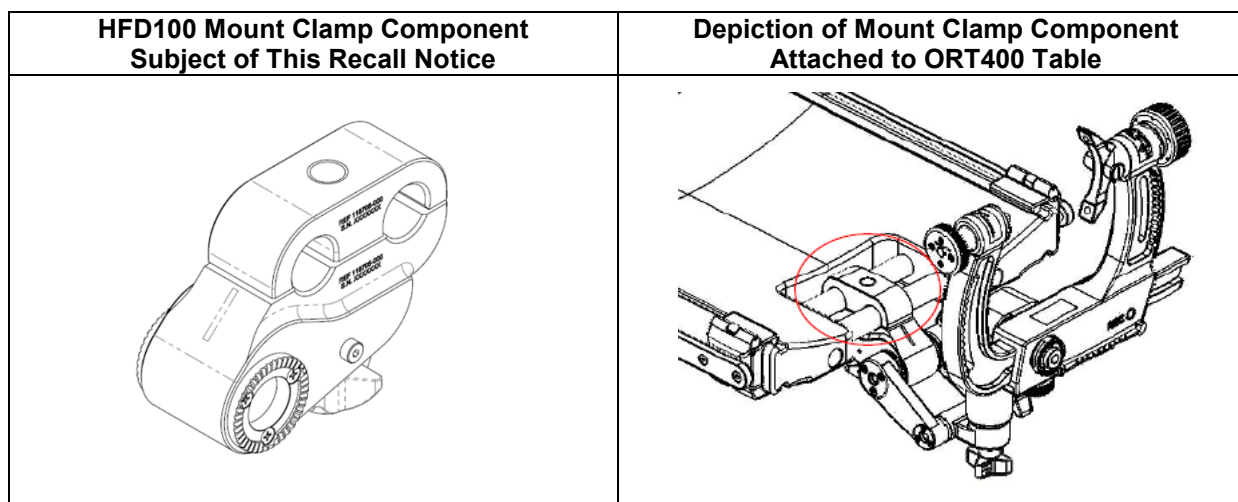
IMRIS is conducting a Field Safety Corrective Action to address a potential risk associated with use of the HFD100 head fixation device linkage with the ORT400 operating room table, and will be completing corrective action to replace the mount clamp component, shown below, in affected HFD100 units at your location.

It has come to our attention that the 'mount clamp' component of the HFD100 linkage, which attaches to the parallel dowels embedded in the ORT400 table, may exhibit rotational movement or deflect under normal or foreseeable forces in clinical use. We have identified limitations in the current design that contribute to this potential hazard. Rotational movement at the table attachment point could result in HFD movement going unnoticed, which could result in a situation where surgical or medical intervention is necessary, a situation where navigation needs to be re-established, or a situation resulting in extended time under anesthesia for the patient. It may also be difficult to loosen the mount clamp component after use, potentially leading to ergonomic injury or a workaround during equipment teardown. IMRIS has not received reports of injury associated with this issue.

- The existing mount clamp component of the HFD100 used with ORT400 tables will be replaced with an improved design. The split block clamp and hand knob used for tightening the component onto the table are being improved to ensure rigid attachment of the HFD100 to the ORT400 table.

- Ensure the instructions in the Operator Manual for proper HFD100 linkage assembly are followed to produce rigid fixation.
- Ensure there is no movement of the mount clamp component and of the HFD100 linkages prior to clinical use.
