Urgent Field Safety Notice

Product name: balanSys REV Stem Screw

FSCA ID No: FSCA 22/01

Bettlach, 15 March 2022

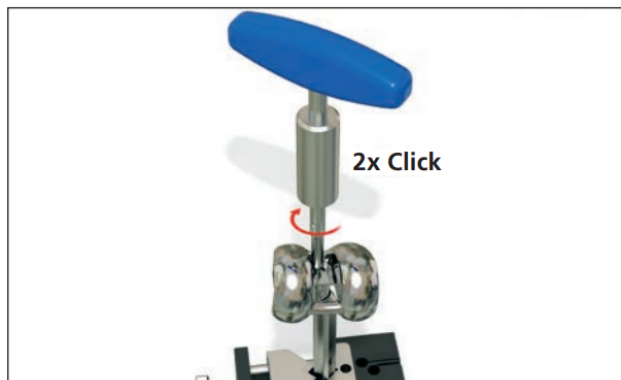
Figure 1: The screw must be tightened with the torque wrench included in the scope of delivery

Tighten the stem screw with the Torque Wrench (18.410-RAL5002) with 2 clicks.

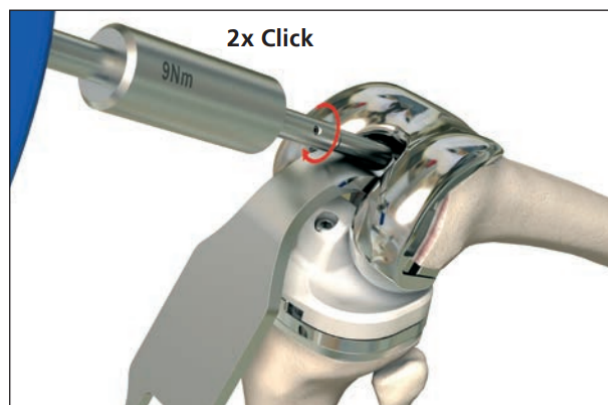
Data from global post-market monitoring show that the femoral screw of the balanSys Rev Stem may loosen post-operatively.

After implantation, the stem screw must be re-tightened since the screw can loosen during impaction!

Figure 2: After insertion of the implant with the impactor, the screw must be tightened again

Insert the Neck Stopper Curved (79.02.0750) into the box of the femur component.

Tighten the stem screw of the component with the Torque Wrench 3.5 with 2 clicks while counteracting the torque with the Neck Stopper Curved (79.02.0750).

After implantation, the stem screw must be re-tightened with the Torque Wrench (18.410-RAL5002) with 2 clicks.
