**URGENT FIELD SAFETY NOTICE**

Tibial Components / Modular Joint Component Units of  
Endo-Model – M Modular Knee Prosthesis System

Tibial Components of  
Endo-Model SL Rotational and Hinge Knee Prosthesis System

## 2. Reason for Field Safety Corrective Action (FSCA)

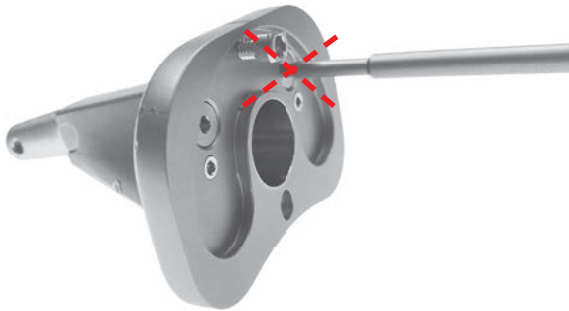
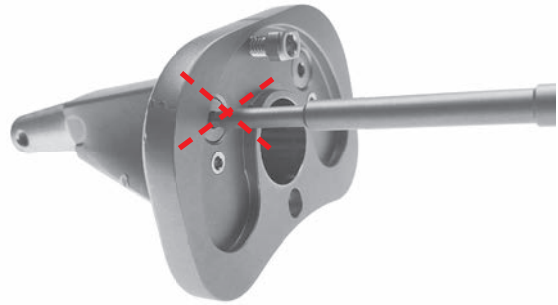
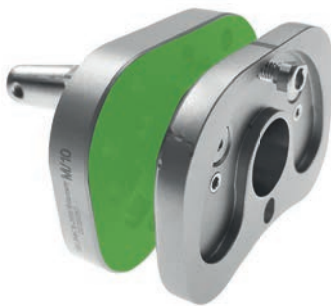
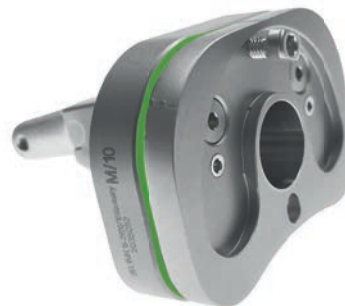
### Endo-Model SL

If a Tilastan proximal spacer is to be used and either one or both blind screws of the modular tibial component cannot be loosened, then the following modified surgical technique is to be performed.

= screw removal impossible?

It has to be observed that a homogenous cement mantle between the Tilastan proximal spacer (full & half) and modular tibial component is ensured. The cement mantle should be 1-2 mm thick.

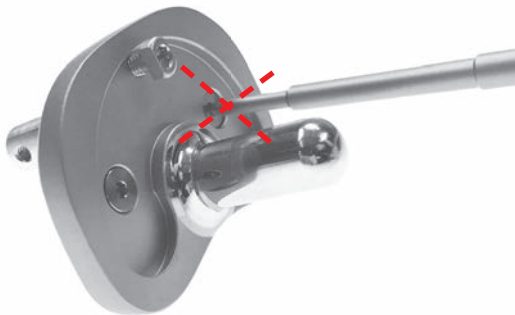
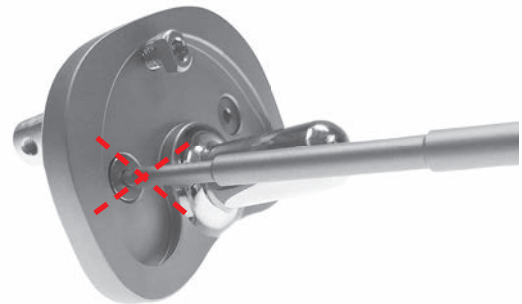
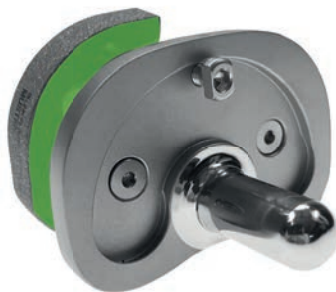
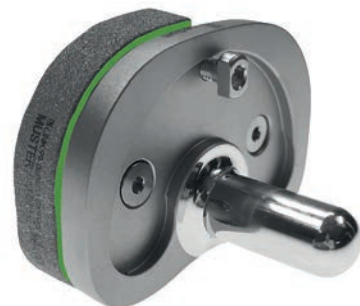
### Endo-Model – M

If a Tilastan proximal spacer is to be used and either one or both blind screws of the modular tibial component cannot be loosened, then the following modified surgical technique is to be performed.

= screw removal impossible?

It has to be observed that a homogenous cement mantle between the Tilastan proximal spacer (full & half) and modular tibial component is ensured. The cement mantle should be 1-2 mm thick.
