Update - Field Safety Notice
Philips Respironics - Hospital Respiratory Care

Philips V680 Ventilator

Software correction regarding error code 1008 - 2020-CC-HRC-004/ FCO86600058

13-May-2022

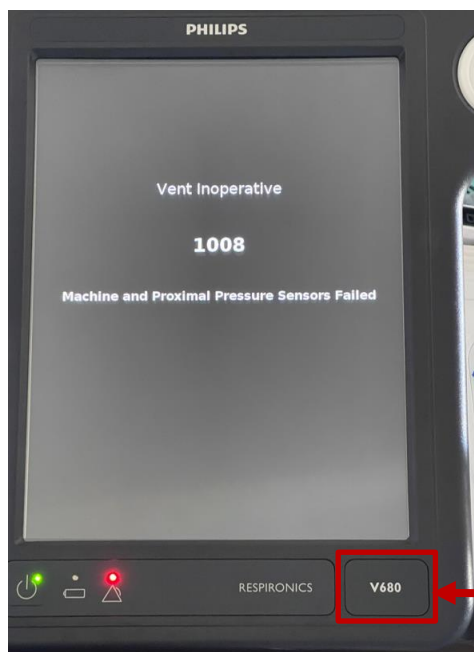
V680 Ventilator Identification

During dual-limb invasive ventilation, a patient cough of sufficient magnitude to drive circuit pressures above 95 cmH₂O for longer than 150 milliseconds may cause a "Vent Inoperative 1008: Machine and Proximal Pressure Sensors Failed" alarm (image shown below), which will cause the V680 ventilator to cease therapy and the ventilator will not function, however, it will remain powered on.

As stated above, if there is a “Vent Inoperative 1008: Machine and Proximal Pressure Sensors Failed” alarm, this will cause the V680 ventilator to cease therapy. A cessation of ventilator therapy while in use on a patient could potentially lead to severe hypoxemia and hypercarbia.

As described above, Philips will be deploying Software Version 1.40 which includes a change to prevent the 1008 error code from occurring as a result of a patient cough.

Philips will be contacting you to schedule an appointment to update your V680 device(s) software to Version 1.40.
