Philips Image Guided Therapy Corporation  
**URGENT Field Safety Notice**  
Philips Laser System (LAS-100) Error 500

JUN-2022

Reference: LAS-100 Error 500, 2022-IGT-IGTD-002

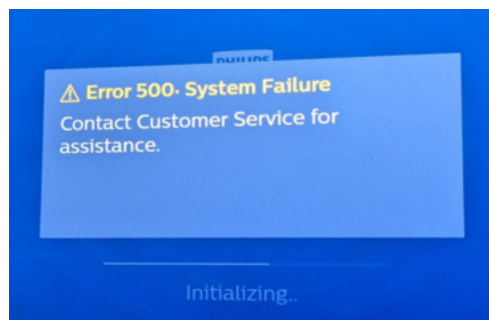
Philips has identified an intermittent mechanical fault with the LAS-100 Philips Laser Systems manufactured prior to 18-MAY-2022. For affected units, on occasion, the system may detect an inoperable hardware component during power up. When this issue occurs, the user will be visually alerted on the system display as “Error 500 – System Failure” (see Figure 1). The user will not be able to proceed until the error is cleared. In this event, a delay in treatment may occur since the device is not able to fully initialize to a ready state. This fault was identified after seven (7) complaints of Error 500 were received. To date, Philips has not received reports of patient or user harm due to this issue.

*Figure 1: Example of an Error 500 visual alert*

Philips internal testing confirms that 1-3 reboots of the system will temporarily resolve the issue. Philips also recommends the continued use of the Philips Laser System, and to follow the Operator's Manual, as there is no expected harm to the user or patient.

Philips will notify all affected customers and arrange for a Field Service Engineer (FSE) to replace the shutter assembly with an improved shutter assembly free of charge beginning June 2022,. The updated assembly improves the Philips Laser System's performance and integrity.

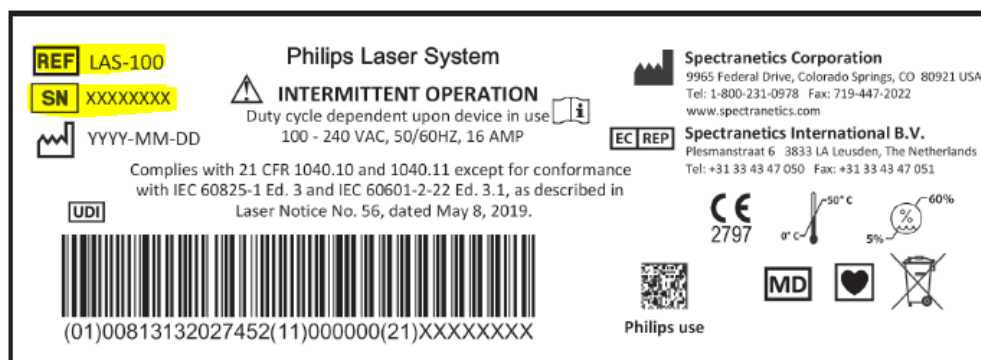
Only the Philips Laser Systems (PLS), model number LAS-100 with the serial number range of 100000 to 100104 are affected. The model and serial number of the PLS are printed on the primary label on the back of the device as shown below.
