## Urgent Field Safety Notice

July 2022

**Subject: Field Safety Notice** – Continued use of older Model 2868 software on Model 3120 ZOOM™ programmers to support transvenous CRT-Ds and ICDs until supply chain constraints on newer programmers<sup>1</sup> are resolved. See Appendix A for affected GTINs (Boston Scientific Field Action Reference: 92822246-FA)

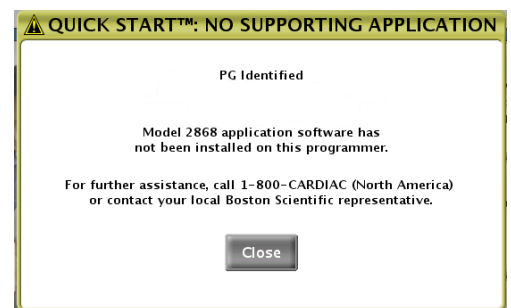
As part of this software upgrade, product labeling was updated to direct users to avoid using outdated 2868 software and Boston Scientific began uninstalling this software from 3120 ZOOM programmers. Soon after, Boston Scientific became aware of the likelihood of pandemic-induced global supply chain constraints on 3300 LATITUDE programmer supply and discontinued the uninstallation process in most regions because there could be insufficient programmers to support implanted TV defibrillators. When 2868 software is uninstalled, the 3120 ZOOM programmer can no longer interrogate TV defibrillators. If a user attempts to interrogate a device without applicable software, a message is displayed (Figure 2) to notify the user that software has been uninstalled on the programmer. To determine if a programmer has 2868 software, select “About” on the programmer screen and review the list of software applications installed. Please note that, 2868 software is the only outdated application on the 3120 ZOOM programmer.

**Figure 2.** Message that displays when a Boston Scientific TV defibrillator is interrogated by a 3120 ZOOM programmer if 2868 software is uninstalled.

- 1) If unable to interrogate a TV defibrillator with a 3120 ZOOM programmer, use a 3300 LATITUDE programmer instead. If this behavior occurs, STAT PACE, STAT SHOCK, and DIVERT THERAPY programmer operations<sup>4</sup> are not available through a 3120 ZOOM programmer, so external pacing/defibrillation or magnet application (to divert shock) may be required if a 3300 LATITUDE programmer is not immediately available.

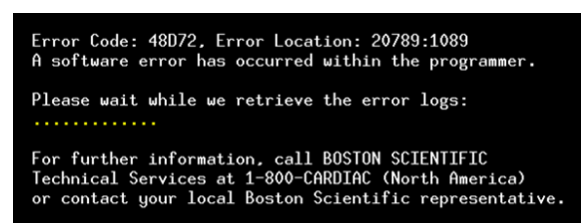
In facilities whose 3120 ZOOM programmers still have 2868 software installed, there may be unanticipated behaviors observed when interrogating TV defibrillators. The most common behavior observed is an inability to interrogate a TV defibrillator due to a Signal Artifact Monitor (SAM) episode. SAM is one of the new TV defibrillator features included in the enhanced software found on the 3300 LATITUDE programmer. SAM is designed to continually monitor the electrogram for Respiratory/Minute Ventilation (MV) sensor artifacts. If artifacts are detected or sensor vector lead impedance measurements are out of range, SAM either switches the vector or disables the sensor, and a SAM episode is recorded.

If a TV defibrillator has a stored SAM episode, the 3120 ZOOM programmer will present the Error Log and Halt message in Figure 3, and the user will need to use a 3300 LATITUDE programmer to interrogate the defibrillator. This error message (Figure 3) is an indication of an incompatibility of any 3120 ZOOM programmer with that specific TV defibrillator. However, the TV defibrillator will operate as intended with the permanently programmed settings. After power cycling the programmer, it may be used to interrogate TV defibrillators without stored SAM episodes. If the user attempts to interrogate the same TV defibrillator with the 3120 ZOOM programmer, the Error Log and Halt message will display again.

**Figure 3.** The specific Error Log and Halt Message on 3120 ZOOM Programmer when interrogation of TV defibrillator with a SAM episode is attempted.

The behavior most likely to be attributed to potential harm when using a 3120 ZOOM programmer is the inability to interrogate a TV defibrillator (e.g. Figure 2 or 3). There have been 9 reports of this behavior which have resulted in a delayed/prolonged procedure until the defibrillator can be interrogated with a 3300 LATITUDE programmer. Furthermore, there has been a single report of delays in reprogramming for phrenic nerve stimulation and a single report of an inability to interrogate for delivery of commanded therapy. None of the reports associated with 3120 ZOOM programmer have resulted in permanent injury.

A 3120 ZOOM programmer update to 2868 software has been developed to resolve the Error Log and Halt behavior associated with TV defibrillators having a stored SAM episode. This software update does not represent a material reduction in patient safety risk, however, it does prevent clinical workflow interruptions and will be released subsequent to approval.
