Urgent Field Safety Notice

Risk of Minute Ventilation artefact oversensing in patients with a subset of abnormal high polarization XFine passive pacing leads, when connected to ALIZEA / BOREA pacemakers.

FSCA identifier: CRM-SAL-2022-001

Affected devices: Subset of MicroPort CRM XFine leads (models XFine TX25D, XFine TX26D, XFine JX24D; XFine JX25D) connected to MicroPort CRM ALIZEA or BOREA pacemakers (models ALIZEA DR 1600, ALIZEA SR model 1300, BOREA DR model 1500, BOREA SR model 1200).

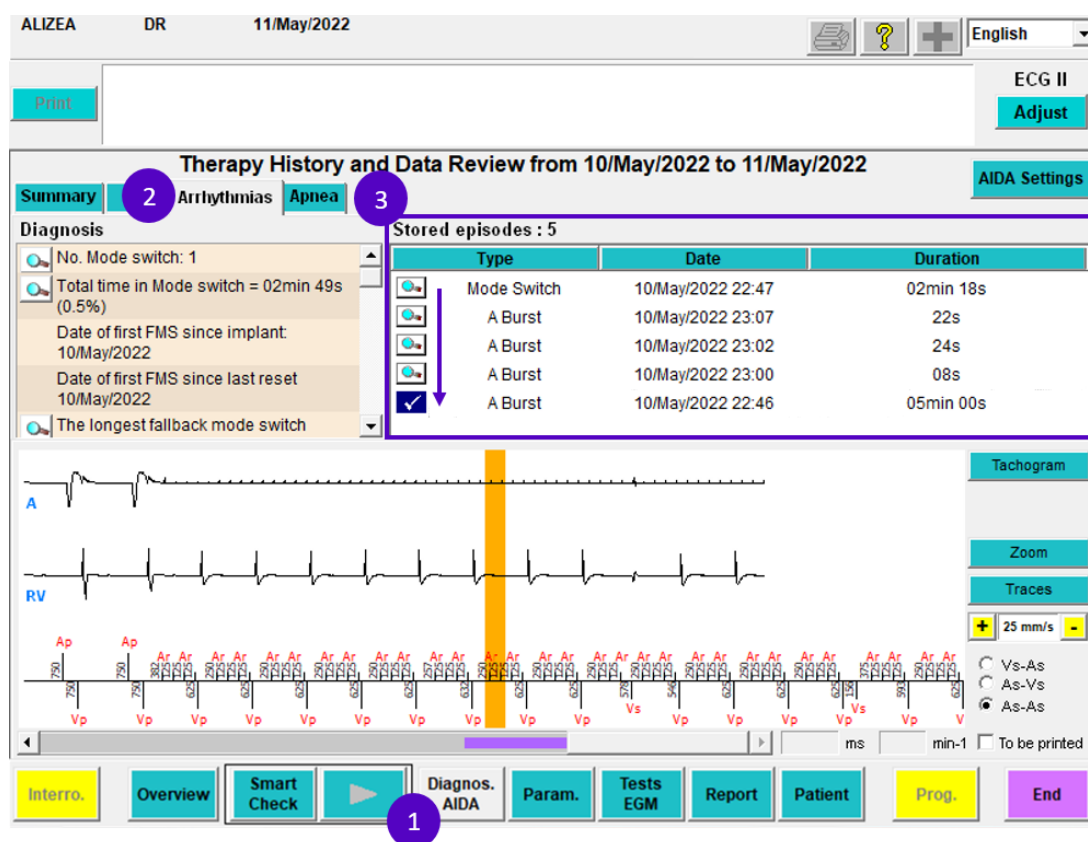
Figure 1: Sequence for checking the presence of MV oversensing in recorded episodes

1. Select the “Diagnos. AIDA” tab in the menu bar at the bottom of the screen;
2. Select the “Arrhythmias” tab;
3. Check recorded episodes individually to identify the presence of MV oversensing.

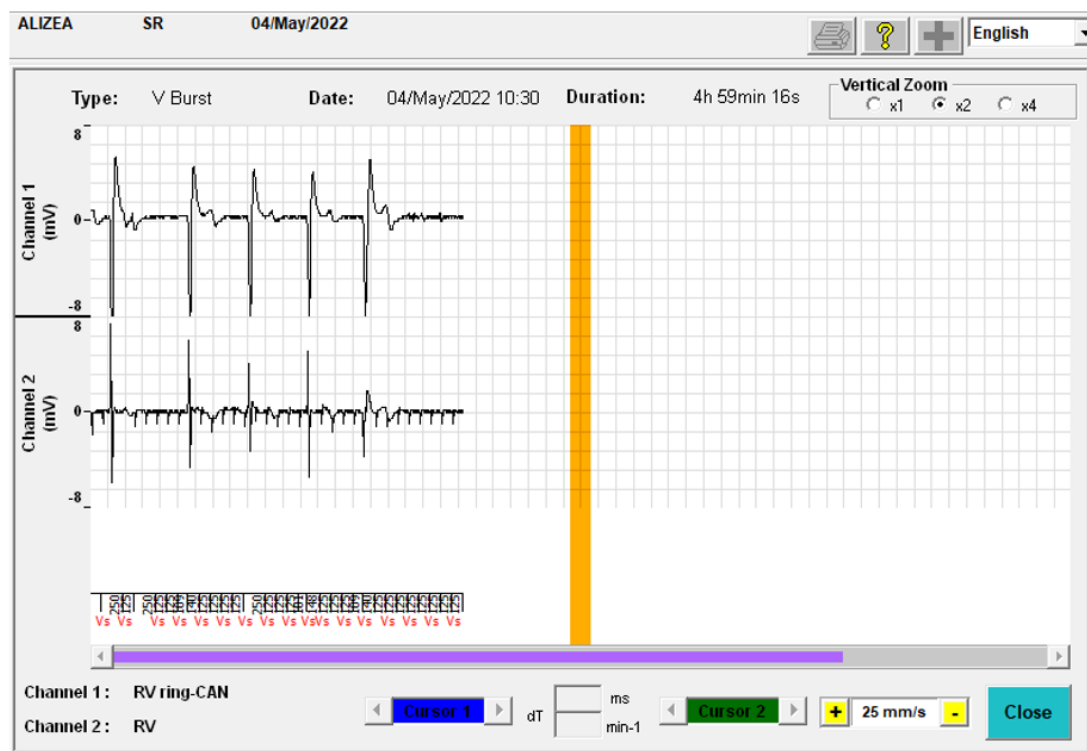
MV noise oversensing is characterized by the presence of repetitive 125ms or 250ms cycles (as illustrated below), visible in:

Figure 2: Illustration of “V Burst” episode due to MV noise oversensing on an SR pacemaker

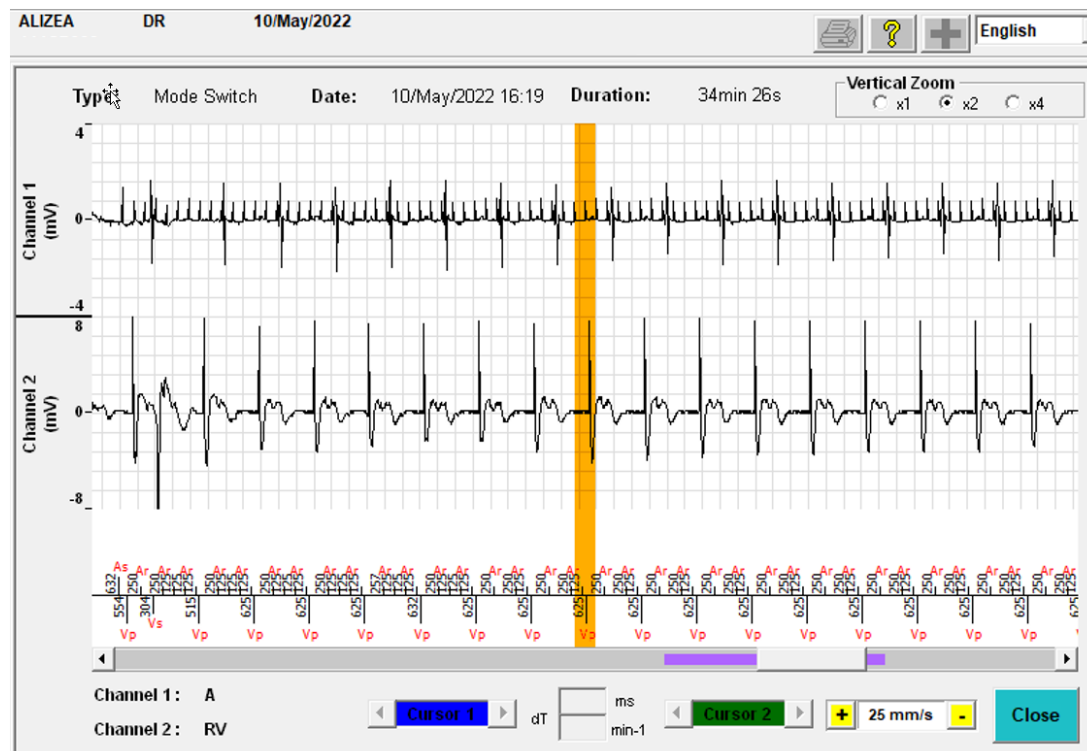
Figure 3: Illustration of “Mode Switch” episode due to MV noise oversensing on a DR pacemaker
