Urgent Field Safety Notice

Risk of Minute Ventilation artefact oversensing in patients with a subset of abnormal high polarization XFine passive pacing leads, when connected to ALIZEA / BOREA pacemakers.

FSCA identifier: CRM-SAL-2022-001

Affected devices: Subset of MicroPort CRM XFine leads (models XFine TX25D, XFine TX26D, XFine JX24D; XFine JX25D) connected to MicroPort CRM ALIZEA or BOREA pacemakers (models ALIZEA DR 1600, ALIZEA SR model 1300, BOREA DR model 1500, BOREA SR model 1200).

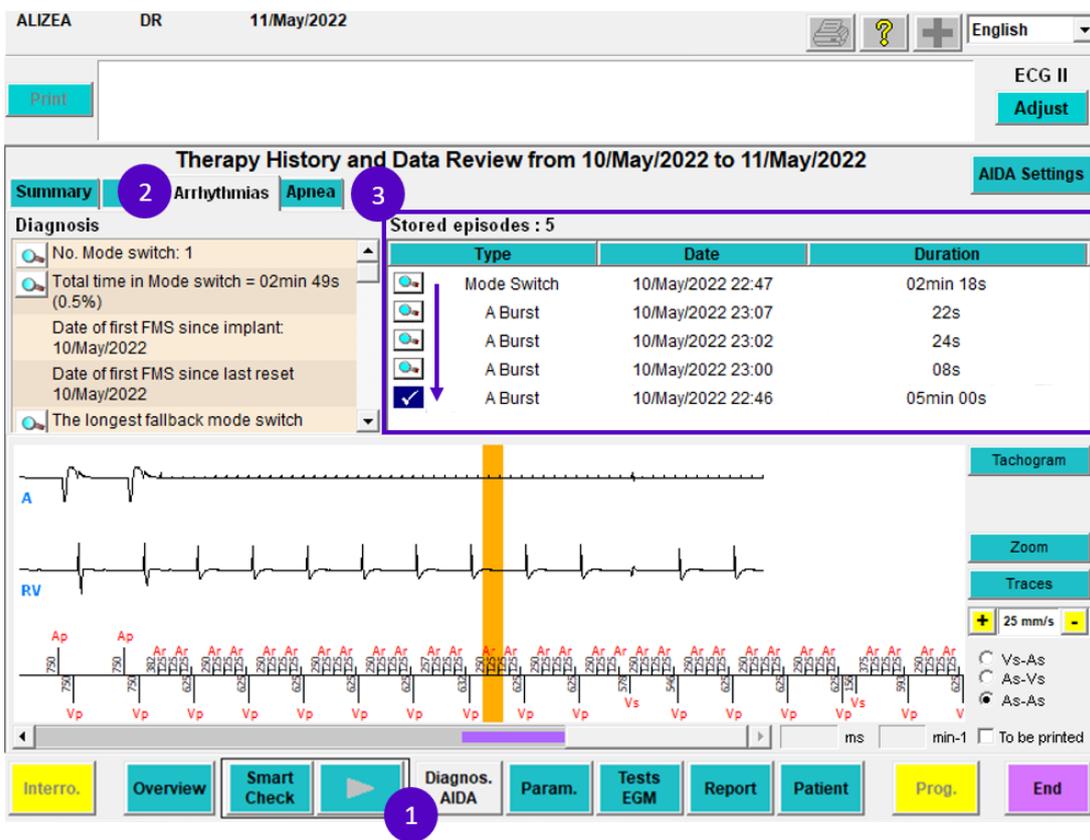
Figure 1: Sequence for checking the presence of MV oversensing in recorded episodes

MV oversensing might be visible in episodes stored in the device memory, as:

- “A Burst” or “V Burst” episodes for SR pacemakers;
- “A Burst” or “Mode Switch” episodes for DR pacemakers.

1. Select the “Diagnos. AIDA” tab in the menu bar at the bottom of the screen;
2. Select the “Arrhythmias” tab;
3. Check recorded episodes individually to identify the presence of MV oversensing.

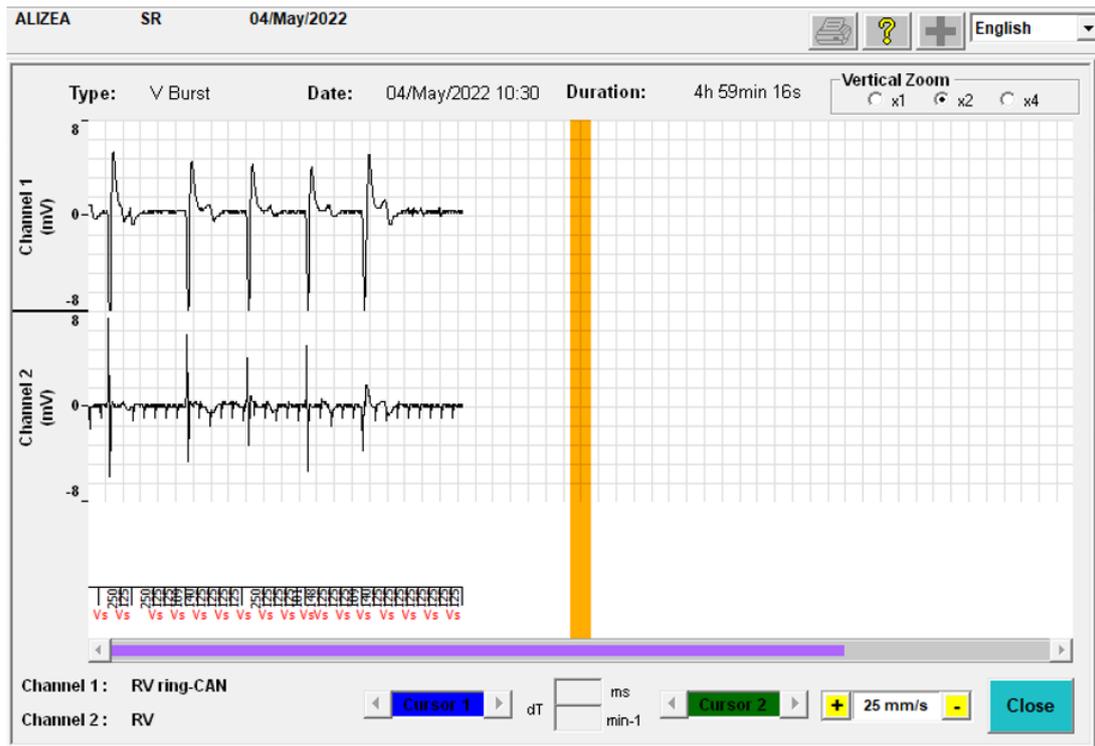
Figure 2: Illustration of “V Burst” episode due to MV noise oversensing on an SR pacemaker

MV noise oversensing is characterized by the presence of repetitive 125ms or 250ms cycles (as illustrated below), visible in:

- The atrial or ventricular channel for SR pacemakers;
- On the atrial channel for DR pacemakers.
