## URGENT IMPORTANT FIELD SAFETY NOTIFICATION

<b>Subject:</b>	A reconstruction error may occur when using the Catheter Bending functionality in Applicator Modeling or Implant Modeling
<b>Product:</b>	Oncentra® Brachy
<b>Scope:</b>	Oncentra® Brachy version 4.0 and higher  In combination with:  Applicator Modeling or Implant Modeling
<b>Notification Released:</b>	November 2022
<b>UDI Reference:</b>	08717213052758, 08717213038660, 08717213020610, 08717213052321, 08717213052314, 08717213052307, 08717213052291, 08717213052246, 08717213052239, 08717213051881, 08717213051843, 08717213051782, 08717213051775, 08717213051294, 08717213020610, 08717213053717, 08717213053700

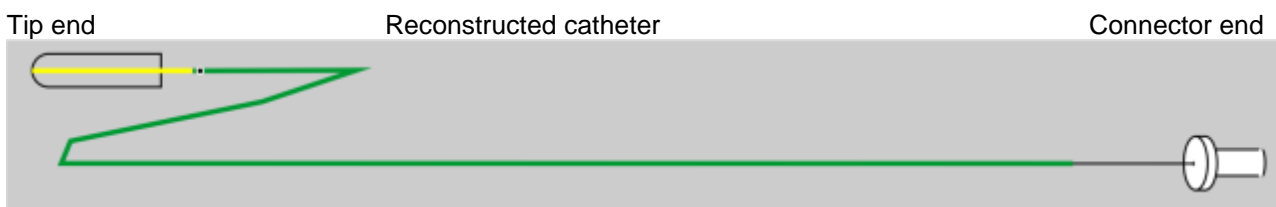
In a rare situation, a reconstruction error may be introduced by Oncentra® Brachy to an existing catheter reconstruction, when using the catheter bending functionality. Erroneously placed reconstruction points may be added that create a double kink in the reconstruction (see Figure 1). If unnoticed, this reconstruction error can result in a difference between the dose distribution in the treatment plan and the delivered dose distribution.

Figure 1. Illustration (not to scale) of the double kink reconstruction error that may be introduced in a rare situation

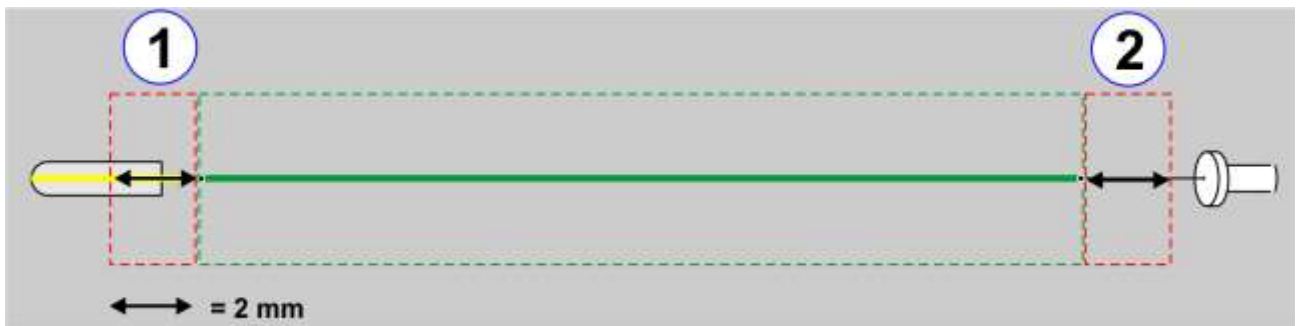
To bend a reconstructed catheter, the user must select two manipulation points: the Bending Indicator and the Bending Point. To ease the selection of those manipulation points, a 2 mm margin around the catheter center line is defined where the user can click to select the manipulation points. This margin is erroneously also applied at the tip end and at the connector end of the catheter.

Figure 2 shows the erroneous margin around the last catheter reconstruction points at the tip end (1) and connector end (2).

Figure 2. Margins around the reconstructed catheter. Green dashed line indicates the 2 mm margin around the catheter. The erroneous margins are shown as red dashed lines, at the tip end (1) and connector end (2).

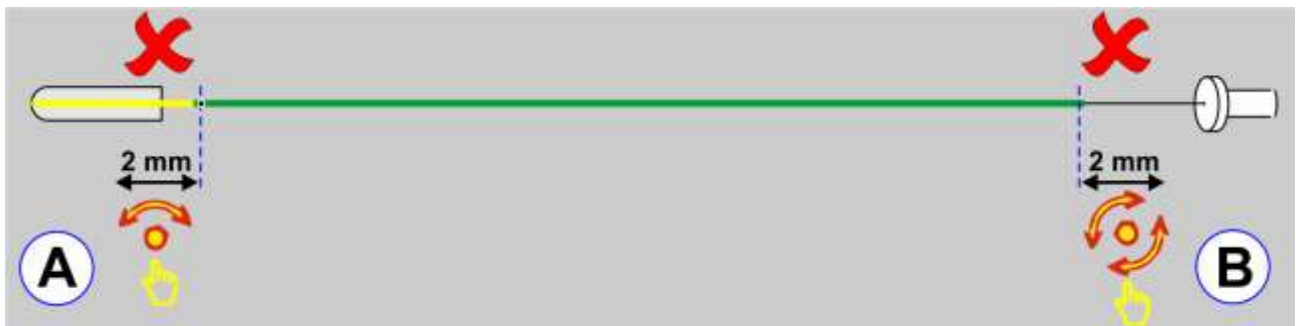
- A. At the tip end: when you position the Bending Indicator beyond the most distal reconstruction point. The Bending Indicator (semi-circle with arrowheads) should not be positioned in the 2 mm area beyond the last catheter point or in the tip end (yellow line in Figure 3). Instead, it should be positioned within the green area as indicated in Figure 4.
- B. At the connector end: when you position a Bending Point beyond the most proximal reconstruction point. The Bending Point (circle with arrowheads) should not be selected in the 2 mm area beyond the first catheter point at the connector end (black line in Figure 3). Instead, it should be positioned within the green area as indicated in Figure 4.

Figure 3 shows an illustration of scenario A and B as described above.

Figure 3. Scenarios A & B in which the use of the Catheter Bending functionality can lead to the introduction of a reconstruction error.

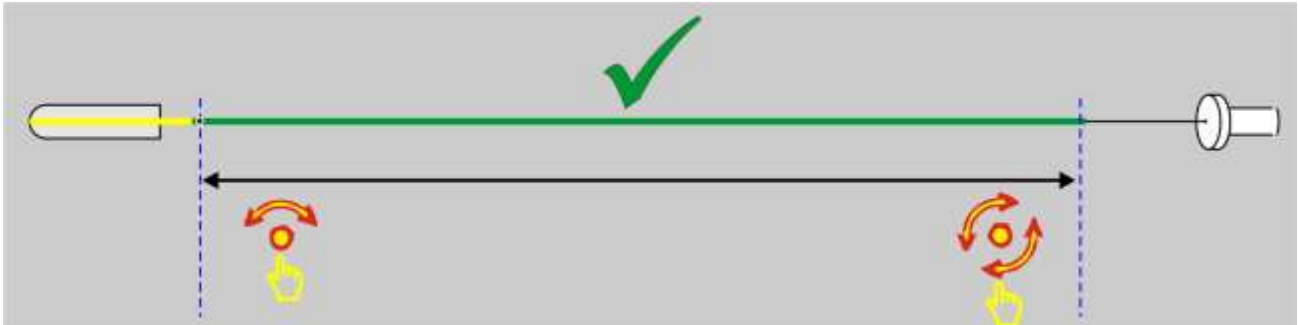
Figure 4 shows how the catheter bending functionality can be used safely .

Figure 4. Scenario in which the use of the Catheter Bending functionality can be safely used.

The Bending Indicator and Bending Point can be safely positioned along the green part of the reconstructed catheter. Keep a distance from the last and first catheter reconstruction points, to ensure that the error does not occur. To increase visibility of the green part of the catheter, adjust the line thickness in the Applicator Visualization setting in the Case Explorer.

- When using the catheter bending functionality, always position the manipulation points in the middle of the reconstructed catheter and keep a distance from the last and first catheter reconstruction points (see Figure 4).
- Always inspect the coordinates of the reconstructed catheter points in the Case Explorer for the presence of any kinks.

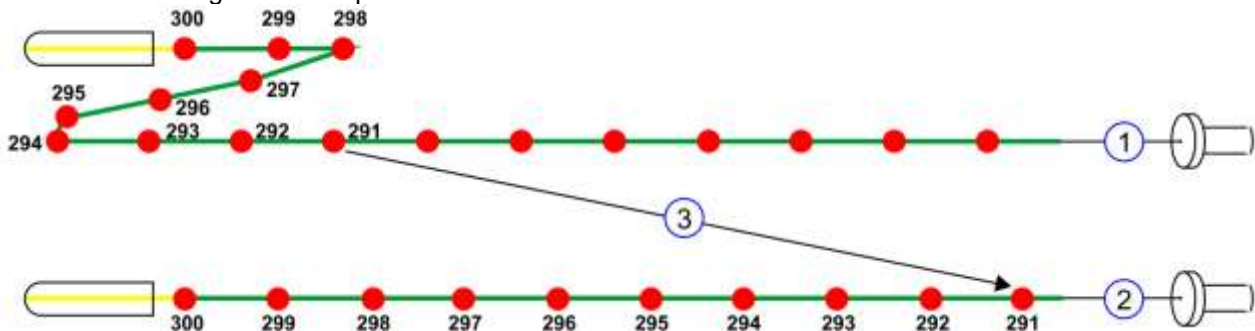
Figure 5 shows how a kink in a reconstructed catheter results in a shift in dwell positions during treatment delivery. The extent of this reconstruction error will depend on where the bending was applied. The added reconstruction length can be up to 8 mm.

Figure 5. Illustration to explain the shift in planned dwell positions.

- (1) Dwell positions in a reconstructed catheter in treatment planning, when bending results in a reconstruction error.
- (2) Dwell positions in the catheter during treatment delivery.
- (3) Shift in dwell positions.
