Urgent Field Safety Notice

Affinity Fusion™ Oxygenator Temperature Monitoring Adapter Notification

February 2023

Medtronic Reference: FA1302

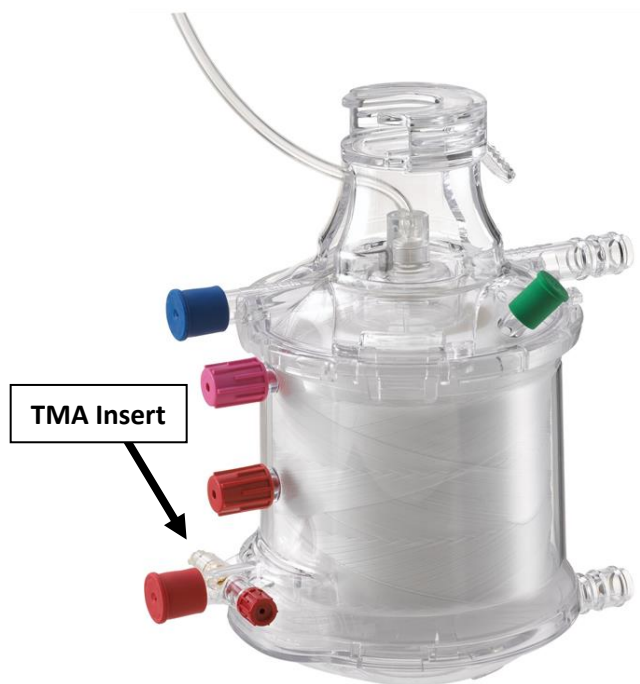
Image 1 - TMA location on the Affinity Fusion Oxygenator

The complaints indicate that the TMA (see Image 1 for the TMA location) had come loose from the oxygenator either during pre-procedure perfusion set-up or post-procedure when disassembling the perfusion circuit.

Since 02 August 2021, there have been 83 complaints globally of TMA separation from the oxygenator, with 70 reported from 07 November 2022 to 26 January 2023. The investigation to date indicates reduced connection strength for TMA connections made in the past 17 months, resulting in detachment prior to or after the procedure. In all instances, the TMA separation only occurred pre- or post-procedure, and there were no adverse patient impacts reported. To date, no TMA events have been reported during a procedure.

- Option 1: Continue to use the Affinity Fusion Oxygenator without using the TMA - use other conventional perfusion circuit temperature monitoring methods; or
- Option 2: Continue to use the Affinity Fusion Oxygenator and the TMA for arterial temperature monitoring. Ensure there is minimal torque applied to the oxygenator TMA when attaching or detaching the Temperature Probe (Product Number ATP210). Also, minimize manipulation of the TMA-probe connection during the clinical procedure.

If the TMA comes detached before the procedure setup or priming, discard the product. If the TMA comes detached during the procedure and an oxygenator replacement is decided, follow the Instructions for Use (IFU), Emergency Oxygenator Replacement section. If the TMA comes detached after the procedure completion, no additional action is required.
