## Field Safety Notice / FSCA 001-23

We would like to share with you, and your team, information about an issue that could be observed on the blood grouping analyzer **IH-1000 software version 04.08.11** intended to be used with the Data Management Software IH-Com version 5.2.5 Service Pack.

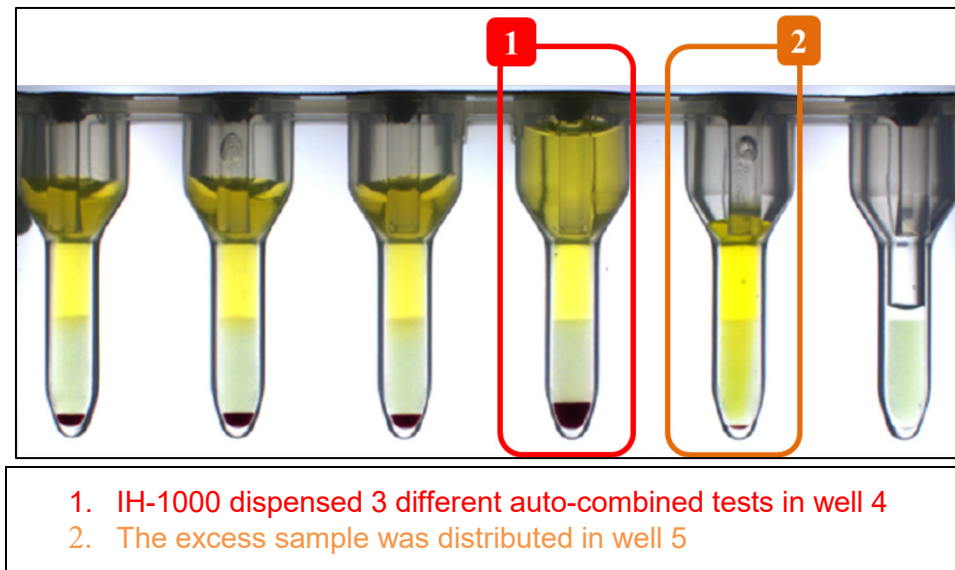
**Figure 1\_Example of misdistribution of the auto-combined test**

When these conditions are fulfilled, separate tests (requested by IH-Com) will be treated as auto-combined tests (execution of PR80D / PR80E / PR80F / PR80H / PY80D) by IH-1000 and samples from the same patient and different donors might be incorrectly dispensed in the same well instead of separated wells (see example in Figure 1).

Once the tests are processed, the IH-Com displays the same well for all crossmatch results.

- 1) Access the IH-1000 Options Menu and, on the “Control” tab, enable the “return of gel cards to drawer for second reading” function selecting the “Customized” option (Refer to IH-1000 User Manual Section 8.4 and 6.1.4 c)

This will prevent the inappropriate execution of an auto-combined test. The gel cards will be put returned to positions 4, 5, 9, 10, 13, 14,15, 18, 19, 20 of the drawer. Make sure that these positions are available and with empty card trays. To ensure a proper identification of the empty trays, use the white trays (REF 009888) for the cards returned to the drawer.
