Cressier, 09-02-2023

Field Safety Notice / FSCA 001-23

We would like to share with you, and your team, information about an issue that could be observed on the blood grouping analyzer **IH-1000 software version 04.08.11** intended to be used with the Data Management Software IH-Com version 5.2.5 Service Pack.

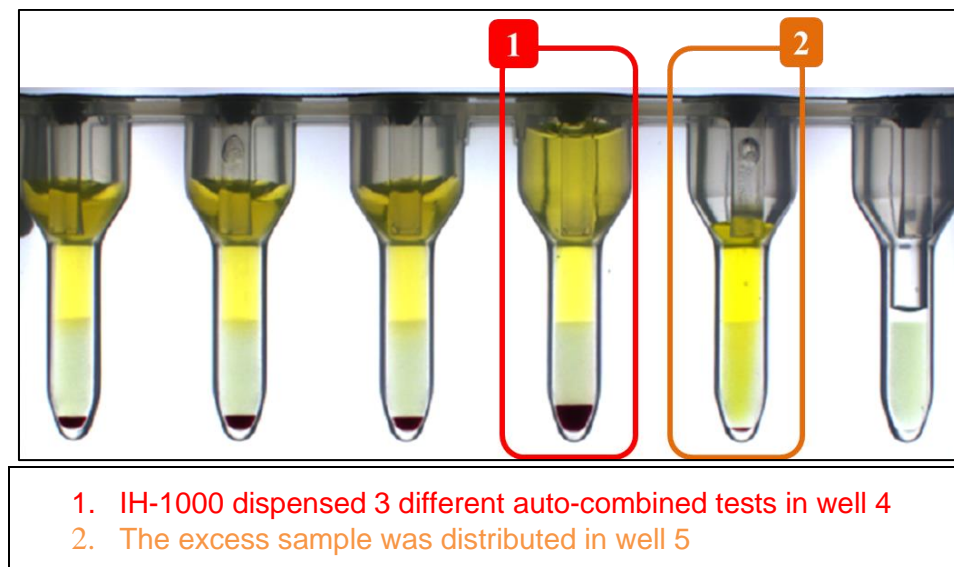
When these conditions are fulfilled, separate tests (requested by IH-Com) will be treated as auto-combined tests (execution of PR80D / PR80E / PR80F / PR80H / PY80D) by IH-1000 and samples from the same patient and different donors might be incorrectly dispensed in the same well instead of separated wells (see example in Figure 1).

Once the tests are processed, the IH-Com displays the same well for all crossmatch results.

Figure 1_Example of misdistribution of the auto-combined test

- 1) Access the IH-1000 Options Menu and, on the “Control” tab, enable the “return of gel cards to drawer for second reading” function selecting the “Customized” option (Refer to IH-1000 User Manual Section 8.4 and 6.1.4 c)

Click “CUSTOMIZED” and in the emergent Menu, select “All” for the Test Categories “Autocontrol” and “Crossmatch”.

This will prevent the inappropriate execution of an auto-combined test. The gel cards will be put returned to positions 4, 5, 9, 10, 13, 14,15, 18, 19, 20 of the drawer. Make sure that these positions are available and with empty card trays. To ensure a proper identification of the empty trays, use the white trays (REF 009888) for the cards returned to the drawer.

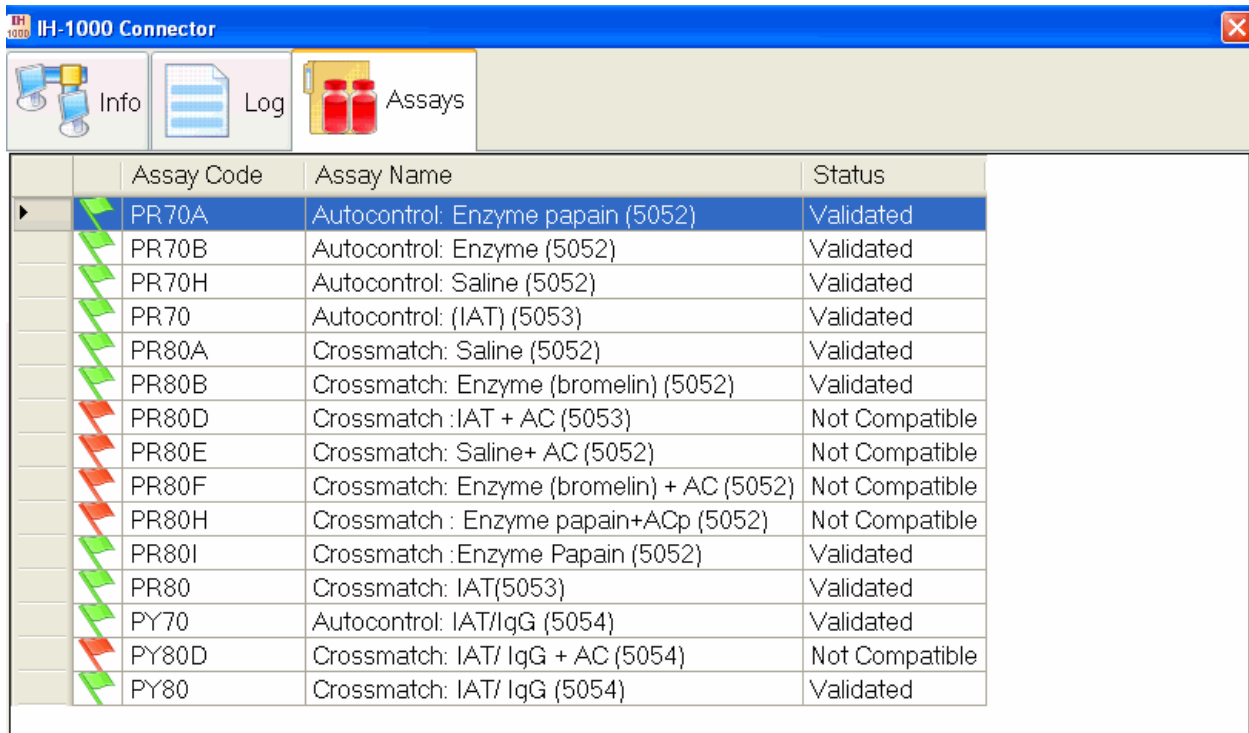
- Check if any of the test codes provided in table 1 is listed with the status Validated.
