# **URGENT Field Safety Notice**

SmartPerfusion, release R1.0, R1.1, R1.1.1, R1.1.5, R1.1.5.1 and R1.1.6

2D Perfusion, release R1.0.x, R1.1.x, R1.2 and R1.2.1

SmartPerfusion and 2d Perfusion May Inaccurately Present Time Density Curves and Images

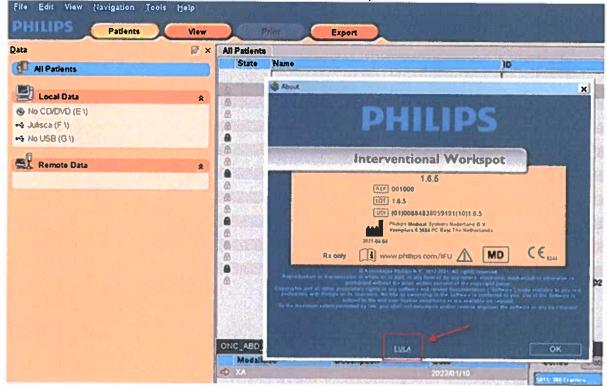
Pic 2: In the about box click on EULA (see red box and arrow)

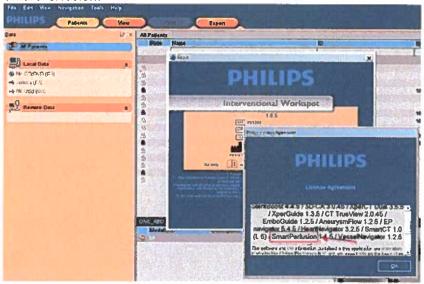
SmartPerfusion:

Pic 3: Check if SmartPerfusion or 2D Perfusion license is available on the system (see red box and arrow)
