Field Safety Notice (FSN)

SpiroScout“SP Plus”

Date: 2023-02-16

Service Note Nr. / CHANGE NR.		QI-69	Issue date: 2023-02-07
Product:	SpiroScout SP plus	<input type="checkbox"/> Software	<input checked="" type="checkbox"/> Hardware
Version:	N.A.	<input type="checkbox"/> initial	<input type="checkbox"/> follow-up

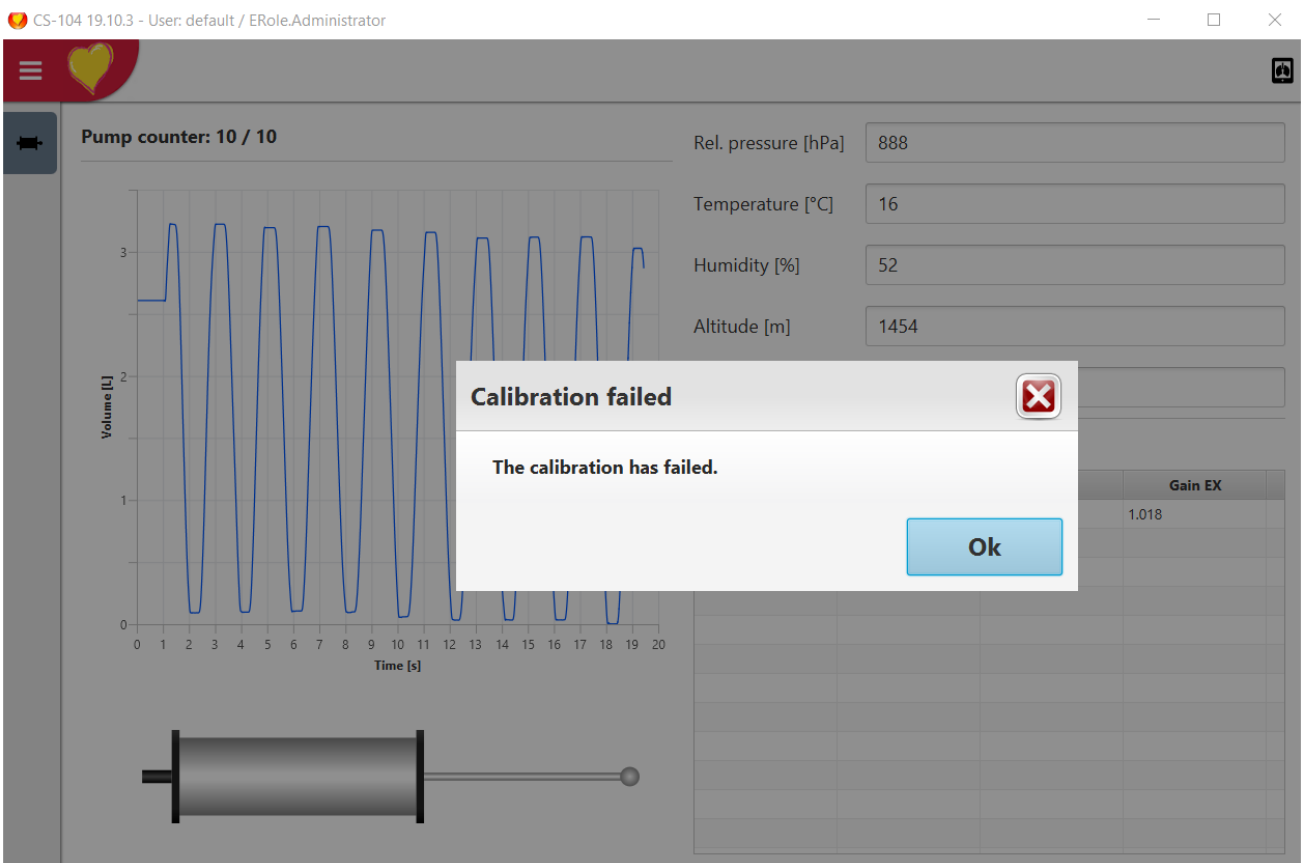
If there are problems with the SpiroScout SP plus volume verification [see picture], it is recommended to check the calibration factors.

Check the SpiroScout SP plus volume calibration factors with the "SpiroScout SP plus Configuration Tool". See separate instructions „Ganshorn.SPplusConfigurationTool.pdf“.
