## Urgent Field Safety Notice

**Commercial name of the affected product:** FlexLab

**FSCA-identifier:** FSCA – FLX - 202303 – 01

**FSN-identifier:** FSN – FLX – 202303 – 01 v.2

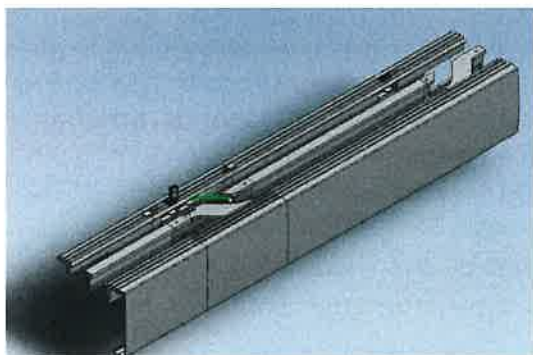
Image 1.a: Divert gate position

To avoid the occurrence of the described issue Inpeco recommends to visually check every day the gates at the buffer lane entry of the impacted modules (refer to Image 1.a and Image 1.b) to verify that:

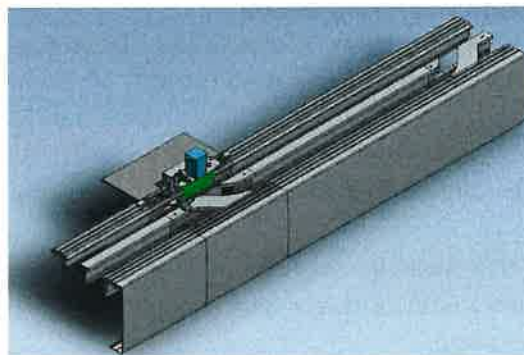
Image 1.b: No Stop Divert position

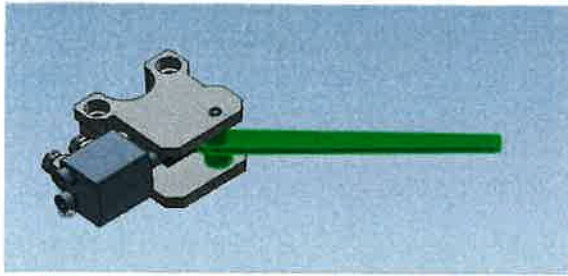
*Image 2.a: Divert appearance*

- there are no obstructions that prevent the correct activation and movement of the divert;
- the divert looks to be intact, refer to Image 2.a and Image 2.b;
- the position of the divert is aligned to the profiles when it is diverting a tube, refer to Image 3.a and Image 3.b; tubes that need to be routed by the module are diverted fluidly, without any missing or partial block of the carrier.

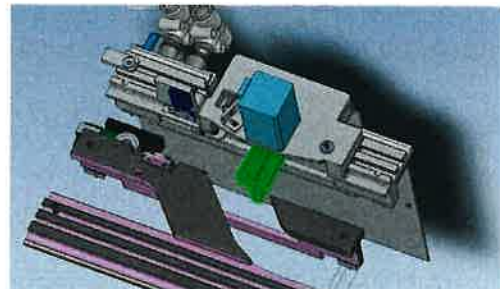
*Image 2.b: No Stop Divert appearance*

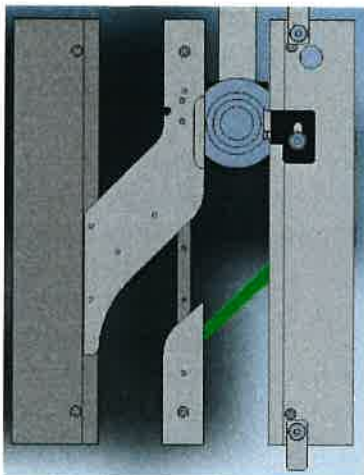
*Image 3.a: Divert alignment*

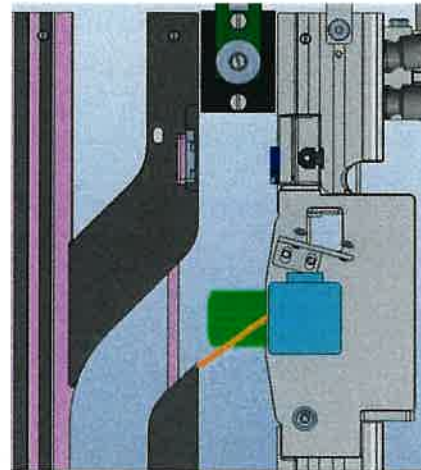
*Image 3.b: No Stop Divert alignment (in orange)*
