Urgent Field Safety Notice

Commercial name of the affected product: Accelerator a3600

FSCA-identifier: FSCA – ACP – 202303 – 02

Date: March 10th, 2023

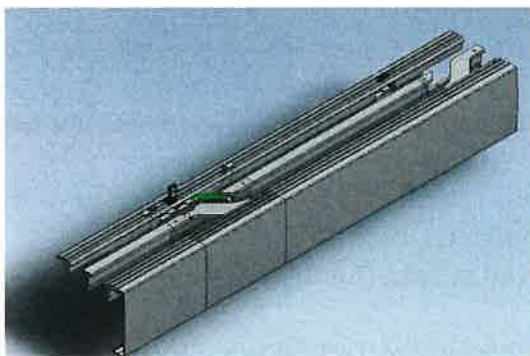
To avoid the occurrence of the described issue Inpeco recommends to visually check every day the gates at the buffer lane entry of the impacted modules (refer to Image 1) to verify that:

Image 1: Divert gate position

If the visual check is not passed, contact your local technical support for assistance before using the Automation System impacted modules to process samples.

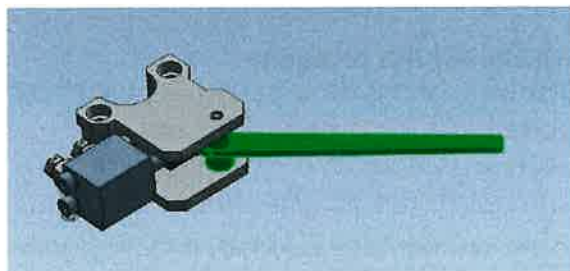
- there are no obstructions that prevent the correct activation and movement of the divert;
- the divert looks to be intact, refer to Image 2;
- the position of the divert is aligned to the profiles when it is diverting a tube, refer to Image 3; tubes that need to be routed by the module are diverted fluidly, without any missing or partial block of the carrier.

Image 2: Divert appearance

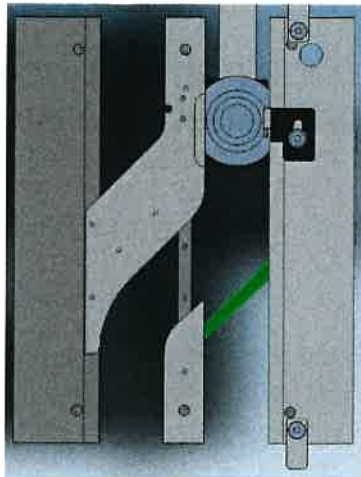
Image 3: Divert alignment
