Urgent Field Safety Notice

Commercial name of the affected product: Aptio Automation

FSCA-identifier: FSCA – AP2 – 202303 – 03

Date: March 10th, 2023

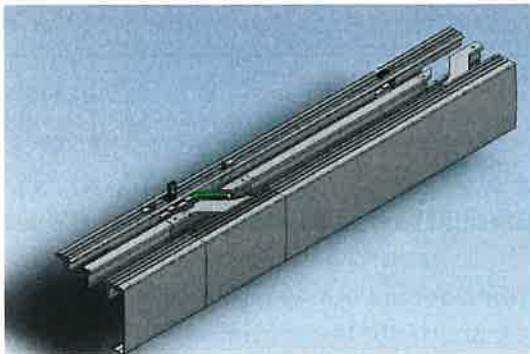
Image 1: Divert gate position

The scenario occurs in the case of a divert malfunction.

To avoid the occurrence of the described issue Inpeco recommends to visually check every day the gates at the buffer lane entry of the impacted modules (refer to Image 1) to verify that:

If the visual check is not passed, contact your local technical support for assistance before using the Automation System impacted modules to process samples.

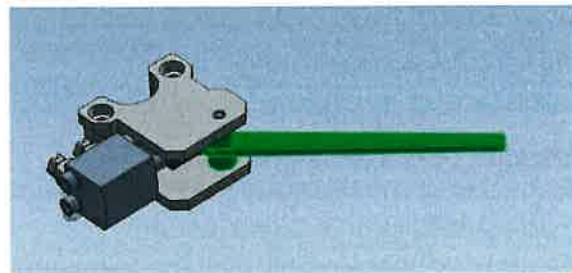
Image 2: Divert appearance

- there are no obstructions that prevent the correct activation and movement of the divert;
- the divert looks to be intact, refer to Image 2;
- the position of the divert is aligned to the profiles when it is diverting a tube, refer to Image 3; tubes that need to be routed by the module are diverted fluidly, without any missing or partial block of the carrier.
