**URGENT: MEDICAL DEVICE
RECALL FSCA-01-2023**

Reference: *FSCA-01-2023*

<p><u>Product information:</u></p> <ul style="list-style-type: none">- Product Name: <i>LATERAL LUMBAR TI-LIFE PLATE</i>- Reference: <i>see table above</i>- Batch Number: <i>see table above</i>	<p><u>Manufacturer :</u></p> <p>SPINEART SA Chemin du Pré Fleuri, 3 1228 Plan-les-Ouates Switzerland</p> <p>Contact Name: Xavier DE BUCHERE VP Global QS & RA</p>
--	---

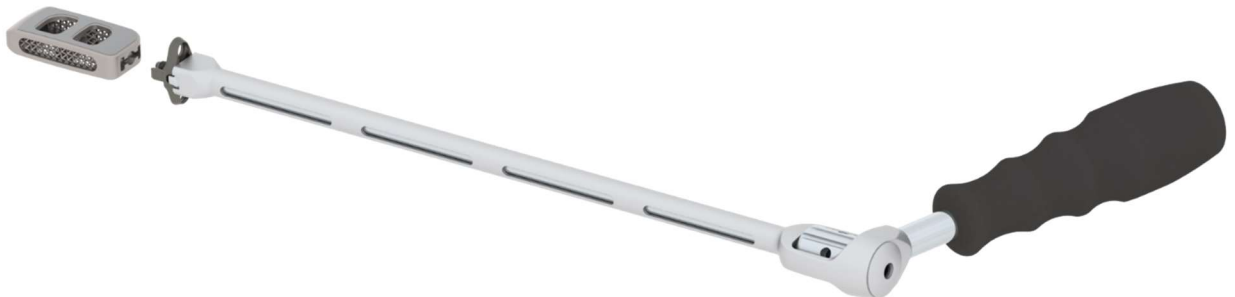
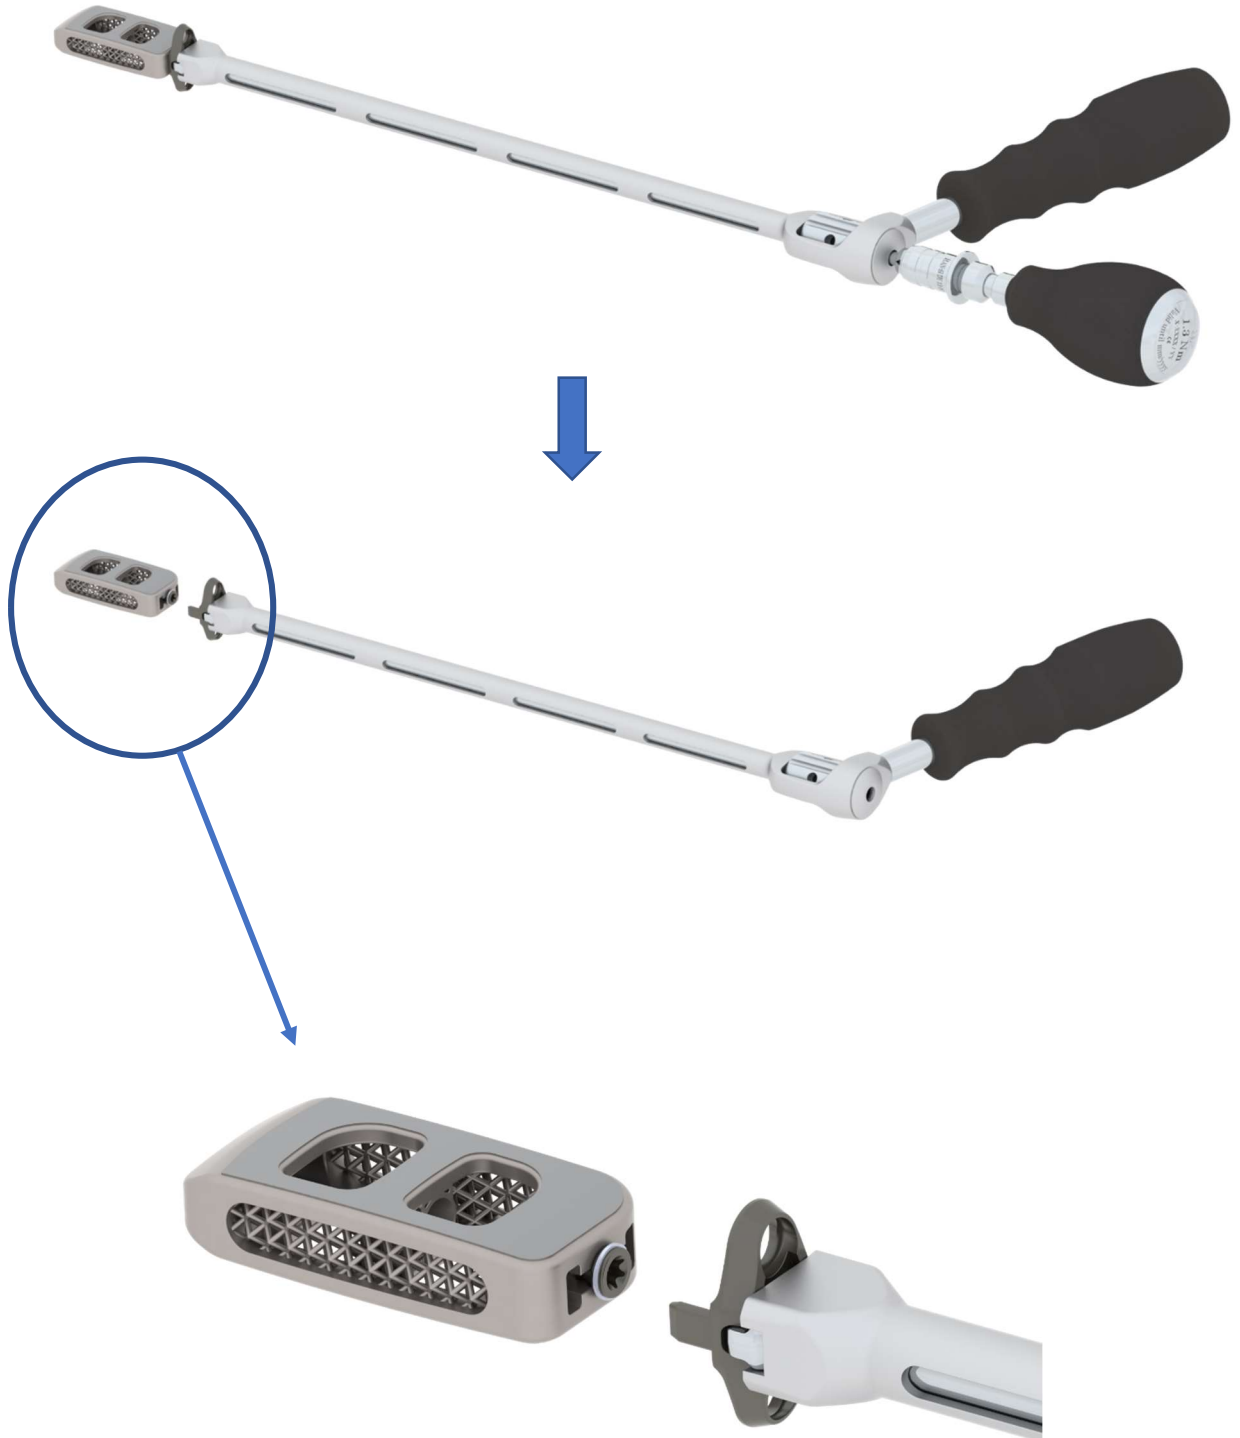
These plates disassembled from the Screw Plate during the insertion into the cage as shown in the pictures below.

Two types of cases have been reported:

- **Case 1: disassembly occurred during the preparation stage before implantation**

During the assembly of the pre-assembled plate/screw into the cage on the operative room table, the surgeon or the nurse immediately encountered the disassembly issue. In any case, the detection is obvious for the operative members.

- **Case 2: disassembly occurred during the surgery when removing the implant Holder**

During the assembly of the pre-assembled plate/screw into the cage in-situ (inside the patient), the surgeon realizes the disassembly when pulling-out the implant holder. The plate remains connected to the instrument. The detection is obvious for the operative members as well.

b) **Plate replacement:** If the issue occurs, the surgeon should proceed as followed:

- 1- Unscrew the Plate screw of the cage with the screwdriver,
- 2- Scrap the current plate assembly,
- 3- Use a new set of pre-assembled plate/screw (a minimum of 2 sets of pre-assembled plates/screws per size are part of the device listing). The cages are to be used with the corresponding plate or higher plate which means that a plate with the same height than the cage can be used but also a plate with higher height.
- 4- In the case of 0° and 8° cages, a pre-assembled plate/screw is not mandatory as described in the surgical technique

1. Immediately review your inventory and quarantine concerned products if any.
2. You may have further distributed this product; please identify concerned customers and notify them at once of this product recall by using this document.
3. Collect and quarantine all products.
4. Sent back all products with the enclosed Response Form to Spineart warehouse SPINEART SLI, ATTN LAURE-ALLISON VERBOUX, 80 RUE DOUGLAS ENGELBART FR-74160 ST JULIEN EN GENEVOIS).
E-mail: regulatory@spineart.com.
5. All returned products will be exchanged.
