Changed_UFSK_FSN_500 XLE_head-side lowering lying surface_SN2000-4506_230531_en.docx

31.05.2023

Safety notice

Restricted use for Treatment chairs 500 XLE with serial numbers 2000-4506

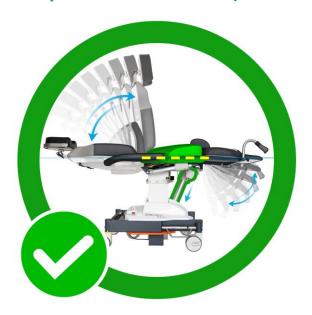
Safe patient positions of 500 XLE (SN 2000 - 4506)

ATTENTION! The seat part must be in a horizontal position to the floor (see green cushion), the seat part drive remains in the retracted position (green marked component). Adjustment movements, e.g. into the reset position, are still possible (see adjustment positions of back and leg part shown in grey).

The seat part drive must be retracted so far with the patient in position that the seat part is in a horizontal position; the seat part must no longer be adjusted with the patient in position (see Annex: Illustration of safe and critical positioning positions).

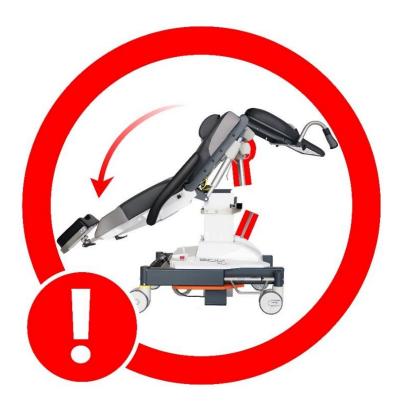
ATTENTION - WORST CASE!

If the safe patient positions are not observed - in "worst case scenario" - this will cause the separation of the seat drive.

It is strongly recommended to replace the seat drive at the latest when carrying out the next safety check (interval 12 months) and to observe the service schedule for safety-relevant components.

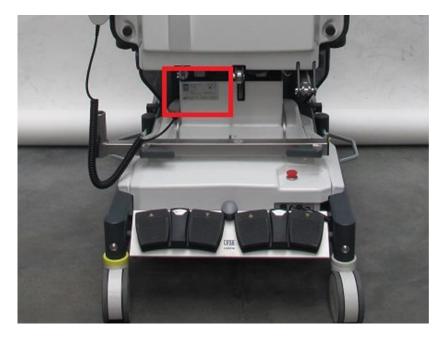
Where is the nameplate with the serial number (SN)?

Here you can find the nameplate of Treatment chair 500 XLE. Identify the SN number! Only SN-range of SN 2000 - 4506 is affected!
