Urgent SAFETY NOTICE

Scewo AG, Switzerland

- Scewo BRO V1
- Scewo BRO V1.1 (Basic UDI-DI: 7649992967BRWF)

Ref: FSCA-50

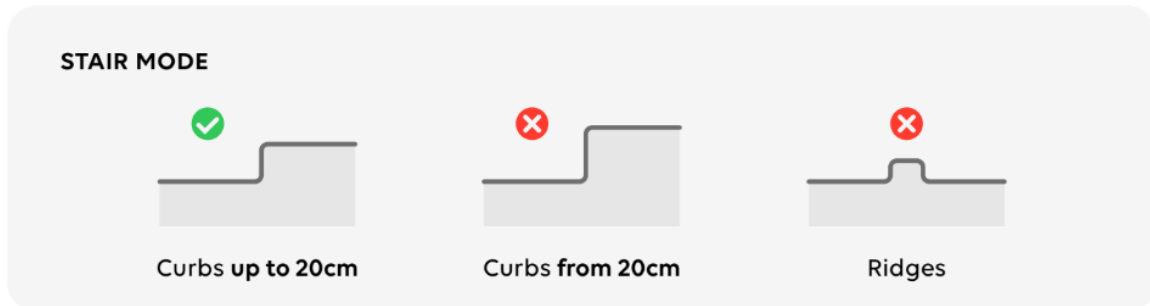
As part of the corrective actions, we would like to re-emphasize the instructions for use when you go **down** a single step with your BRO: for a step of 5 cm to 20 cm high, it must be overcome in **STAIR MODE**.

✓ BRO can drive over the ridge.

✗ Unfortunately, BRO cannot drive over the ridge.

This mode has to be chosen latest before the front of the tracks are over the edge of the step (in drive mode we recommend a minimum of 50 cm of safety distance to switch to stair mode).

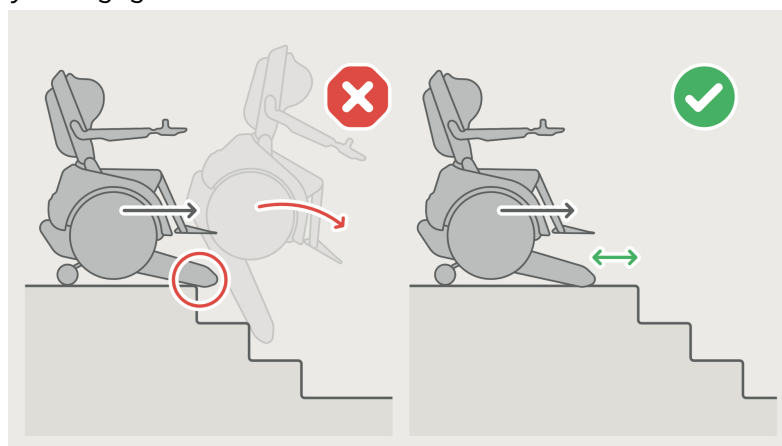
Despite these software changes you should still ensure that the front of the tracks are not over the edge before you engage stair-mode to avoid such a situation at all:

- BRO will deny going forwards if the BRO user switches to stair mode after a cliff was already detected by the sensors. The user has to go back to the platform completely before the stair mode gets activated.
- In case BRO falls from the step with the support system extended and tips backwards, the anti-tip system (ATS) will be triggered.
