24.07.2023

URGENT FIELD SAFETY NOTICE – Product Advisory Notice with subsequent Recall

Link OptiStem, Rasp Handle Stainless Steel

17-5220/01	
------------	--

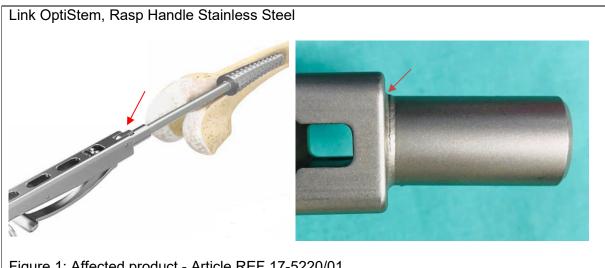
Figure 1: Affected product - Article REF 17-5220/01

It was noticed that the weld in the frontal area of the instruments of the current version may not last the full planned lifetime.

If a crack in the weld of the rasp handle is not taken seriously it may lead to a fracture of the frontal sleeve when the rasp is further impacted or extracted. The rasp remains intact. The rasp needs to be pulled out by a clamp leading to a prolongation of surgery or modified surgery.

Waldemar Link received one complaint regarding a fractured weld during surgery. No consequence to the patient was reported.

Since we like to ensure that scheduled surgeries are performed and patients are provided with desired prostheses (Link OptiStem or CustomLink) we will for safety reasons and **immediate action** provide **2 rasp handles** for the planned surgeries **until replacement** with **optimized rasp handles** is available and these products are recalled. See 4.4

If you notice a crack on the weld during surgery, please use the second rasp handle for completion of the bone preparation.

Please have both rasp handles sterilized for surgery and make sure the inspection prior use according to IFU H50 is conducted properly.
