URGENT FIELD SAFETY NOTICE – Product Advisory Notice with subsequent Recall

Link OptiStem, Rasp Handle Stainless Steel

04026575284658

Description from Follow up FSN 27.02.2024:

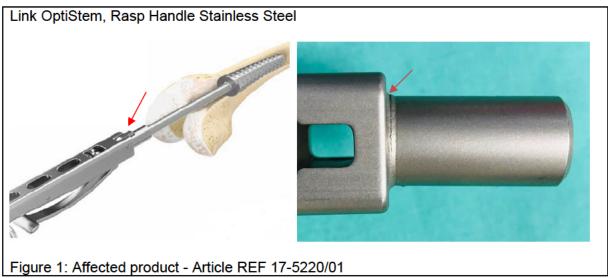
It was noticed that the weld in the frontal area of the instruments of the current version may not last the full planned lifetime.

If a crack in the weld of the rasp handle is not taken seriously it may lead to a fracture of the frontal sleeve when the rasp is further impacted or extracted. The rasp remains intact. The rasp needs to be pulled out by a clamp leading to a prolongation of surgery or modified surgery.

The optimized rasp handles are available for replacement: Therewith the affected rasp handles will be completely removed from the field.
