## Urgent Field Safety Notice

### Hugo™ Robotic-Assisted Surgery (RAS) System

Arm Cart Assembly Model # MRASC0002, Tower Model # MRASC0003, MRASC0005  
Service

Medtronic Reference: FA1228

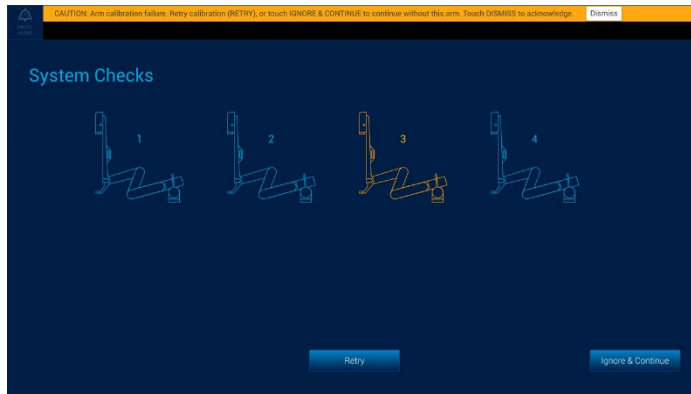
1. If any arms encounter a problem calibrating, the System Checks screen will show the particular arm with the error and provide options to either re-calibrate the arm or ignore the arm and continue.

If an arm has failed calibration, do not select the **Retry** or **Ignore & Continue** button. Instead, restart the arm by performing the following steps:

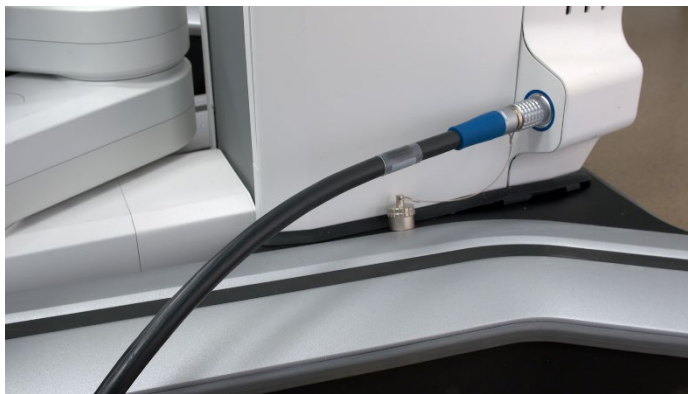
- a. Unplug the arm cart data cable from the arm with the error. The arm will shut down and the system will display a message that the arm is no longer connected.

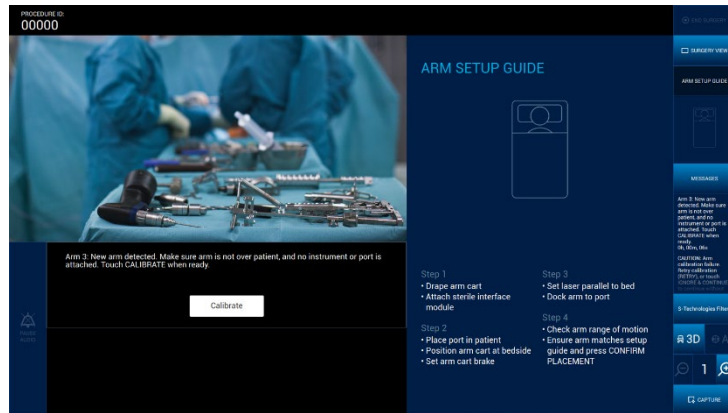
- b. Reconnect the arm cart data cable. When the arm completes its startup, the arm cart LEDs will be green and the system will detect the connected arm and display the following message:

"Arm [ARM #]: New arm detected. Make sure arm is not over patient, and no instrument or port is attached. Touch CALIBRATE when ready."

Press **Calibrate**.

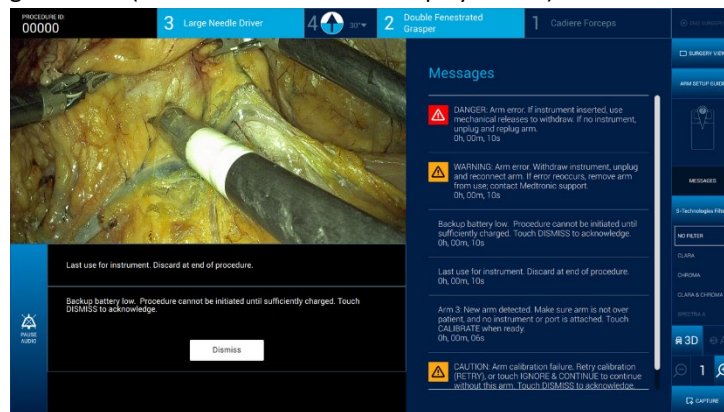
- c. If the arm fails calibration again, shut down the arm by unplugging the arm cart data cable and remove the arm from service.
2. Press the "**Messages**" button located on the menu located at the right of the OR team interactive display. The messages for this procedure are displayed in reverse chronological order (the most recent will be displayed first).

3. If either of the following errors appear in the list of messages, restart the arm according to the instructions in Step 1. If the error appears again, shut down the arm by unplugging the arm cart data cable and remove the arm from service.
