Updated URGENT Field Safety Notice

Allura Xper Allura Centron, and Azurion systems
Potential loss of imaging functionality resulting from no or intermittent X-ray radiation initiation
through the wired foot switch

Philips Reference: 2023-IGT-BST-004

27-October-2023

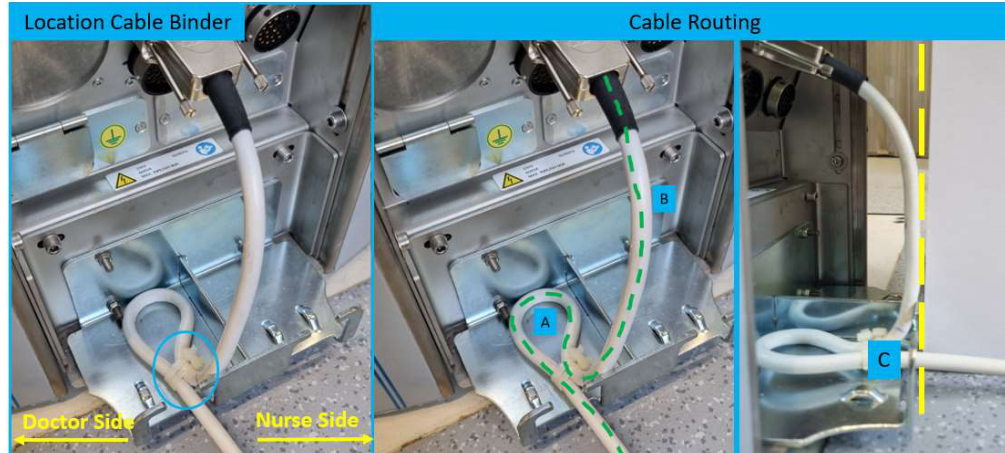
Figure 1: AD7XT and AD7XNT Patient Table

Number of cable binder(s): 2 (two)

If strain relief or routing is not correct, repair according to the repair instructions.

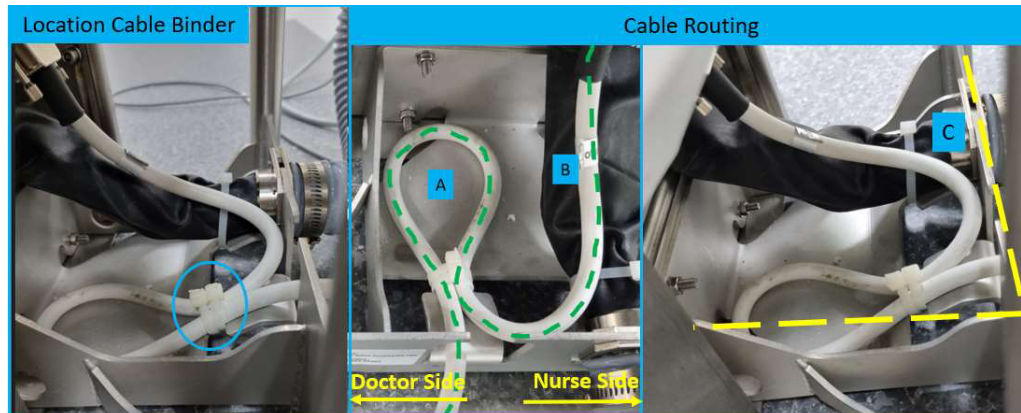
Figure 2: AD7XT and AD7XNT Auxiliary OP Rail Patient Table Strain Relief

Number of cable binder(s): 2 (two)

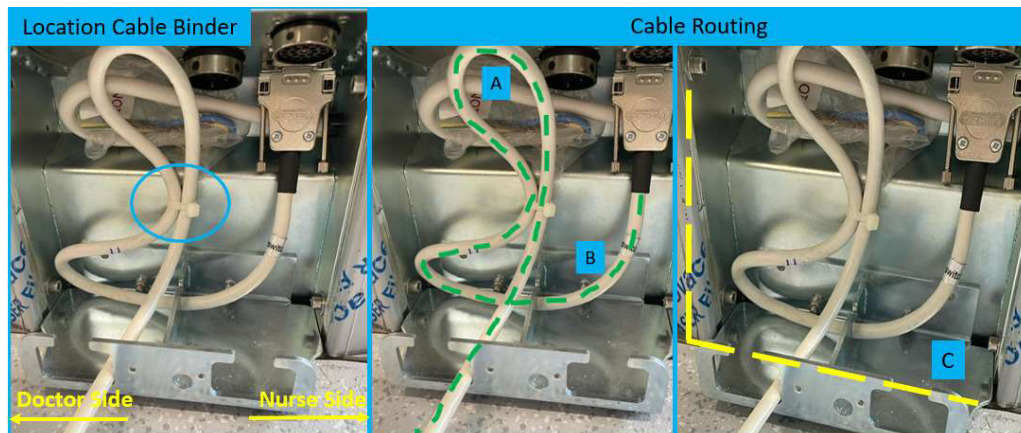
Figure 3: AD7 Patient Table

Number of cable binder(s): 1 (one)

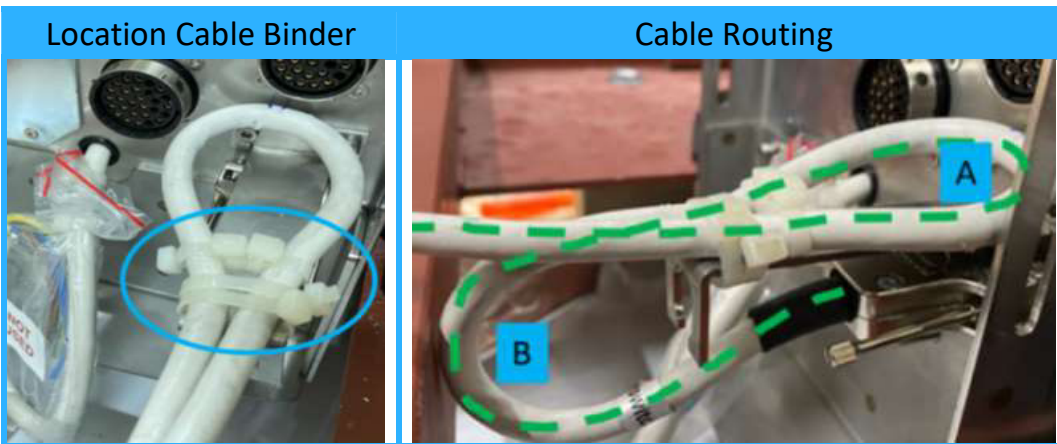
Figure 4b: AD7NT Patient Table with cable tie strain relief

Number of cable binder(s): 5 (five)

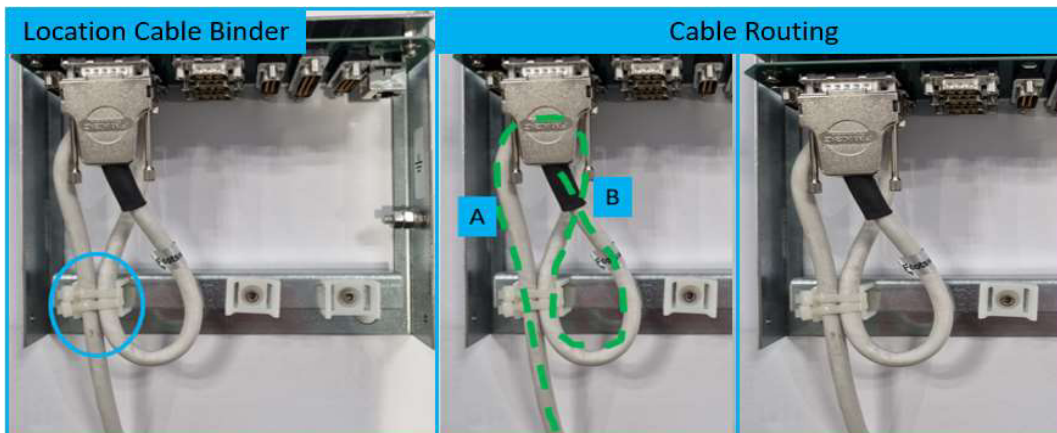
Figure 5: Pedestal Wall Connection Box

Number of cable binder(s): 2 (two)

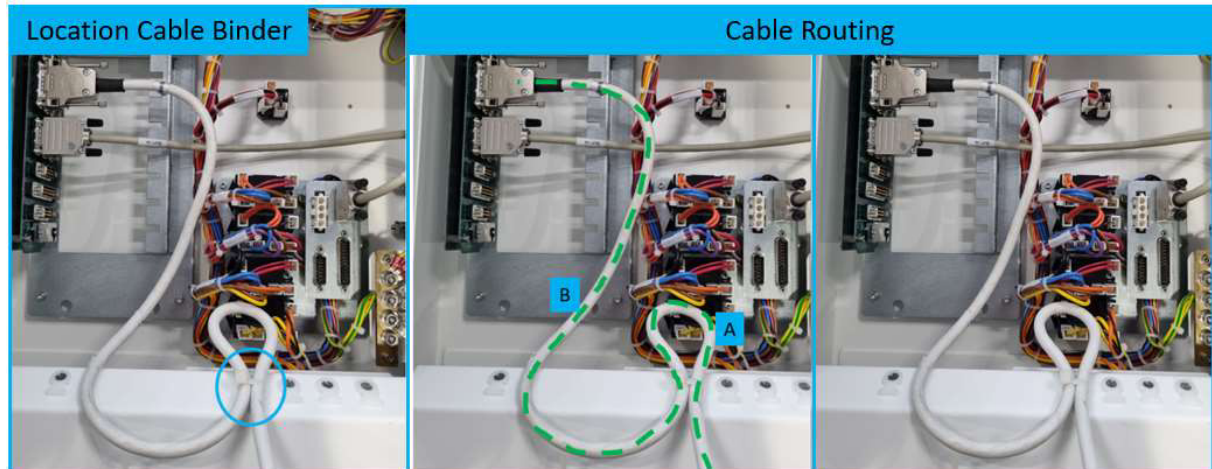
Figure 6: Surgery Wall Connection Box

Number of cable binder(s): 1 (one)

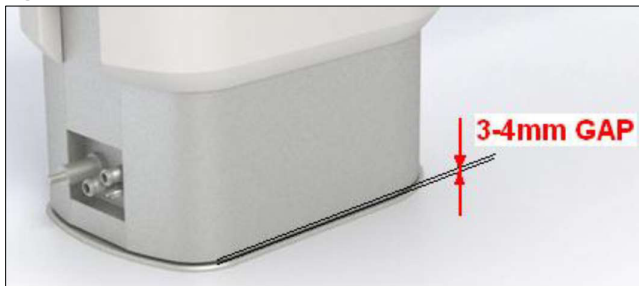
Figure 7: Non-swivel table (AD7NT, AD7XT and AD7XNT)

- For a non-swivel table
 - Make sure that the clearance to the fluid protection plate is 3-4 mm
 - Refer to Figure 7
- For a swivel table
 - Make sure that the clearance to the swivel cover is 3-4 mm
 - Refer to Figure 8

If the gap between the plinth covers and the floor does not satisfy the above requirement, adjust the plinth cover according to the repair instructions.
