Updated URGENT Field Safety Notice

MultiDiagnost-Eleva systems
Potential loss of imaging functionality resulting from no or intermittent X-ray radiation initiation
through the wired foot switch

Philips Reference: 2023-IGT-BST-004

27-October-2023

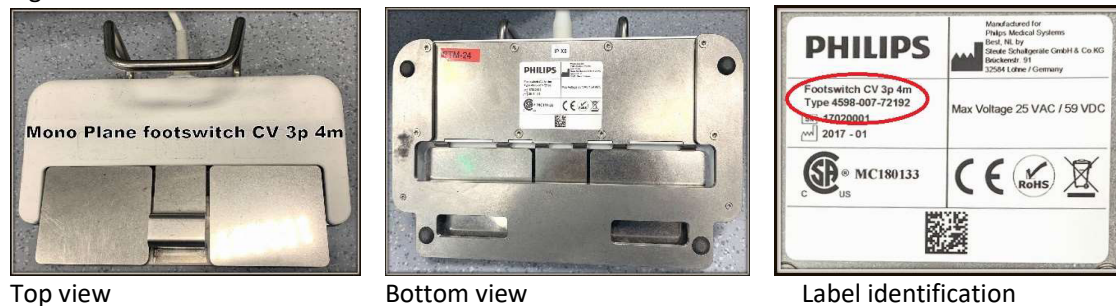
The reference/type of the wired foot switch can be found on the label located on the bottom of the wired foot switch, as shown in Figure 1.
