FIELD SAFETY NOTICE

for End-Customers using Hamilton Medical In2Flow Nasal cannulas Reference #: FSCA 2023-08-04

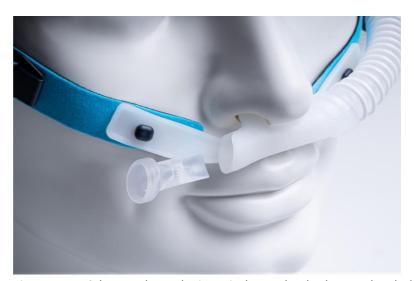
Hamilton Medical AG is informing about a potential health risk when using the In2Flow Nasal cannula after receiving reports that the plug became detached from the soft part as shown in Figure 1.

Several complaints were received where the plug (the one at the opposite side of the tubing) became detached from the In2Flow Nasal cannula, causing leakage due to unintentional disconnection of that part. This may result in degraded high flow support and oxygen delivery, which may lead to patient O2 desaturation.

Figure 1: An In2Flow Nasal cannula size M is shown. The plug became detached from the opposite side of the tubing. (This is an example; sizes S and L are also affected.)

In case the plug becomes detached from the In2Flow Nasal cannula during high flow therapy desaturation of the patient with SpO2 < 80% might result.

Periodically check the position and stability of prongs, as indicated in the Instructions for Use (Document 10083250/02, page 10) and that the plug is still in its intended position.

- 1. Keep monitoring patient's O2 saturation and act accordingly.
- 2. Check if plug of In2Flow Nasal cannula became detached.
- 3. If the plug is still in place, check for other reasons for O2 desaturation.
- 4. If the plug became detached, exchange the affected In2Flow Nasal cannula, and use a new In2Flow Nasal cannula.
