**Internal exocad Reference:** #271391

**exocad product, commercial name:** *exoplan 3.1 Rijeka*

## Field Safety Notice #271391 related to *exoplan 3.1 Rijeka*

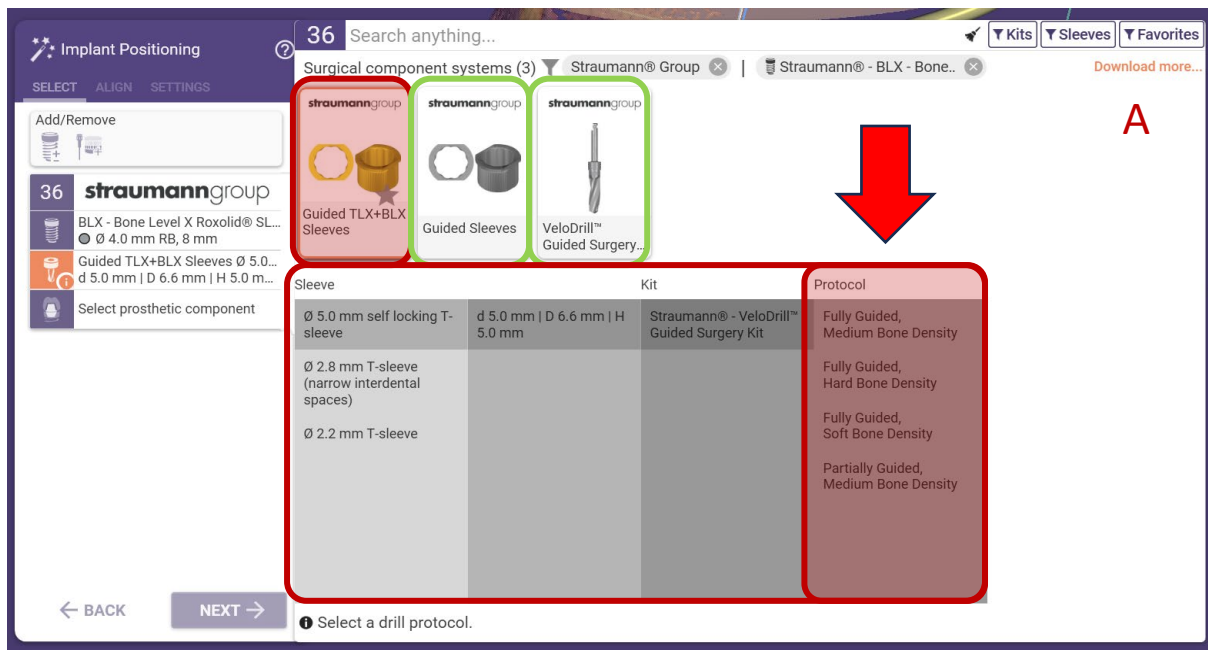
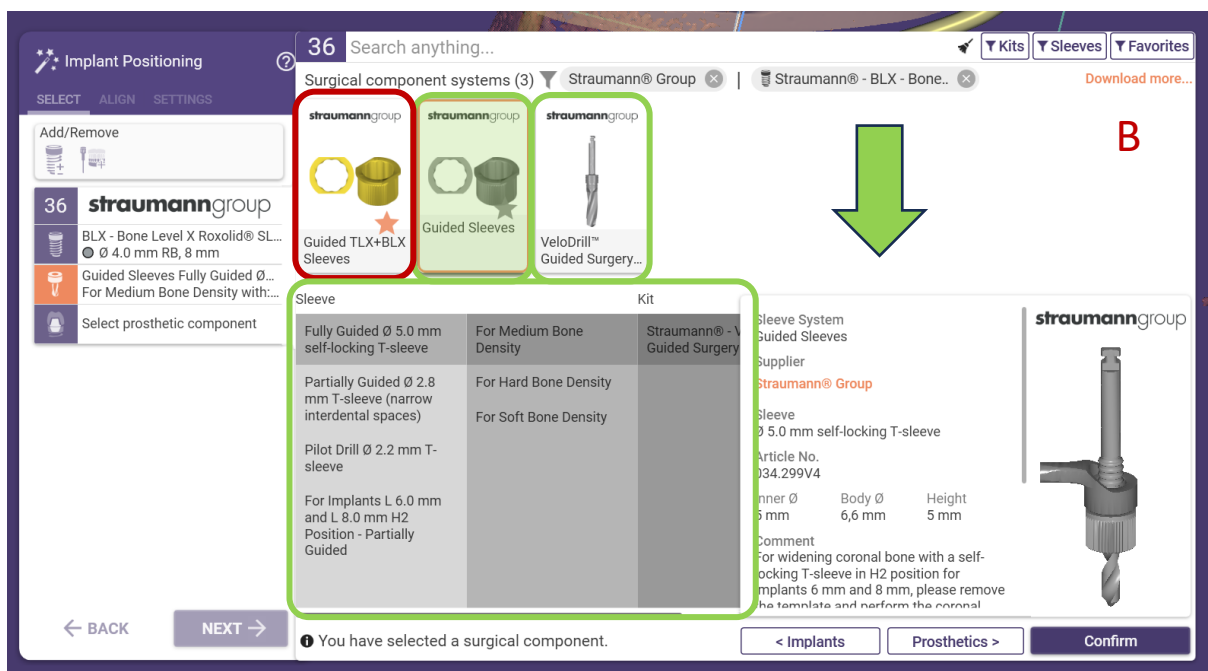
Figure 1: Examples comparing between selecting a “protocol” library (case A) and selecting libraries without protocol (case B). The picture shows all entries that should not be used in red. Those that can be used without interference are marked in green. If no “Protocol” column is present, the library is not affected by this FSN.

- 1) Do not use the affected libraries - see section "Affected libraries" above - with *exoplan 3.1 Rijeka*.
- 2) Upgrade to the available new *exoplan 3.1 Rijeka* and if you are intending to use the affected libraries, update also to compatible, new Straumann® BLX/TLX /VeloDrill full step-by-step drill protocols available for download at <https://exocad.com/integration/exoplan-library-integration>.

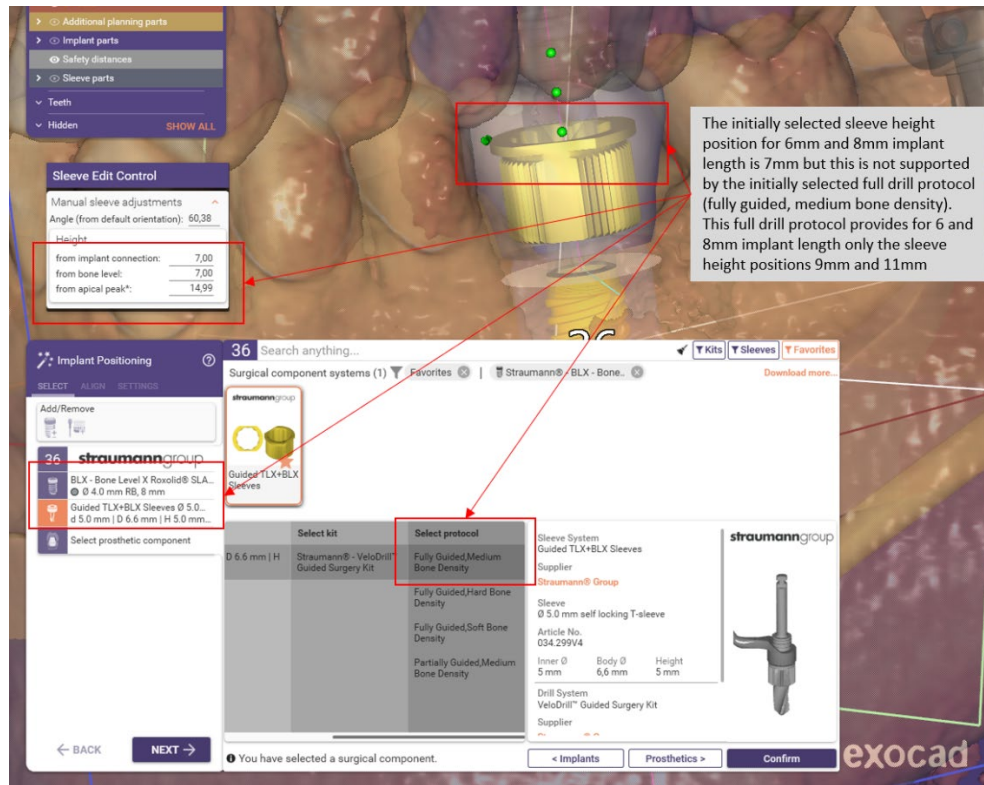
When a Straumann® BLX/TLX implant with 6 mm or 8 mm length in combination with a Straumann® BLX/TLX sleeve and the Straumann® VeloDrill-kit with full drill protocols is used, the software places the sleeve for the initially selected full drill protocol “Fully Guided Medium Bone Density” to a height position of 7 mm (see figure 2). For this protocol, however, only 9mm and 11 mm are allowed. Internally, the software selects the full drill protocol for a sleeve height position of 9 mm and shows this also in the surgical protocol (see figure 3). If a user follows the full drill protocol sequence from the surgical report when printing and using this guide with that wrong sleeve position, the drill depth would be 2 mm deeper than planned and might damage anatomical risk structures close to the implant apical positions (e.g., nerves, or neighbored tooth roots).

Figure 2: Example of one critical combination between unsupported sleeve height position for the selected full drill protocol. See explanation in the image.

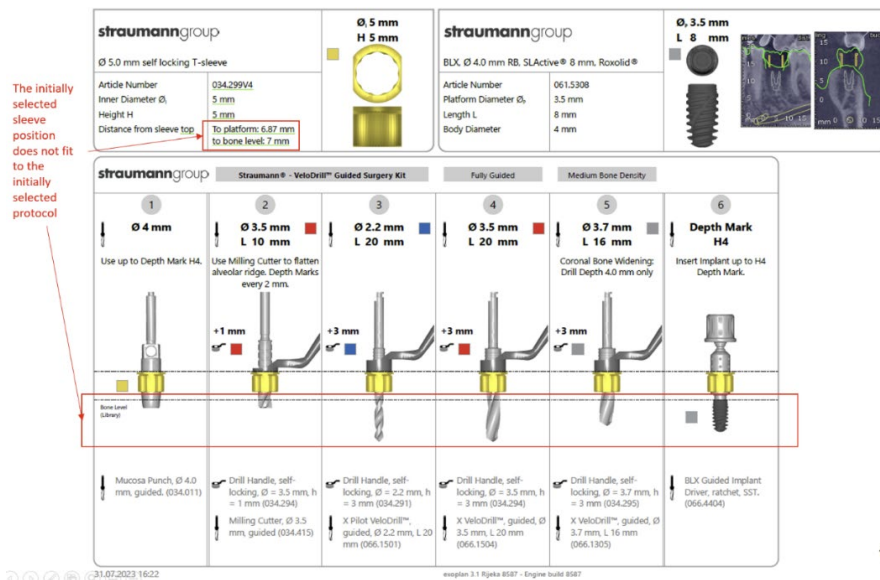
Figure 3: Extract from the surgical report that depicts the mismatch between the initial sleeve height position and the full step-by-step drill protocol where the distance from sleeve top to implant shoulder is incorrect.

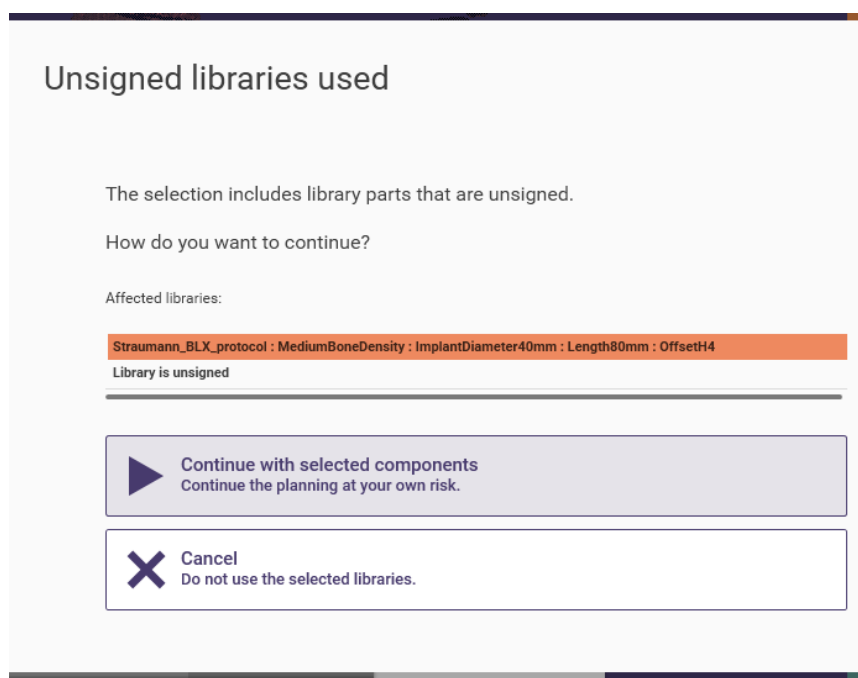
Figure 4: Unsigned library message of a blacklisted Straumann® full drill protocol library to the user when selecting it in the software or when the planning and surgical guide output data is generated. Users notified by this warning should click “cancel” and not “continue.” If users click continue, they continue at their own risk.

- 2) As a result of the blacklisting, if the user tries to select a component in the affected library, the user receives a message indicating that the selected full drill protocol library is marked as “unsigned” (see figure 4) and should no longer be used. This message appears when the user selects the blacklisted protocol library, as well as before the implant planning and surgical guide output data is generated. Users notified by this warning should click “cancel” and not “continue.” If users click continue, they continue at their own risk.

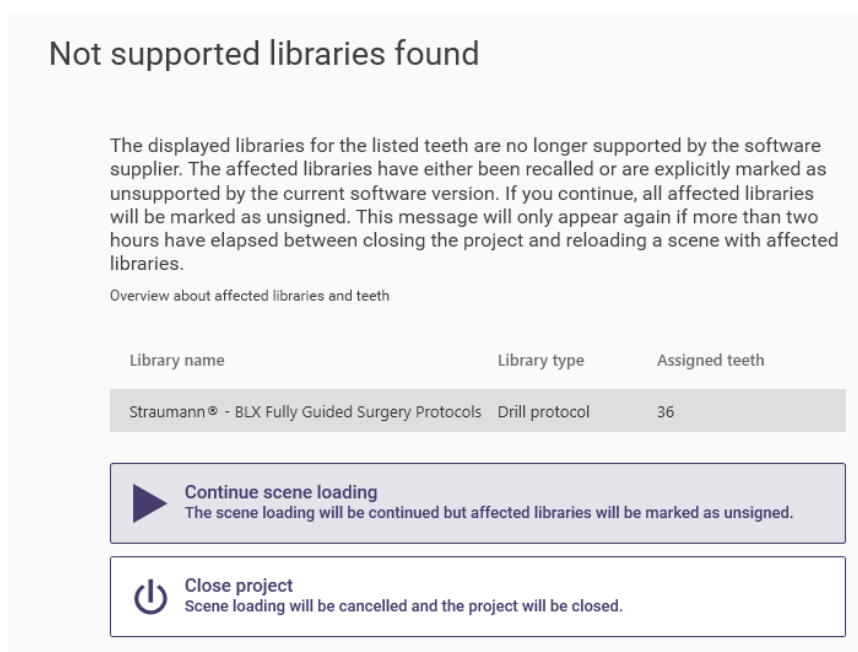
Figure 5: Unsigned library message of a blacklisted Straumann® full drill protocol library to the user when loading a scene file that already contains the affected library.

- 3) If an implant planning “scene file” (file containing all the information about a planning or design scene, e.g., workflow state, scene objects) is loaded into exoplan that previously used the blacklisted full drill protocol library in the implant placement planning, a warning message appears to inform the user about the unsigned library (see figure 5).
