To all users of the following systems: Cios VA30

Product/Trade Name:	Cios Spin, Cios Alpha, Cios Flow	EU-SRN	DE-MF-000006122
		E-mail	advancedtherapies-fsca.team@siemens-healthineers.com
UDI-DI:	04056869153506, 04056869153490, 04056869246628	Date	September, 2023
		Corrective Action ID	AX036/23/S

## Customer Safety Information (CSI) for Field Safety Corrective Action

**Subject: Fulfillment of new requirements from DIN and IEC standards for Cios VA30 Systems**

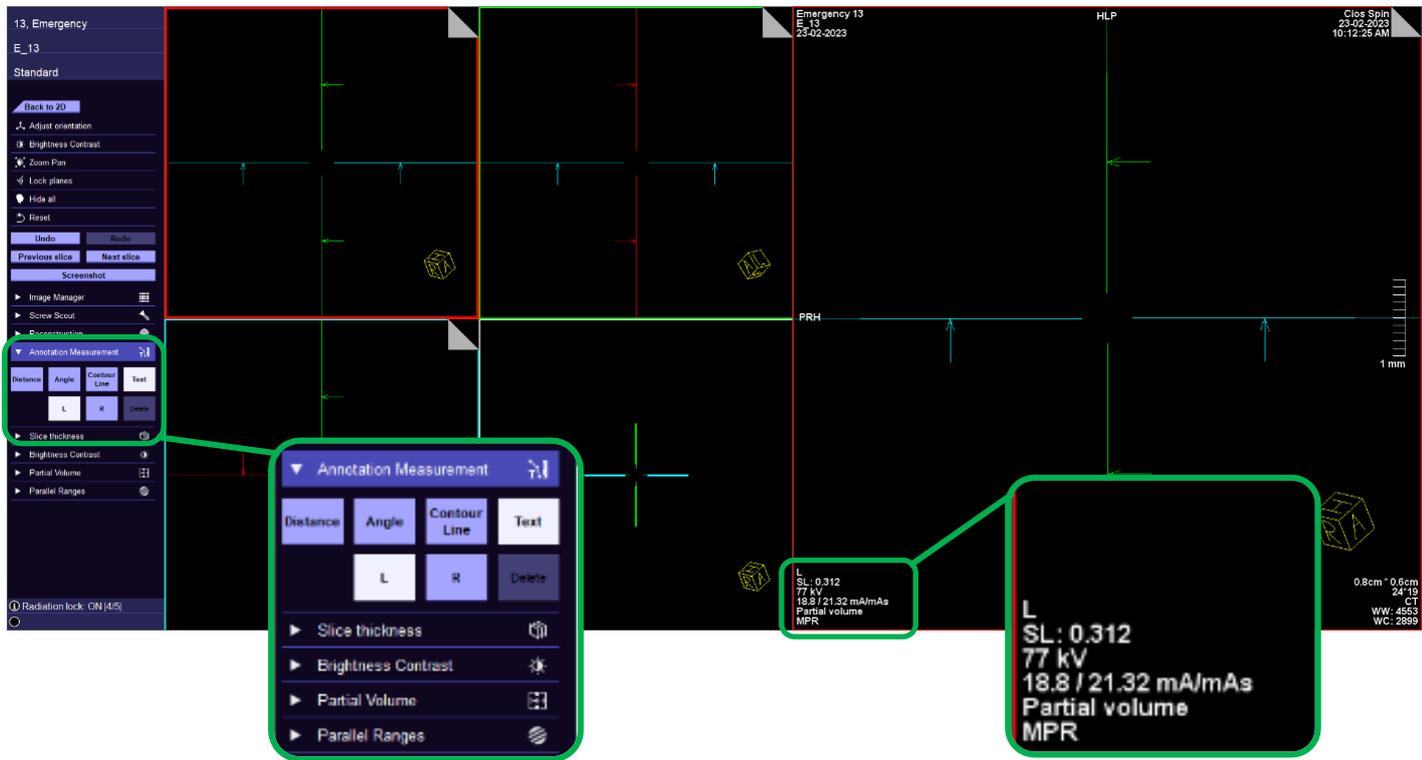
So far, in 3D mode, information about image orientation regarding “laterality” (i.e., L = left / R = right) cannot be defined and saved with the clinical image by the user.

In 3D mode, the user could mix up the patient orientation regarding “laterality”. Therefore, the user could carry out a wrong diagnosis and/or wrong treatment based on the acquired clinical images, which does not show clear information about patient orientation.

With software version VA30K, the user interface of Cios VA30 systems will be changed to consider the current standards DIN 6862-3 and IEC 60601-2-54.

In 3D mode and if patient orientation information is important in a procedure, the user can predefine the patient orientation “L/R” (left/right), and therefore “laterality” information will additionally be saved in the clinical image (see screenshot of user interface below).
