Urgent Field Safety Notice

Title: ORBIS Medication: Adding value for carrier solution leads to two solutions being inserted with same value -> wrong dilution

Internal Reference: MST0073175

- ORBIS Medication 03.18.02.00 in ORBIS 84.40.02.00 and higher in Germany, Austria, Switzerland, Luxembourg - Manufacturer: DH Healthcare GmbH
UDI-DI: 4260693990026

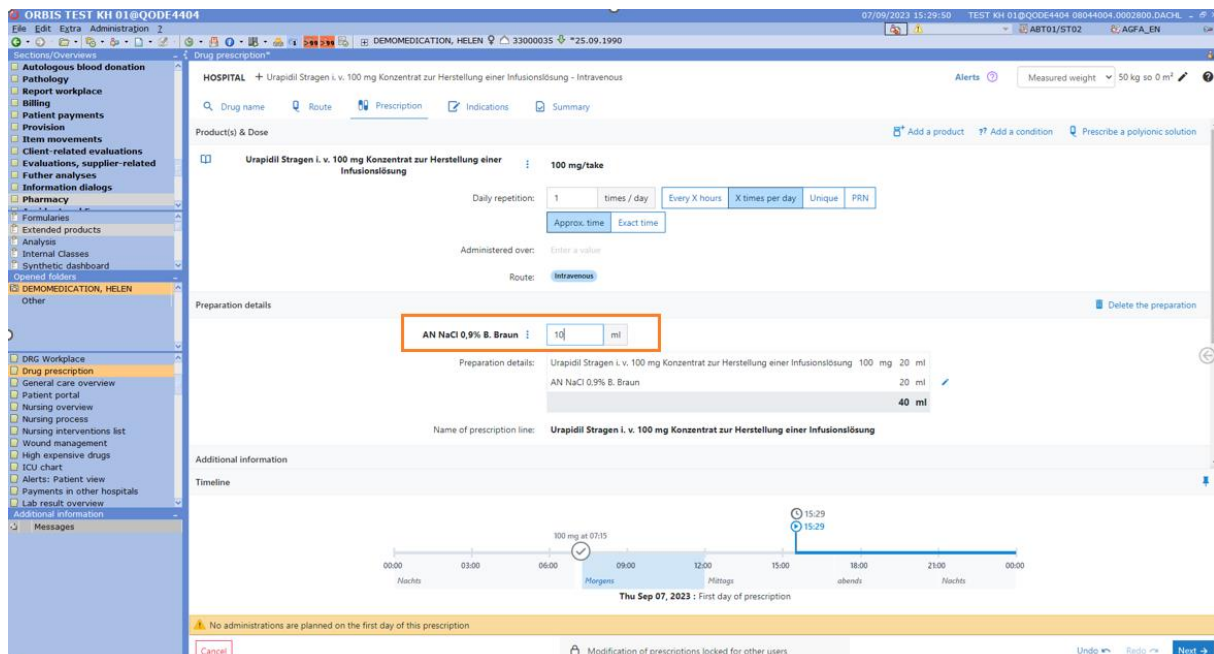
After update to ORBIS Medication 03.18.02.00 or higher, an issue occurs when a product is prescribed with a fixed carrier volume: the preparation details are wrongly initialized, and the physician cannot adapt them properly.

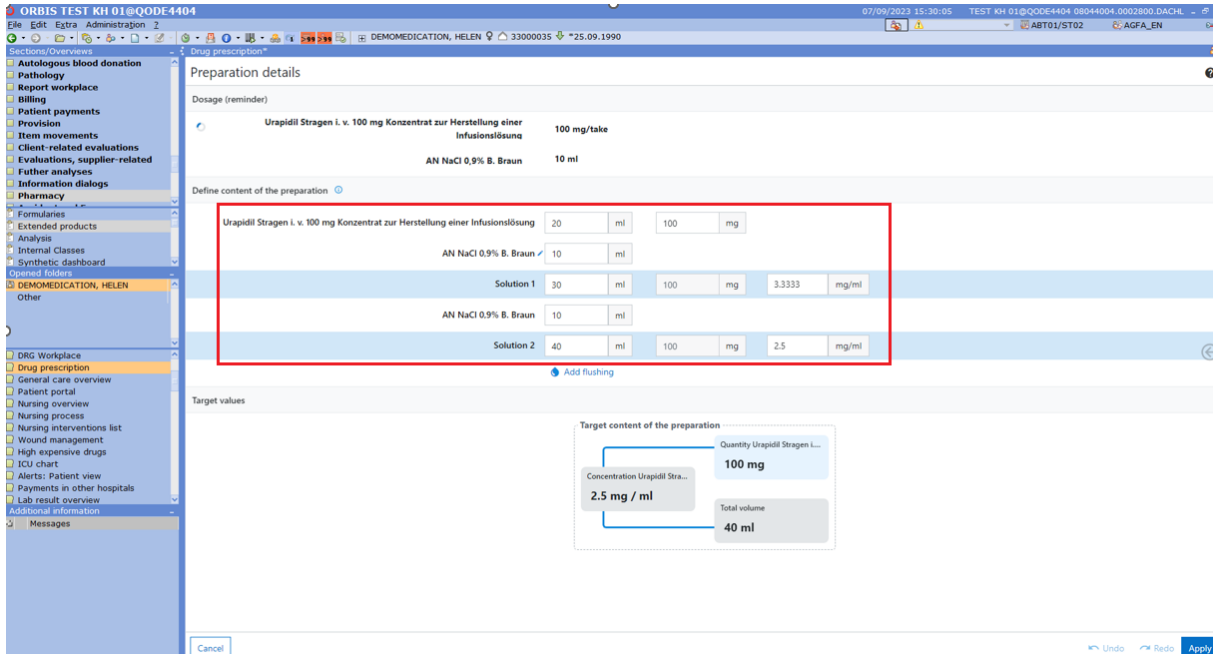
The issue is the following: the drug is prepared with two successive dilutions, the volume of carrier in the first dilution is different from the one defined in product configuration and there is no possibility to prepare the drug in one dilution only.

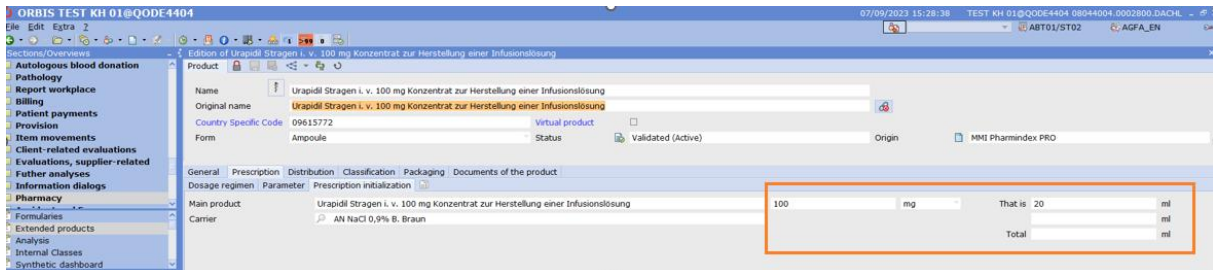
This wrong initialization of preparation details occurs when the product is configured with a quantity to prepare and (or) a volume of carrier to be used for reconstitution/dilution.
