URGENT Field Safety Notice

Big Bore RT, Upgrade Brilliance CT Big Bore (Product Codes 728242, 728243, 728244)

Patient Position Image Shift may result in Incorrect Treatment

09-OCT-2023

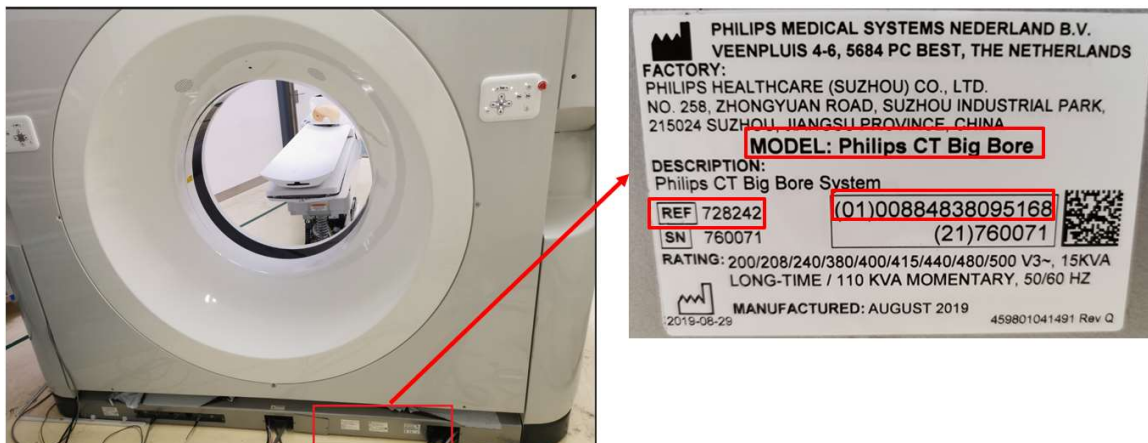
Figure 1. Example system label

Identify the product model name and product code on the back of the gantry in the bottom right corner as shown in Figure 1.

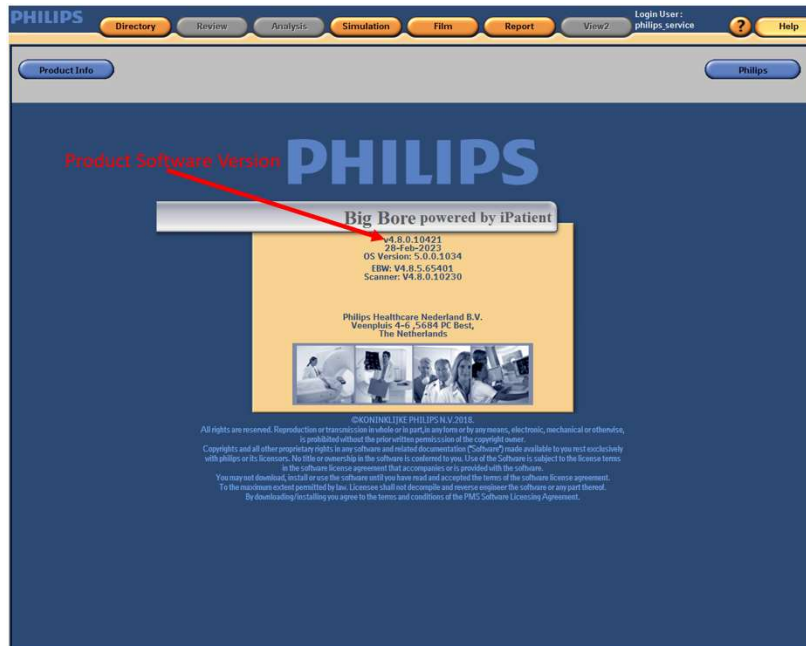
Figure 2. Big Bore software version display as an example

1. From the Directory, select the **Help** button.
2. Select **About** and the software version is then displayed. The software version begins with **v**.
