## **URGENT Field Safety Notice**

**BrightView, BrightView X, BrightView XCT**  
Patient Extremity Entrapment Hazard while using Pre-Programmed Motion

November 28, 2023

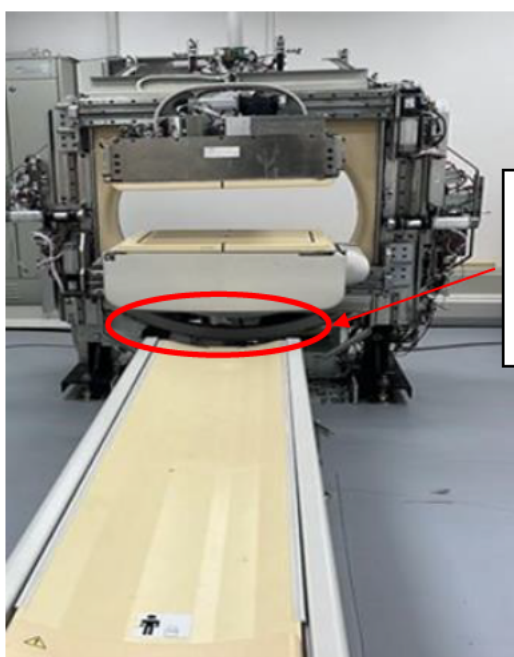
*Figure 1. Image of gap between the patient support and detector*

While using Pre-Programmed Motion (PPM) during an extrinsic quality assurance scan, a gap is created between the patient support and the detector. This gap presents a potential extremity entrapment hazard for patients while the system detectors and patient support are in motion.

Gap between the detector and patient support. During PPM, the gap may decrease creating the potential for extremity entrapment.

Philips has received one (1) report of an adverse event associated with this issue. In this reported event, the operator positioned a patient on the patient support and initiated the total body Pre-Programmed Motion (PPM). While the patient support and detectors were in motion, the patient straightened their leg due to a cramp, causing their foot to extend and become entrapped between the patient support and the detector. The patient sustained a foot fracture.

- **Monitor the patient during system movement when the Pre-Programmed Motion is in use and review the warning and caution guidance information below, as outlined in *Section 2: Safety and Regulatory Agency Compliance in the Instructions for Use*:**

- If the patient extends beyond the end of the imaging table, reposition the patient before starting any preprogrammed motion.
  - Vigilantly watch the patient to make sure that equipment or patient motion does not result in patient harm or equipment damage.

- If you perform a PPM with the patient on the imaging table, monitor the equipment motion closely to avoid contact with the patient object.
  - If any part of the system looks as if it is going to collide with the patient, use an emergency stop button to immediately stop system motion.

Philips will contact you to schedule a time for a Philips Field Service Engineer (FSE) to visit your site and install a technical solution to resolve this issue (refer to FCO88200537).
