FSN Ref: 2023-11(01)
Date: 01 Dec 2023

Urgent Field Safety Notice (FSN)
Mölnlycke® Procedure Trays
Dispo Medical Insufflation tube within Mölnlycke® Procedure Trays

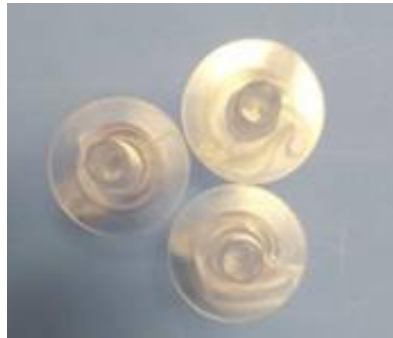
1.	<p>4. Device Model/Catalogue/part number(s)</p> <p>See Appendix I Product Table</p>
1.	<p>5. Affected serial or lot number range</p> <p>See Appendix I Product Table</p>
2 Reason for Field Safety Corrective Action (FSCA)	
2	<p>1. Description of the product problem*</p> <p>Mölnlycke has recently been informed of an action initiated by Dispo Medical, who is the legal manufacturer of the device listed above. The issue is relating to an error which occurred during the injection moulding process of one of the filter connectors during production. A relatively small part of these connectors appears to be impenetrable and is blocked from the inside by an occluding fleece, as picture 1 below.</p>

<p>Picture 1 – Incorrect filter connectors with occluding fleece.</p> <p>These faulty connectors may be incorporated into some of the Dispo Medical devices, which Mölnlycke subsequently includes in Mölnlycke® Procedure trays.</p> <p>Mölnlycke has decided to follow the legal manufacturer FSN and perform a Field Safety Corrective Action. At the point of use of these Mölnlycke® Procedure trays, the user is required to identify the affected component 2323184-00 (Insufflation tube) and check whether the connector is open. If you encounter a blocked connector, please discard, and inform vigilance@molnlycke.com</p>
2	<p>2. Hazard giving rise to the FSCA*</p> <p>Information from Dispo Medical:</p> <p>There is no immediate danger to the patient, however the product will not function due to the fact gas cannot flow through it. A blocked connector will cause discomfort during use and may delay the procedure using the medical device in question.</p>

<p style="text-align: center;">3. Type of Action to mitigate the risk</p> <p>3. 1. Action To Be Taken by the User</p> <ul style="list-style-type: none"> <input checked="" type="checkbox"/> Identify Device <input checked="" type="checkbox"/> Quarantine Device <input checked="" type="checkbox"/> Take note of amendment: affix a copy of this FSN to each Mölnlycke® Procedure tray and make this FSN information available for the user <p>We need your help in ensuring that <u>all affected products</u> are located and that below actions are performed.</p> <p>Please follow below instructions:</p> <ol style="list-style-type: none"> 1. Identify and isolate the unused Mölnlycke® Procedure Trays at your facility, please see Appendix I for affected product information. 2. Affix a copy of this Field Safety Notice (FSN) to each Mölnlycke® Procedure tray and make sure that its contents is brought to the attention of all relevant personnel to read before use. 3. At the point of use of the tray, the user is required to check whether the connector is open. If you encounter a blocked connector, please discard, and inform vigilance@molnlycke.com 4. Fill out the Customer Reply Form or Distributor Reply Form with the quantity of identified affected products. Please sign and email/fax the Customer Reply Form or Distributor Reply Form per its instructions within 10 business days.

At the point of use of these Mölnlycke® Procedure trays, the user is required to **identify the affected component** 2323184-00 (Insufflation tube) and check whether the connector is open. **If you encounter a blocked connector, please discard and inform** vigilance@molnlycke.com.
