## **URGENT Field Safety Notice**

Philips **Azurion System** R1.0, R1.1, R1.2, R2.0, R2.1, and R2.2  
Potential loss of imaging functionality and clinical data stored in the system

January 2024

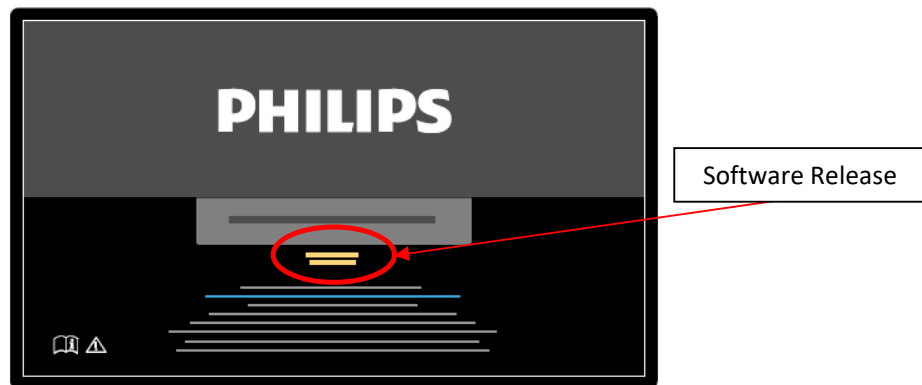
Figure 2: System start-up screen

The software version of the Philips Azurion system can be identified during start-up (Figure2).

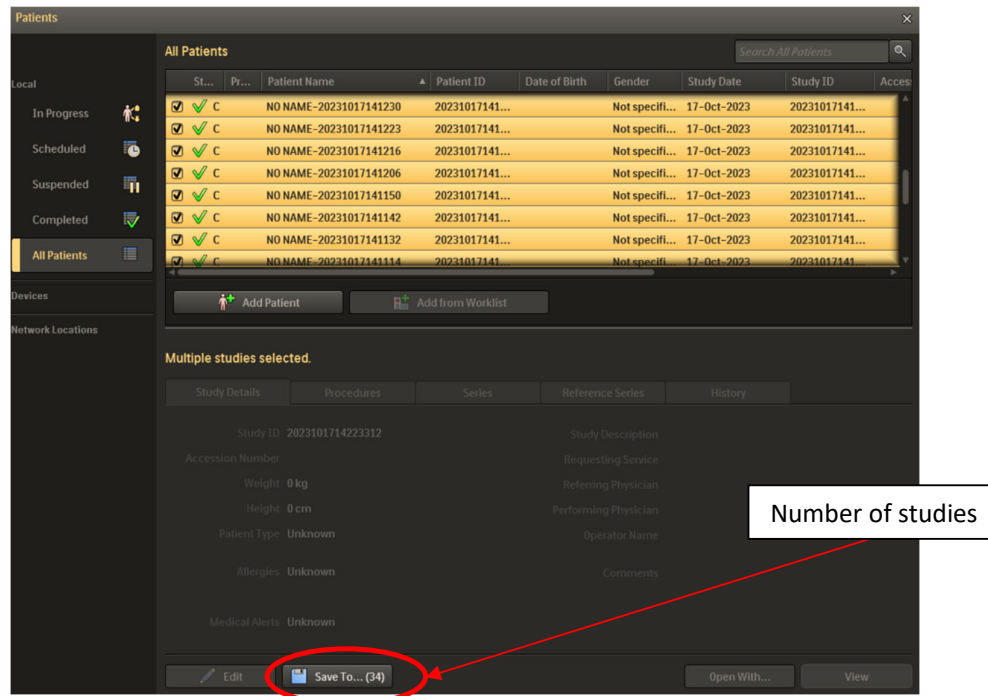
The number of studies can be determined by selecting all studies in the table (Ctrl+A). The number of studies is displayed at the lower part of the screen, see image below.

Note: There is no direct relation to the image disk space used. The number of studies can be high while the image disk is only partially filled, in case only a few images are saved for each patient.

- When deleting studies, ensure the studies are archived and delete the studies in small batches (<10).
- Circulate this notice to all users of the system so that they are aware of the issue.
- Return the attached response form (page 5) to Philips promptly and no later than 30 days from receipt to confirm that the users of the system have reviewed and understood this Field Safety Notice and required actions to be taken.
