**URGENT Field Safety Notice**

5000 Compact Series Ultrasound Systems (Models 5500 and 5300)  
Multiport adapter issue with a potential to cause a burn in the esophagus

March 20, 2024

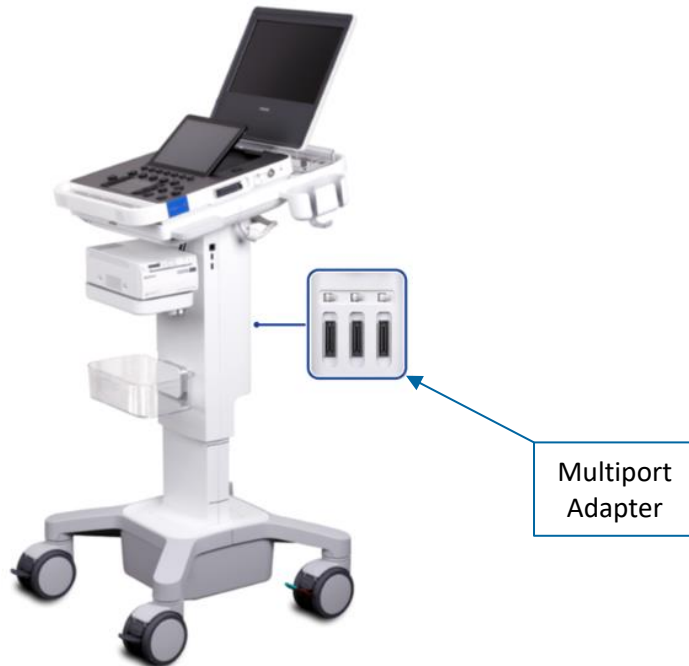
Figure 1. Multiport Adapter shown on a 5000 Compact Series Ultrasound System

The 5000 Compact Series Ultrasound Systems with Deluxe and Premium Cart options come with a Multiport adapter (MPA) as shown in Figure 1 below. This Multiport adapter enables connection of up to three transducers.

If, during a procedure where multiple transducers are connected to the Compact 5000, one of which is a transesophageal echocardiography (TEE) transducer and imaging is being performed with one of the other transducers, the TEE transducer may continue to receive power, which may cause the transducer head to exceed the established temperature limit (43°C/109.4°F). The fault condition is triggered by the vibrations caused by disconnecting and connecting/reconnecting of the transducer(s).

If the TEE probe remains unselected through all the steps outlined above, there is a possibility that the MPA will allow power to be directed to the TEE probe. Under these conditions, the temperature monitoring and control function for the TEE probe is circumvented which may result into the temperature of the TEE transducer head to exceed the established temperature limit.

Option 2: Whenever adding a transducer to, or removing a transducer from the MPA, disconnect and reconnect the MPA connector on the Compact 5000 system connector port, followed by a transducer selection on the touch screen. By performing this step when adding or removing a transducer, the monitoring and control systems are re-initialized.

A Philips representative will contact you to schedule a time for a Field Service Engineer to visit your site and implement the solution to resolve the issue (reference FCO79500569).

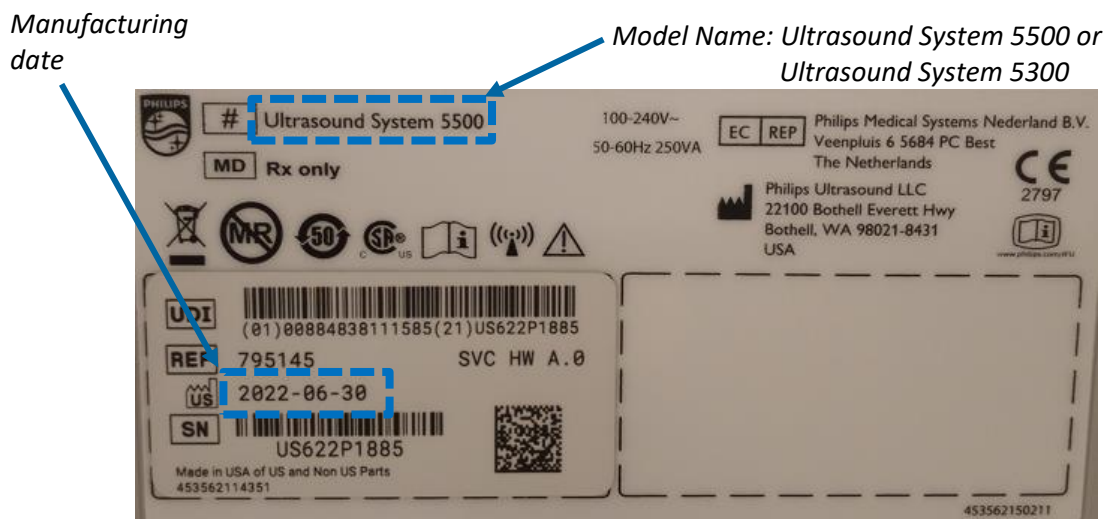
Figure 2. Example System Label

- 1) Model Name indicated on the label (located at the bottom of the system) is “Ultrasound System 5500”, or “Ultrasound System 5300”. Figure 2 is shown as an example below. And:
- 2) The cart used with the system has a Multiport Adapter as shown in Figure 1 above.

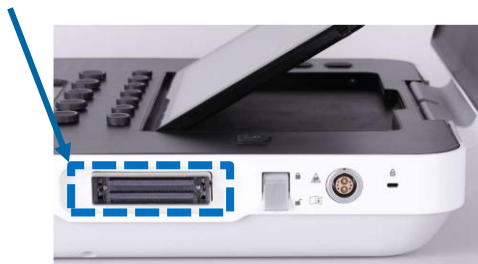
*Figure 3. Port on the side for a directly connected transducer*

The issue is associated with the MPA, therefore by using the port on the Compact 5000 directly, the issue is avoided.

Option 1: To prevent the issue from occurring, when using the TEE transducers, connect directly to the Compact 5000 system using the port on the side of the system as shown in Figure 3 below.
