### **Safety Advisory Notice**

To all affected users of the SIEMENS systems  
Luminos Agile Max, Luminos dRF Max, LUMINOS  
Lotus Max with display ceiling suspension and  
Multitom Rax with display wall suspension

### **Re: Potential risk of unintentional lowering of the support arm for display ceiling suspension / display wall suspension**

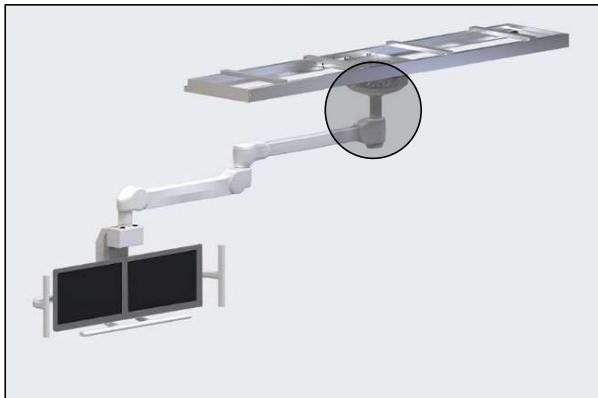
Please visually inspect the mounting screw on the ceiling tube (Figure 1) or wall tube (Figure 2) of the display suspension as far as this is possible from the ground.

Figure 1 Display ceiling suspension  
with ceiling tube circled

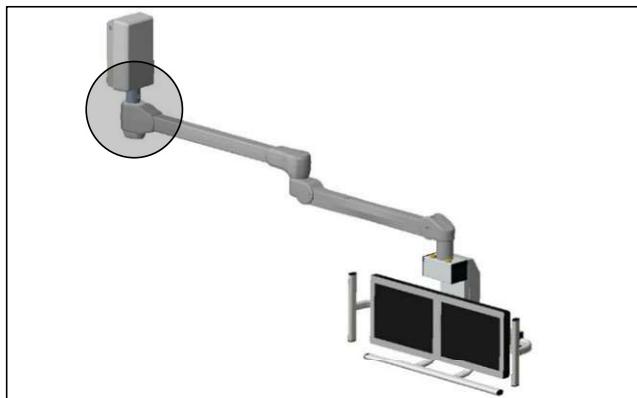
Figure 2 Display wall suspension  
with wall tube circled

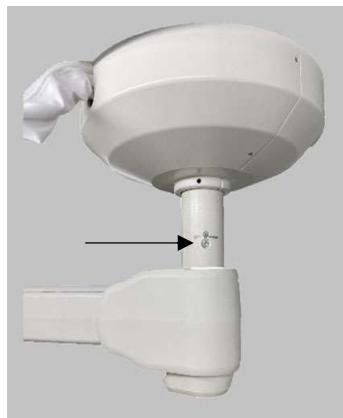
Figure 3 Correct:  
Mounting screw available  
and no visible damage

In case the visual inspection of the mounting screw does not show any abnormalities, you can continue to use the system. Nevertheless, until the system has been checked by Siemens Healthineers customer service with the planned field action, we recommend:

- not to swivel the support arm of the display ceiling/wall suspension to the mechanical limit with great force and
- to ensure that there is no one under the display ceiling/wall suspension when positioning the displays.

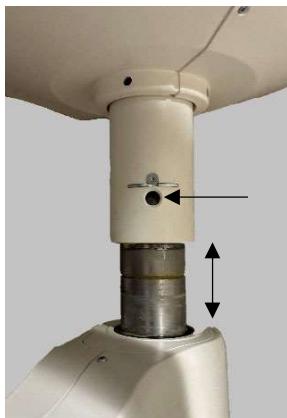
There is a potential risk that the mounting screw on the support of the display ceiling/wall suspension may loosen or be missing, causing the support arm with displays to lower downwards with continued use. In a worst-case scenario, the support arm could lower suddenly and cause serious injury. During service activities Siemens Healthineers XP became aware of two cases in which the mounting screw was missing. No injuries were associated.

Figure 4 Incorrect:  
Mounting screw missing  
and/or lowered support arm

If the mounting screw is missing, or if the screw head protrudes or is broken, discontinue use of the system immediately. Please inform the Siemens Healthineers customer service. Furthermore, if the display ceiling/wall suspension has lowered, discontinue use of the system immediately and inform customer service of the issue.

This Customer Safety Advisory Notice (update XP017/24/S) is being distributed to all potentially affected customers. Siemens Healthineers is preparing a field safety corrective action that will be provided with Update XP018/24/S starting in the third quarter of 2024. The corrective action will involve check and replacement of the attachment of the support arm for the display ceiling/wall suspension by a service technician in an onsite visit. In instances where the mounting screw is broken, the support arm will also be replaced with update XP019/24/S.
