## **URGENT Field Safety Notice**

### **Philips Azurion System R1.x**

Potential Loss of Imaging (X-ray) Functionality and/or Longer Time to Perform Cold Restart

11-JUL-2024

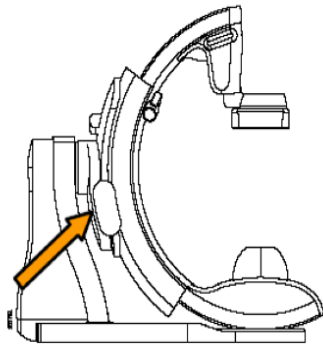
Figure 1- System Identification Label

The System Product Name and Model Number can be found on the System Identification Label located on the System stand (*Figure 1*). The software version of the Philips Azurion system can be identified during startup (*Figure2*).
