## **URGENT Field Safety Notice**

Philips Azurion, Allura Xper, Integris and MultiDiagnost Eleva  
Potential Detachment of the Cable Hose Carrier which May Result in Parts Falling and/or Part of the  
Cable Hose Dropping

22-AUG-2024

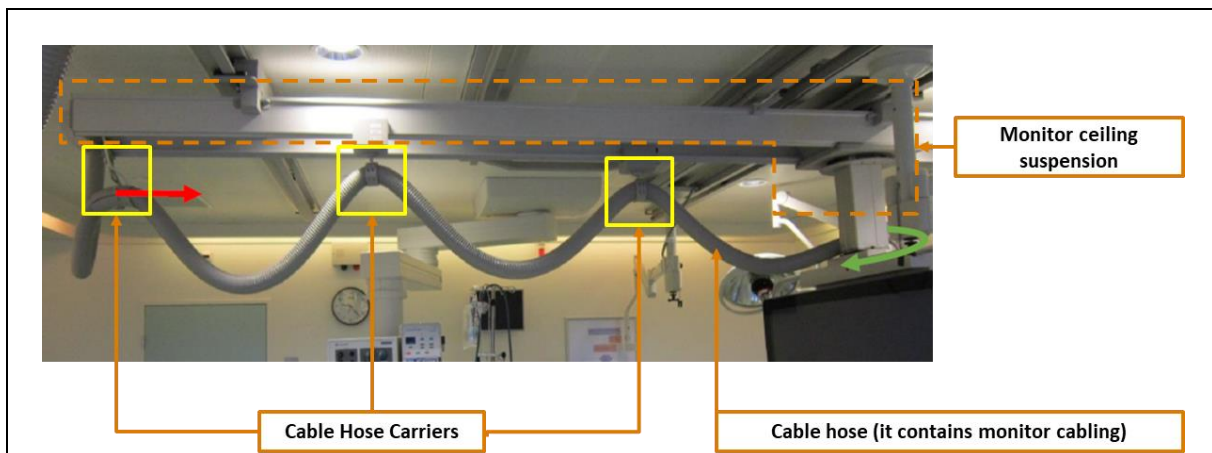
Philips has identified that due to the forces applied when moving or turning the monitor of the system, the bolts and plastic parts of the Cable Hose Carriers that hold the cable hose to the monitor ceiling suspension may become loose and/or break (see Figure 1). If this issue occurs, plastic parts and/or metal bolts of the Cable Hose Carrier(s) may fall and/or part of the cable hose may drop following the detachment of a Cable Hose Carrier.

*Figure 1: When the monitor is moved or turned (green arrow), the cable hose pulls the Cable Hose Carriers and applies forces to their joint and bolted connections (yellow box).*

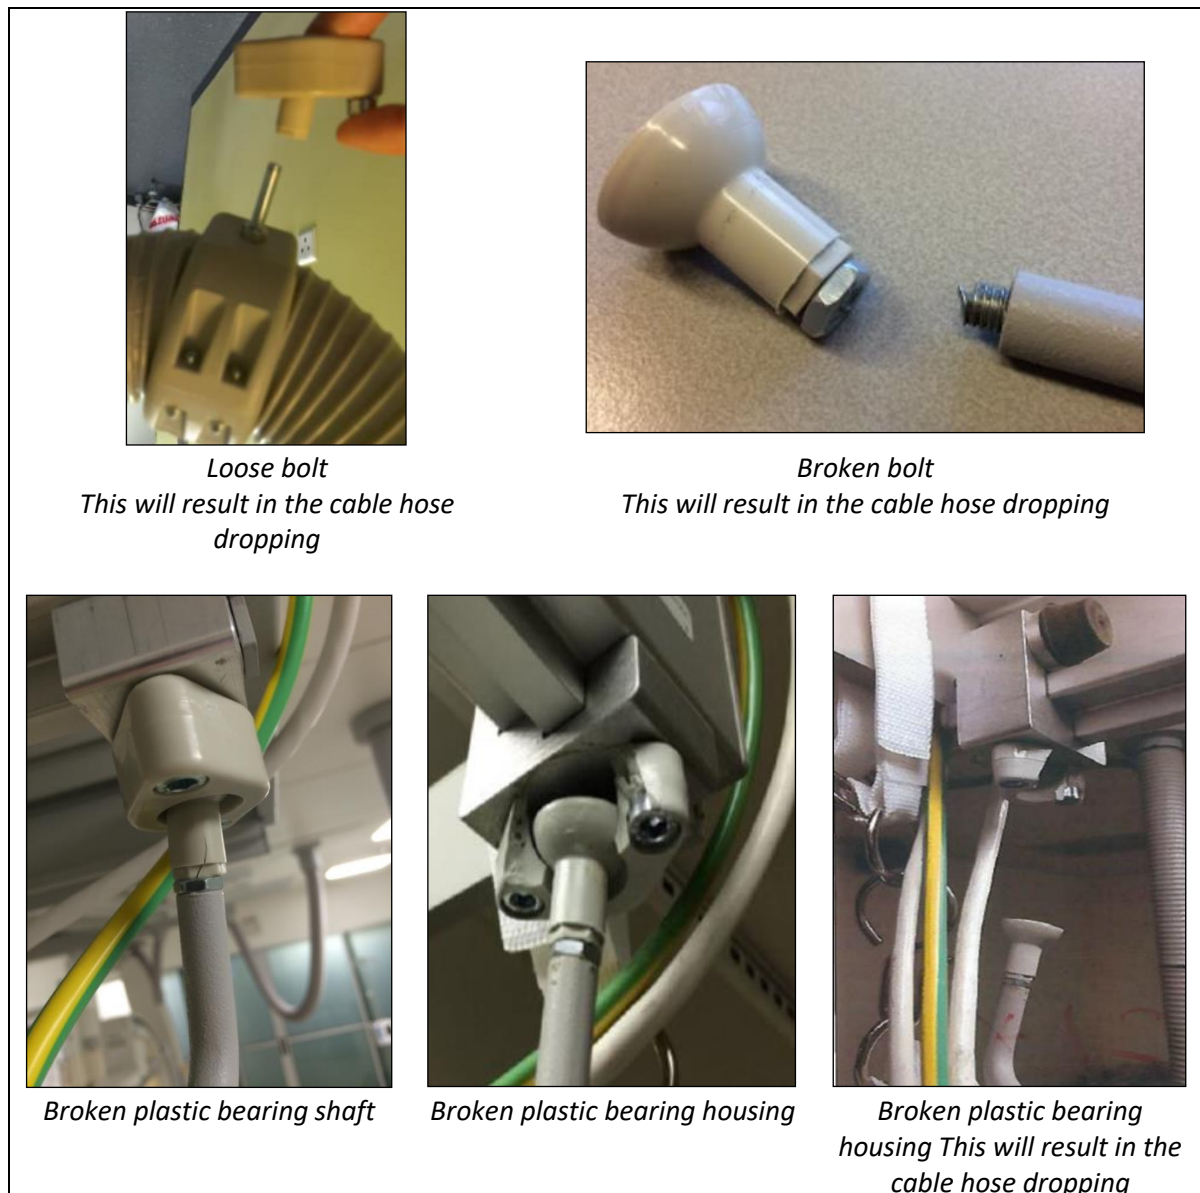
*Figure 2: Examples of loose and broken bolts and plastic parts*

- c. Avoid having the patient located underneath the Cable Hose Carriers (e.g., during transport).
- d. If you notice loose or broken bolts and/or broken plastic parts of the Cable Hose Carriers (see Figure 2), please contact your local Philips representative immediately.

Philips is redesigning the Cable Hose Carriers. Once the redesigned cable hose carriers are available, Philips will contact you to schedule a visit to install them in the affected system(s) (reference FCO72200536, FCO72200576, and FCO72200577). As of the date of this urgent Field Safety Notice letter, Philips expects the solution to be available by Q3 2025.

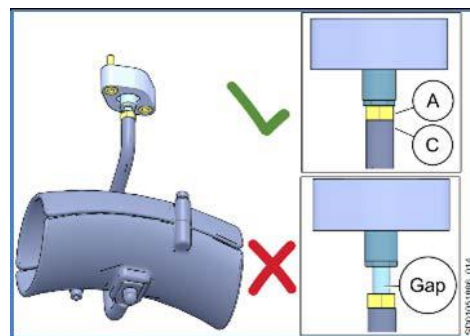
Fig. 04: Correct 'V' and incorrect 'X' banana carrier suspension

5. Make sure that all the nuts are tightened.
6. See if there is a visible gap.

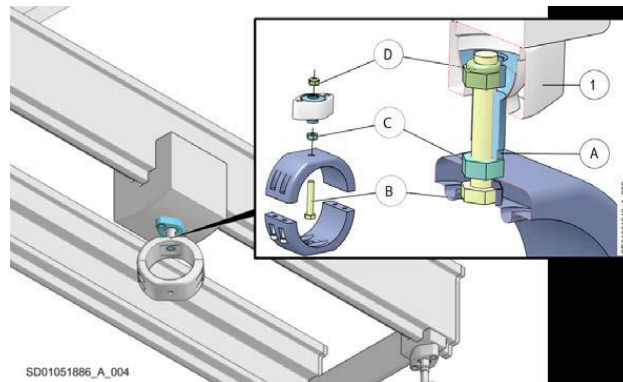
*Fig. 05: Cable hose carrier with ring*

7. If there is a visible gap for a carrier with ring:

- Loosen base (1) (2x M6).
- Loosen the plastic arm carrier (A) with nut (D).
- Loosen nut (C).
- Apply Loctite 243 to the thread of the bolt (B).
- Assemble the hose ring with bolt (B) and nut (C).

- Hold the nut (C) in position, then rotate and tighten the plastic arm carrier (A) with nut (D) until there is no gap.
