**UPDATED: URGENT Field Safety Notice**

Trilogy Evo, Trilogy Evo O2, Trilogy EV300  
Flow Sensor Nebulized Aerosol Deposition

21-NOV-2024

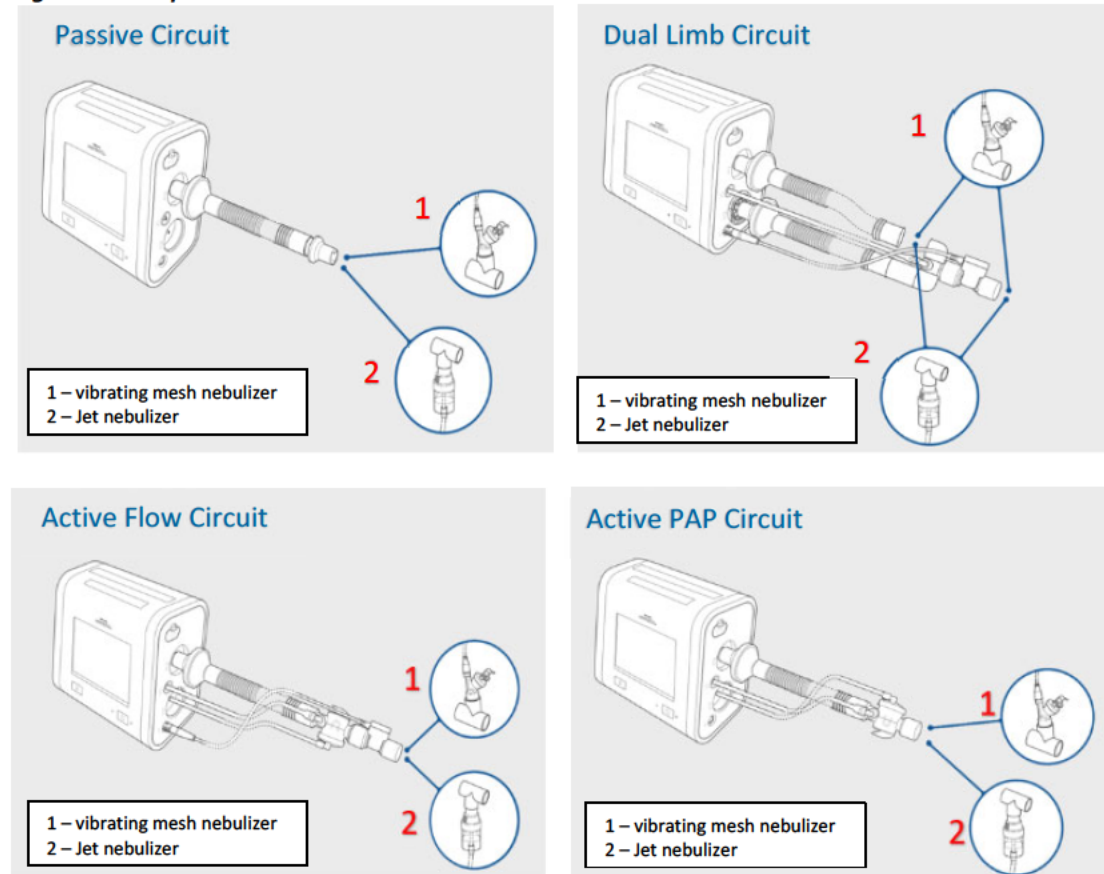
**Figure 1: Acceptable In-Line Nebulizer Placement**

- When tidal volumes greater than 700 mL are used with a passive circuit, nebulized aerosol deposition can occur even if the nebulizer is placed as pictured.

- If using in-line nebulizer treatments:
  - The circuit must be configured as pictured in the images in Figure 1 below.
  - For prescriptions needing tidal volumes greater than 700 mL with a passive circuit, transition patient to alternate circuit (Active PAP, Active Flow, or Dual Limb).

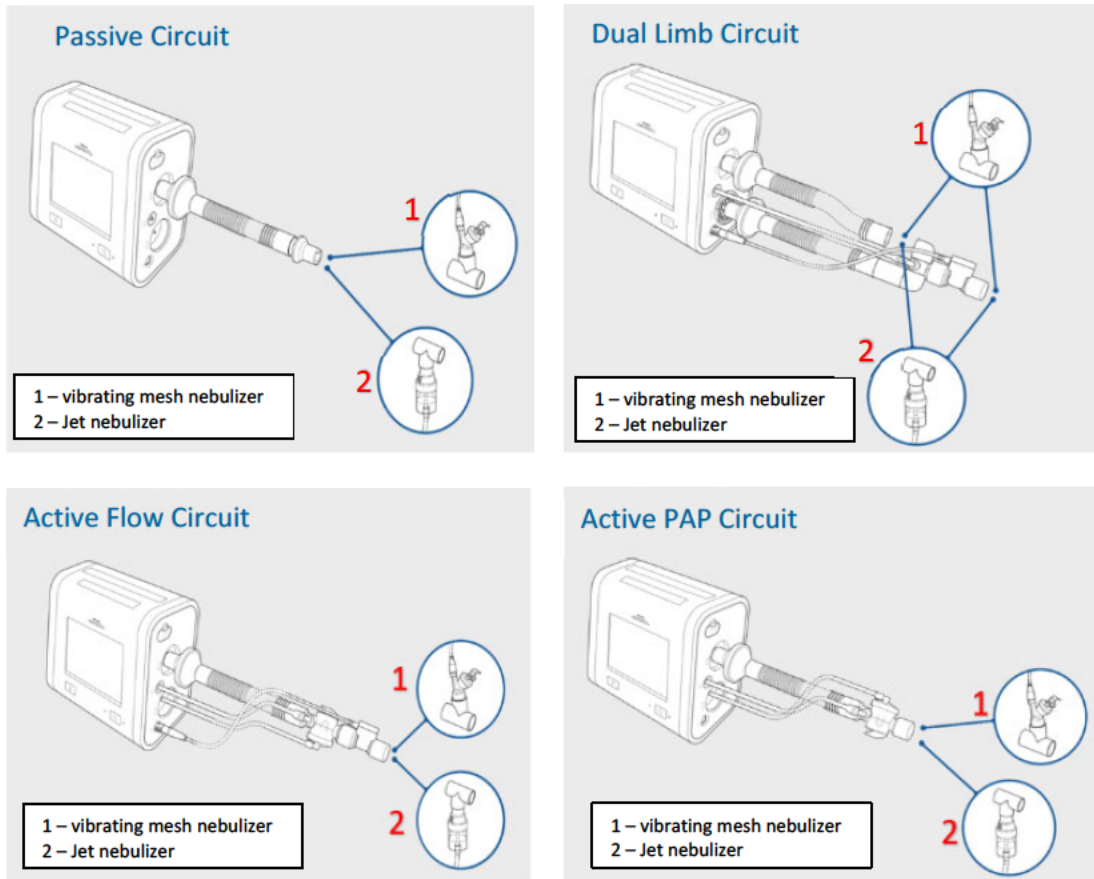
### Appropriate Circuit Configurations for Use With In-Line Nebulizers

- When tidal volumes greater than 700 mL are used with a passive circuit, nebulized aerosol deposition can occur even if the nebulizer is placed as pictured.

If using in-line nebulizer treatments, ensure the circuit is configured as shown in the images below.

Note: For prescriptions needing tidal volumes greater than 700 mL with a passive circuit, transition patient to alternate circuit (Active PAP, Active Flow, or Dual Limb).
