FA-2024-056:Dringender Sicherheitshinweis Korrektur für den OP-Tisch TruSystem 7000

104483 Version 01 Owner, Status, Date: see SAP

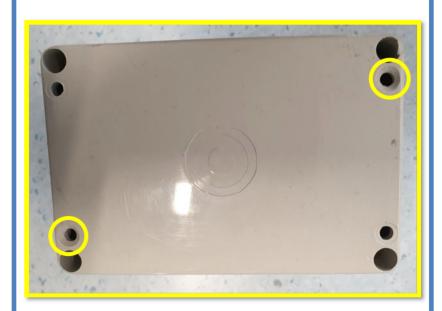
1. Installation situation of the battery (underside with holes for the positioning pins):

The batteries must be seated in the positioning pins provided for this purpose on the base of the column and must sit completely flat on the base of the column. Furthermore it must be made sure that there are no cables under the batteries.
	It is mandatory to reassemble the battery mounting bracket and in mobile columns the cable holder in the <u>correct</u> position. A mounted holder, however, does not mean that the battery is correctly fully seated on the column base.
	CHECK: The distance between the top edge of the battery and the top edge of the pot can be measured as a check. This should be approx. 10cm (see photos) if the battery is installed correct.

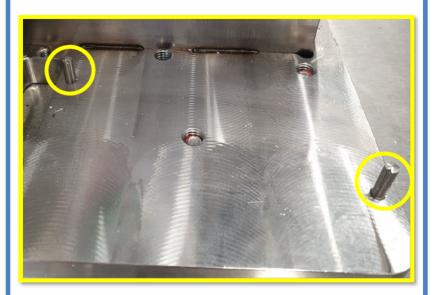
Installation situation
 TS7500/TS5500 (power supply side, without pot), positioning pins:

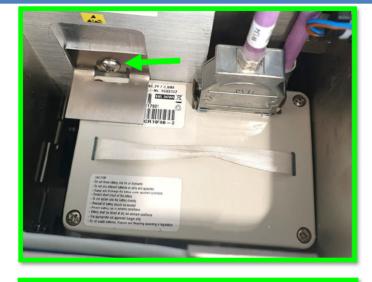
3. Battery correctly mounted in TS7500/TS5500 (power supply side) battery mounting bracket is installed correct, battery is flat on bottom of column, distance correct:

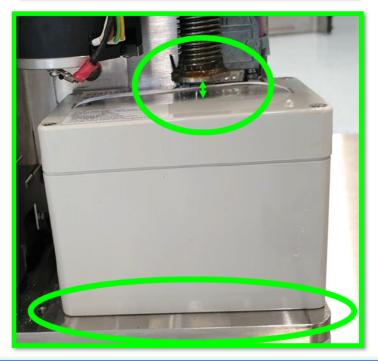
4. Lowest position of main lift incl. additional lift TS7500/TS5500 (without pot) when correctly mounted (distance between spindle and battery approx. 8mm, battery is flat on bottom of column):

After the batteries have been replaced, the column with the tabletop must be moved to the lowest lift position by the technician (including additional lift!). If there is a noticeable noise, it is imperative that the condition of the batteries is checked again, if they are damaged, replace them.

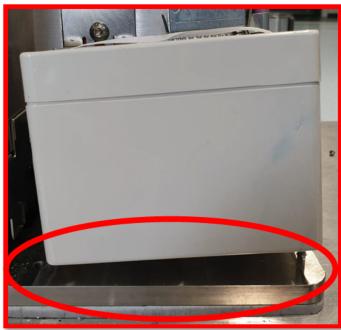
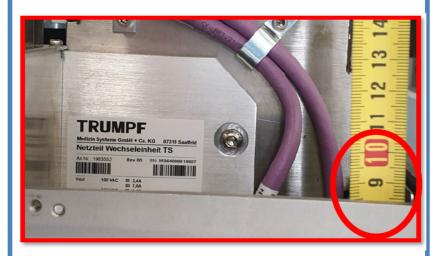
, , , , , , , , , , , , , , , , , , ,	
Issue details	When replacing the rechargeable batteries, Mat.1533137 or Mat.2066802, it is important to ensure the correct positioning of the batteries in the operating table. If the batteries are not placed correctly, the batteries or the battery plug may be damaged by the spindles of the tilting motor in the lowest column position.
	A damaged Li-lon battery is a safety risk and must be replaced.
	ATTENTION! Failure to follow the instructions in the service manual and as a result an incorrect battery position can lead to a short circuit / smoke development / fire!!!
Solution/Action	TS7000 / TS7000dV: Instructions from the Service Manual 4990344 Chapter 6 and 18.1 must be strictly followed.
	TS7500 / TS7500 Hybrid: Instructions from Service Manual 4990348 Chapter 7 and 20.4 must be strictly followed.
	TS5500: Instructions from Service Manual 1681913 Chapter 5 and 13.3 must be strictly followed.

5. Battery incorrectly mounted in TS7500/TS5500 (power supply side, without pot), battery mounting bracket is installed incorrect, battery is not flat on bottom of column, distance incorrect:

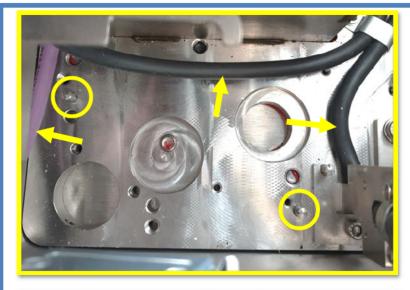
6. Installation situation TS7500/TS5500 (motor side, mobile columns only), positioning pins and cables:

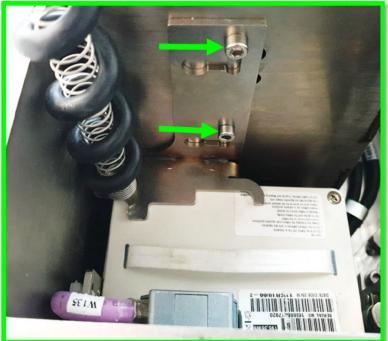
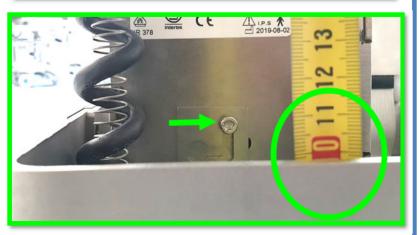
7. Battery correctly mounted in TS7500/TS5500 (motor side, only mobile column) cable holder is installed correct, no cable under the battery (flat on base), distance correct:

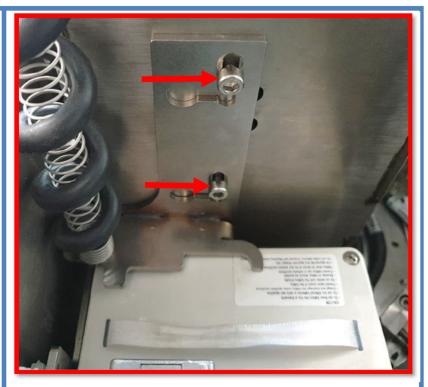
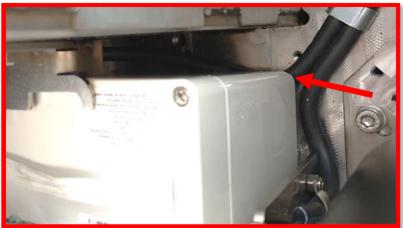
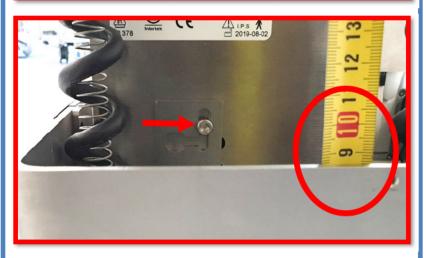
8. Battery incorrectly mounted in TS7500/TS5500 (motor side, only mobile column), cable holder is installed incorrect, cable under the battery, distance incorrect:

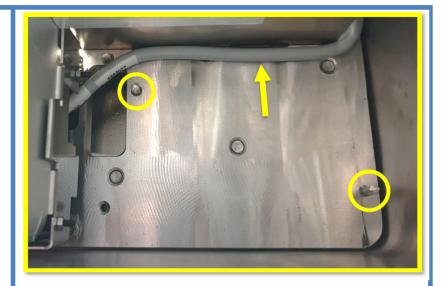
Installation situation
 TS7000(dV) (power supply side),
 positioning pins and cable on the guide side:

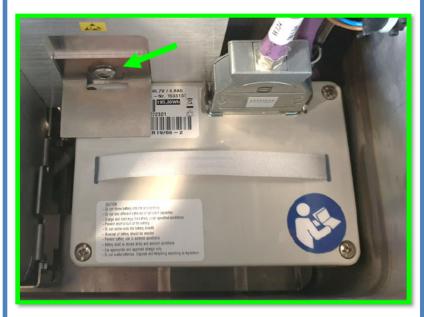
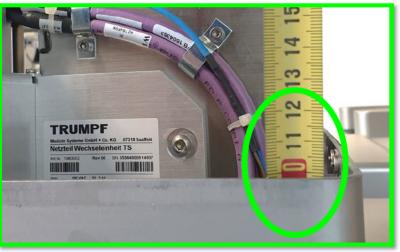
10. Battery correctly mounted in TS7000(dV) (power supply side), battery mounting bracket is installed correct, battery is flat on bottom of column, distance correct:

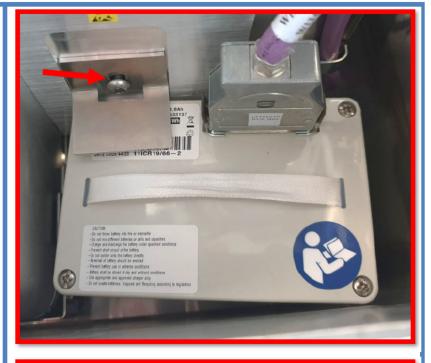
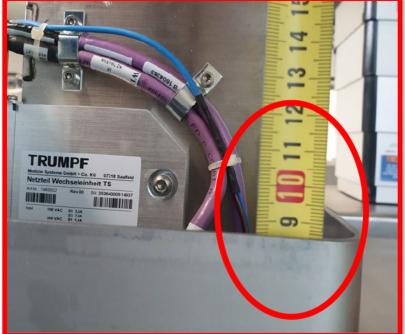
10. Battery incorrectly mounted in TS7000(dV) (power supply side), battery mounting bracket is installed incorrect, battery is not flat on bottom of column, distance incorrect:

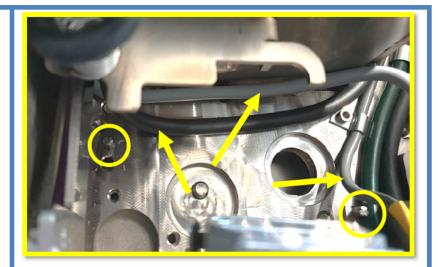
11. Installation situation TS7000(dV) (Motor side) positioning pins and cables:

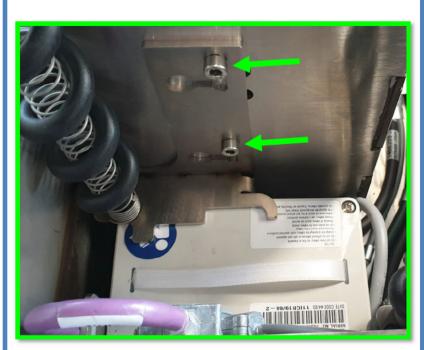
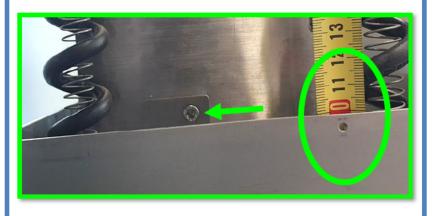
12. Battery correctly mounted in TS7000(dV) (motor side), cable holder is installed correct, no cable under the battery (flat on base), distance correct:

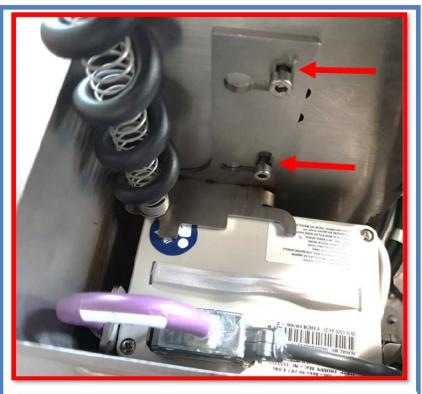
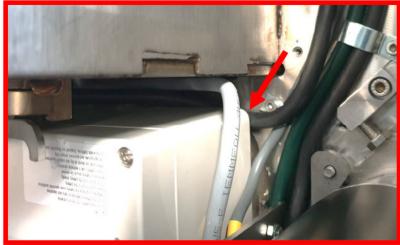
13. Battery incorrectly mounted in TS7000(dV) (motor side), cable holder is installed incorrect, cable under the battery, distance incorrect:
